Des Moines Pool Metropolitan Park District

September 26, 2023 7:00 p.m. Regular "Hybrid" Meeting

MOUNT RAINIER POOL EXISTING CONDITION ASSESSMENT and FEASIBILITY STUDY

CONDITION ASSESSMENT REPORT for MOUNT RAINIER POOL

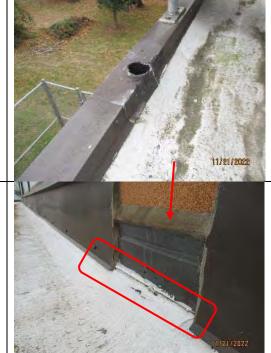
- 5. Overview of the one-piece counterflashing at the roof to wall transition at the east end of the main roof. The sealant along the top edge of the counterflashing is cracking (arrow) and the roof membrane (and coating) does not terminate behind the counterflashing (highlighted). Recommendation: Remove counterflashing, extend roof membrane further up vertical surface, termination bar at top edge, and install new counterflashing set in a saw cut.
- 6. Closer view of previous photo showing roof membrane and coating not installed behind metal flashing.

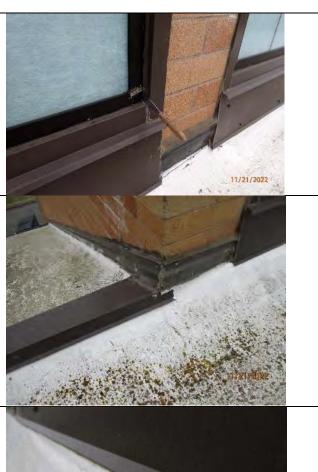
12. View of open lap joints in drip edge metal, as indicated in previous item.

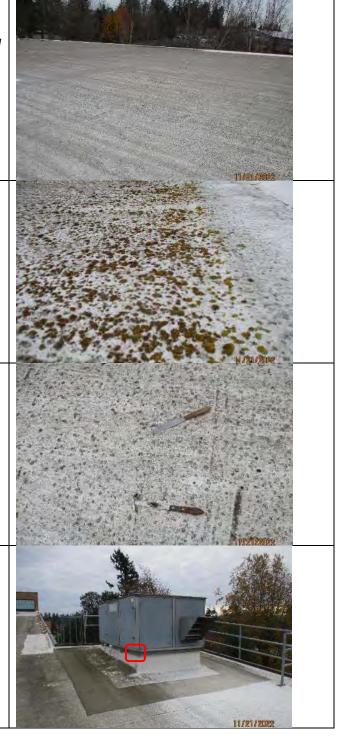
20. Closer view of the breach in the curb baseflashing highlighted in the previous photo.

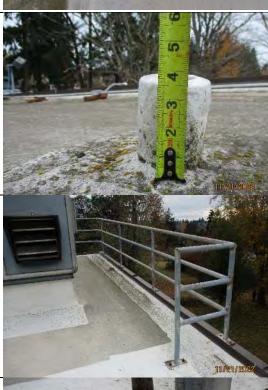
22. Railing installed around mechanical unit at the south end of the roof is mounted with fasteners driven directly through the coping and roofing membrane, without flashing. Recommendation: Install reinforced liquid flashing membrane up pipe penetrations, covering bolts and base plates. Verify there are no open holes in pipe

23. Showing void around base plate of railing attached through roofing.

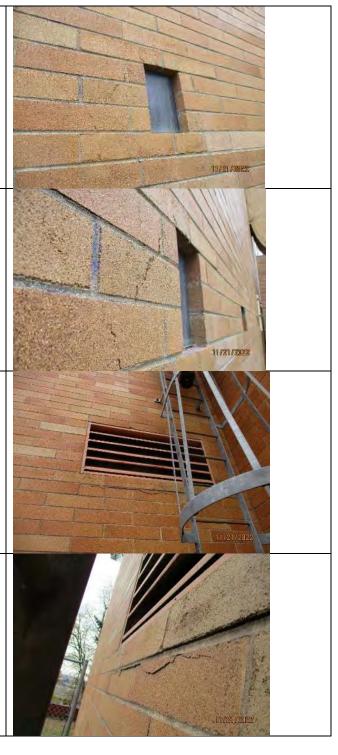
18. Looking down from the roof at the south elevation, where the main roof transitions to the clerestory structure. There is a large crack in the brick and

Recommendations: Structural repair appears necessary to prevent future cracking, followed by replacement of the brick. Another option is to install new cladding, insulation, and weather barrier over the brick after structural repairs.
