Des Moines Pool Metropolitan Park District

August 22, 2023

**MOUNT RAINIER POOL
EXISTING CONDITION ASSESSMENT
and FEASIBILITY STUDY**

PART 1: EXISTING CONDITION ASSESSMENT

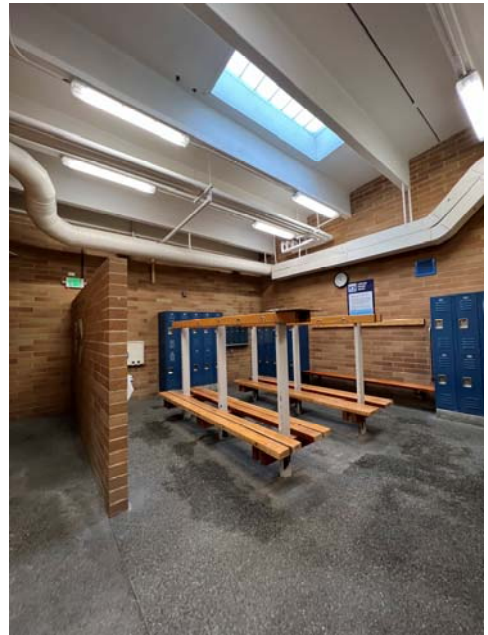
13. Men's and Women's Locker Rooms –Shower and Restroom Areas

Deficiency/Observation: the restroom areas, shower areas, and plumbing fixtures are worn and aged; the shower tile and restroom stalls are stained and aged, but still function. Privacy shower and changing areas are not available (unless the accessible shower stall is being used for this)

Recommendations: the plumbing fixtures will likely require replacement. Refer to mechanical report for details; replace all of the shower tiles and replace the restroom stalls with new heavy duty use stalls (HPDE) for easier maintenance and durability. Provide privacy shower and changing stalls in each locker room. While these areas minimally comply with accessibility requirements, improvements to provide better accessibility pathways and stalls should be considered.

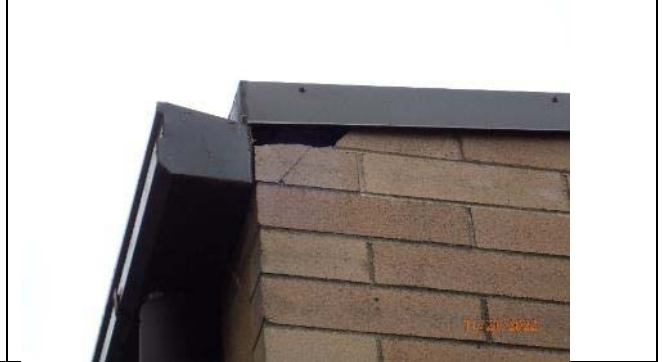
22. Missing masonry at the southwest corner of the building, behind the gutter.
Recommendations: Temporary solution would be to install sheet metal counterflashing tucked under the outer leg of the coping metal. More permanent repair would require replacement of cracked brick with new brick to infill to roof line. Another option is to install new cladding over new weather barrier.

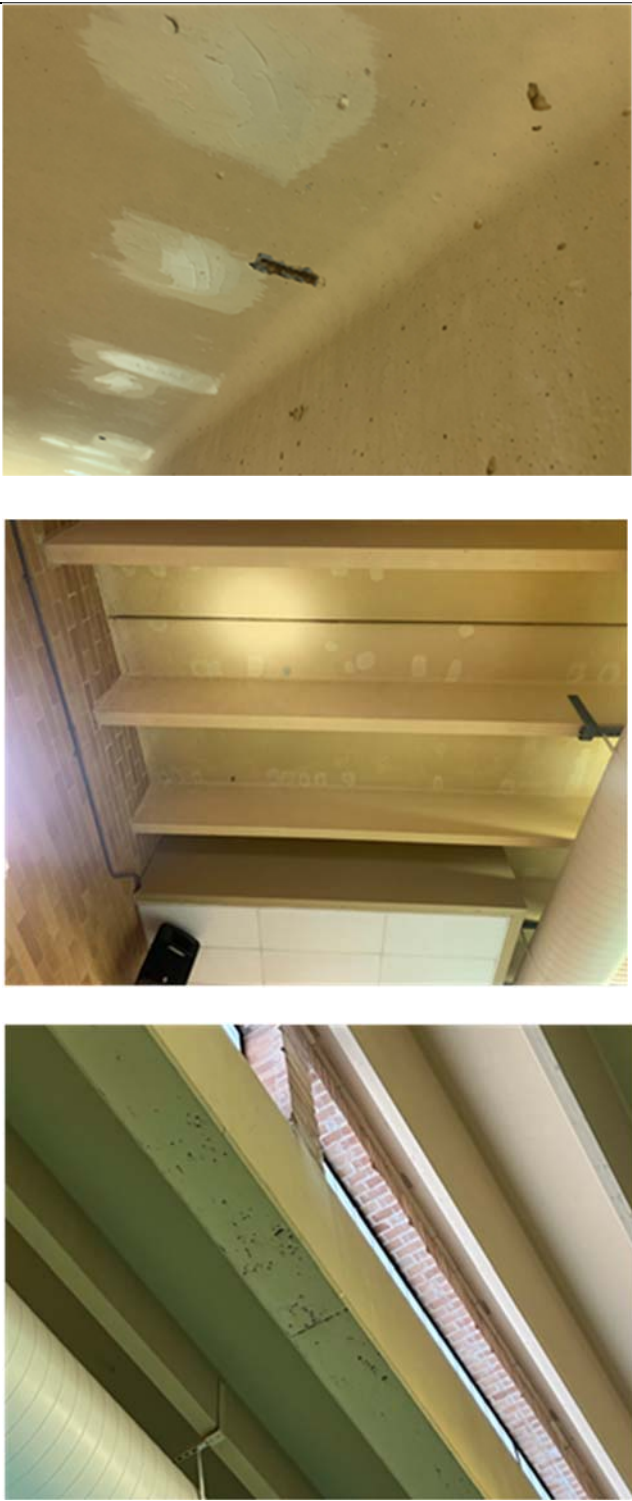
<i>Description</i>	<i>Photo</i>
<p>1. Pitting and spalling in precast concrete roof system</p> <p><u>Deficiency/Observation:</u> Pitting and local spalling exposing sections of reinforcing is common on the underside of the precast roof system.</p> <p><u>Recommendation:</u> Clean areas where pitting and spalling are observed, including any exposed reinforcing. Excavate the concrete around the corroded reinforcing bars and coat the exposed steel, then patch the spall area.</p>

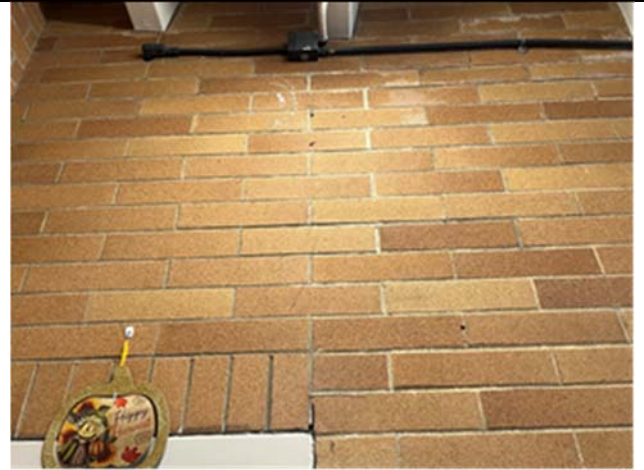
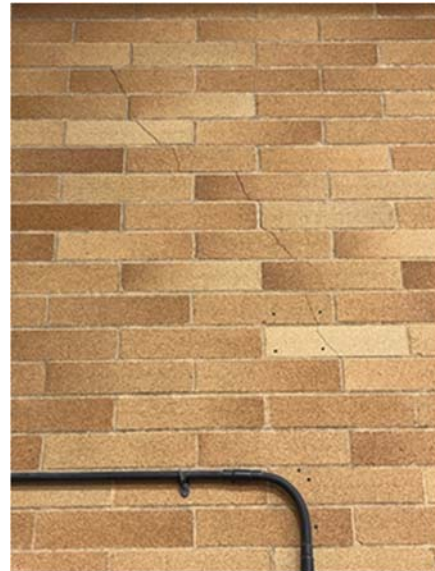
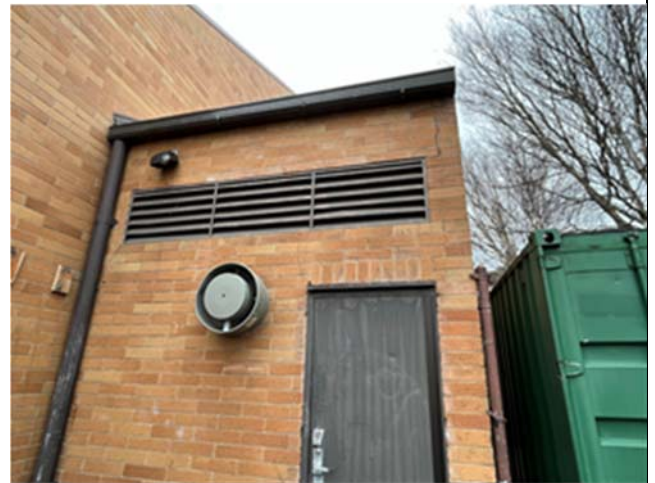
2. Cracking in the brick masonry

Deficiency/Observation: Cracking through the face of the brick masonry is observed in both interior and exterior walls at multiple locations.

Recommendation: Replace cracked brick faces, with the focus being on significant cracks that could allow water intrusion.

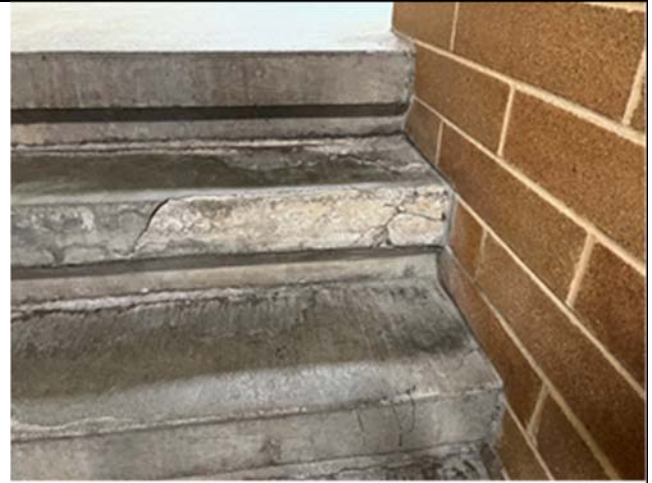
3. Concrete stair tread deterioration

Deficiency/Observation: Cracking and deterioration observed in concrete stair treads at the seating area west access stairs.

Recommendation: Remove any loose material, clean base concrete and any exposed reinforcing, and apply patch using appropriate methods. Inject cracks that are greater than 0.1 inches in width with high-pressure low-viscosity epoxy.

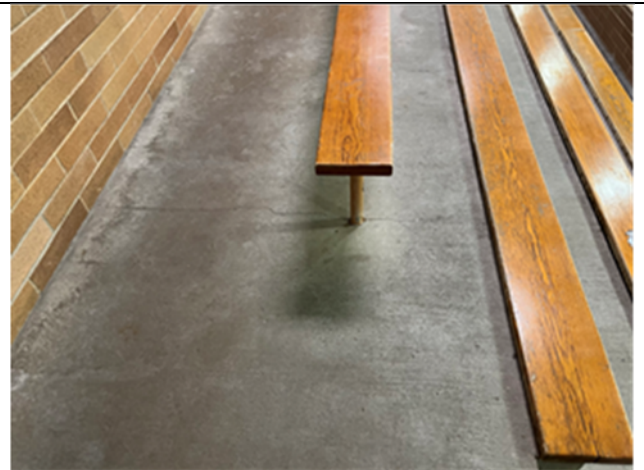
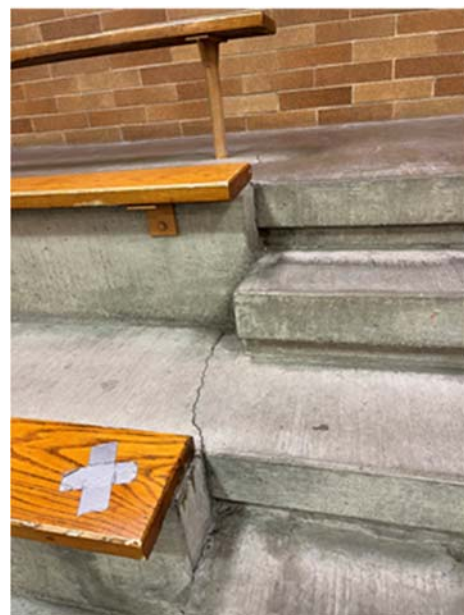
4. Concrete cracks at seating area

Deficiency/Observation: Cracking observed in the concrete in the bleacher seating area at every bench post penetration through the slab and at each side of the intermediate concrete stairs.

Recommendation: Inject cracks that are greater than 0.1 inches in width with high pressure low-viscosity epoxy.

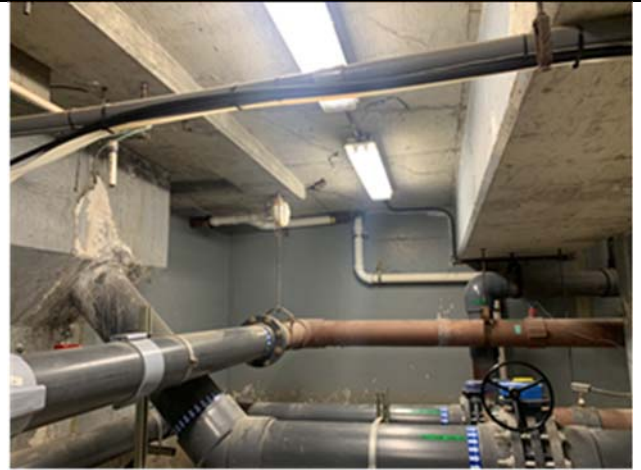
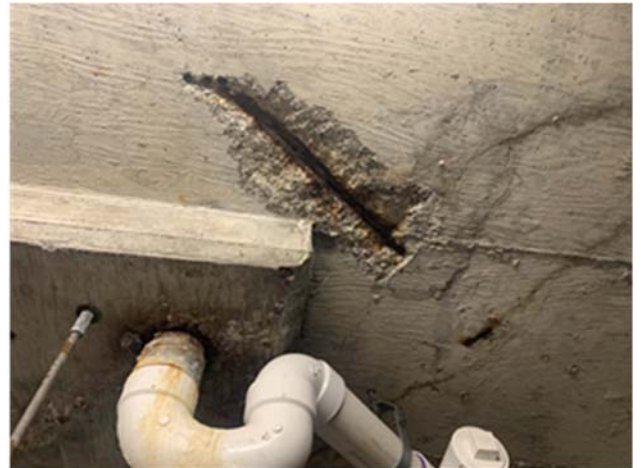
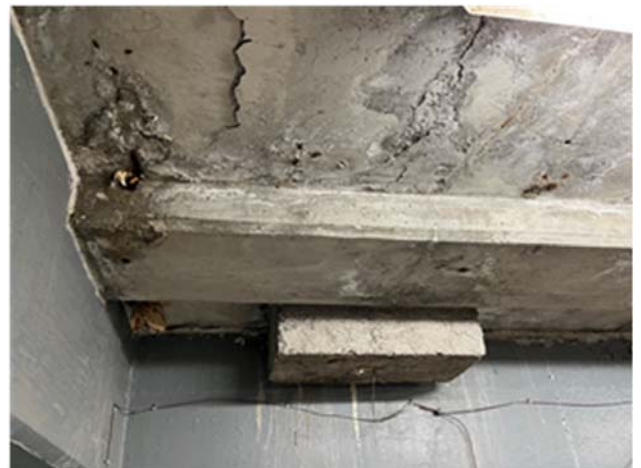
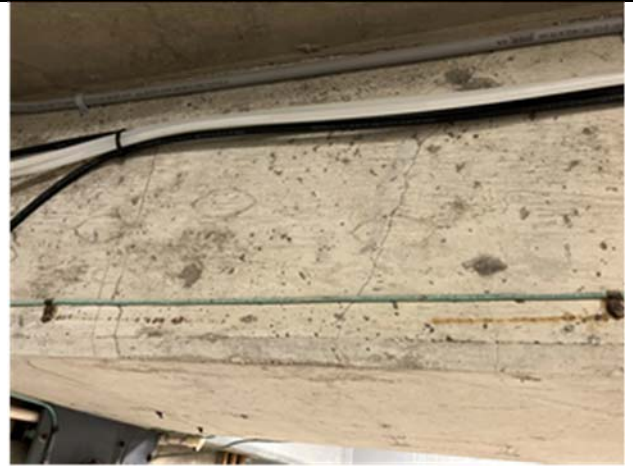
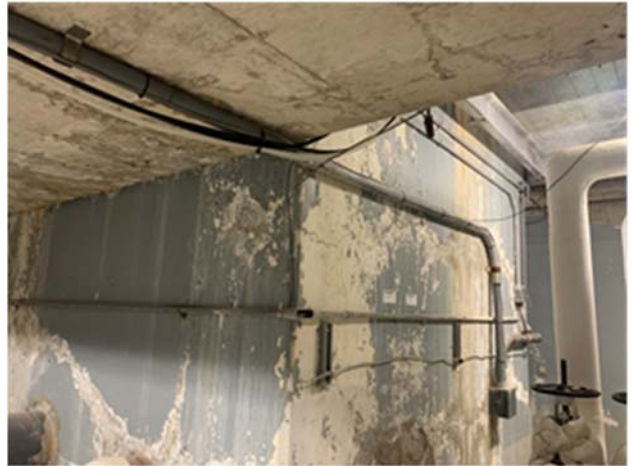
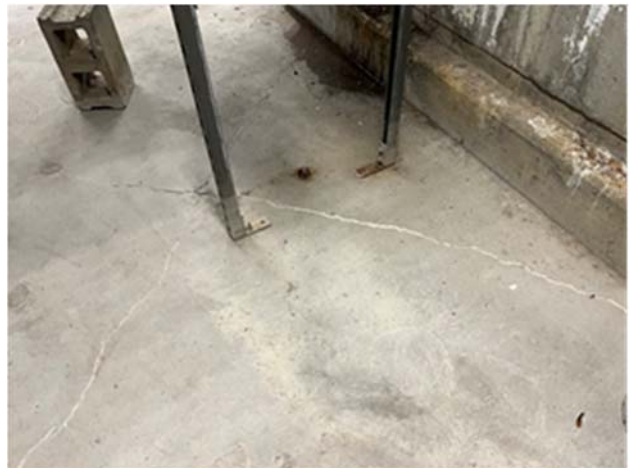
5. Filter Room basement concrete deterioration

Deficiency/Observation: Significant issues observed in the cast-in-place concrete. Delamination and spalling on the underside of the suspended slab exposing reinforcing, cracking in concrete beams, tank walls, and slab-on-grade.

Recommendation: Remove all delaminated concrete from the suspended slab. Clean and coat all exposed reinforcing, rebuild suspended slab, and fill spalls with new reinforcing added where required. Excavate behind corroded rebar where corrosion surrounds rebar. Inject cracks that are greater than 0.1 inches in width with high pressure low-viscosity epoxy.

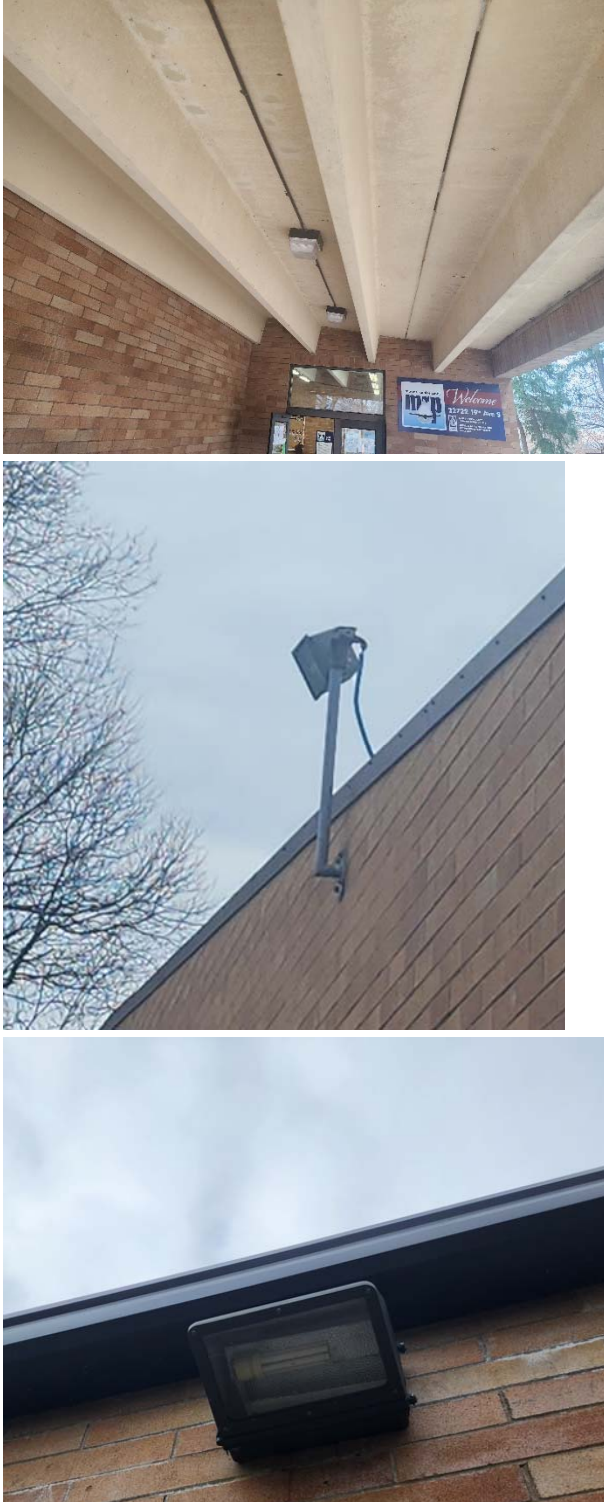
<i>Description</i>	<i>Photo</i>
<p>1. Exterior Lighting</p> <p><u>Deficiency/Observation:</u> Exterior lighting is either Metal Halide or High-pressure sodium or fluorescent.</p> <p><u>Recommendation:</u> Replace exterior building lighting with new LED fixtures listed for outdoor location.</p>

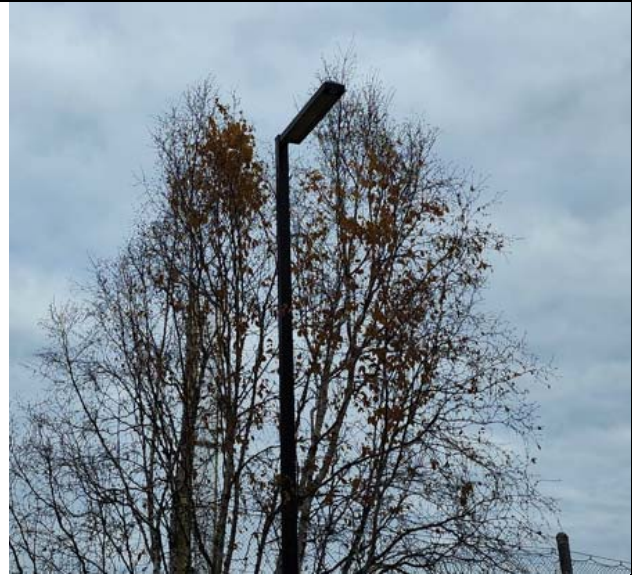
10. – Parking lot Lighting

Newer LED pole lights appear to be sufficient.

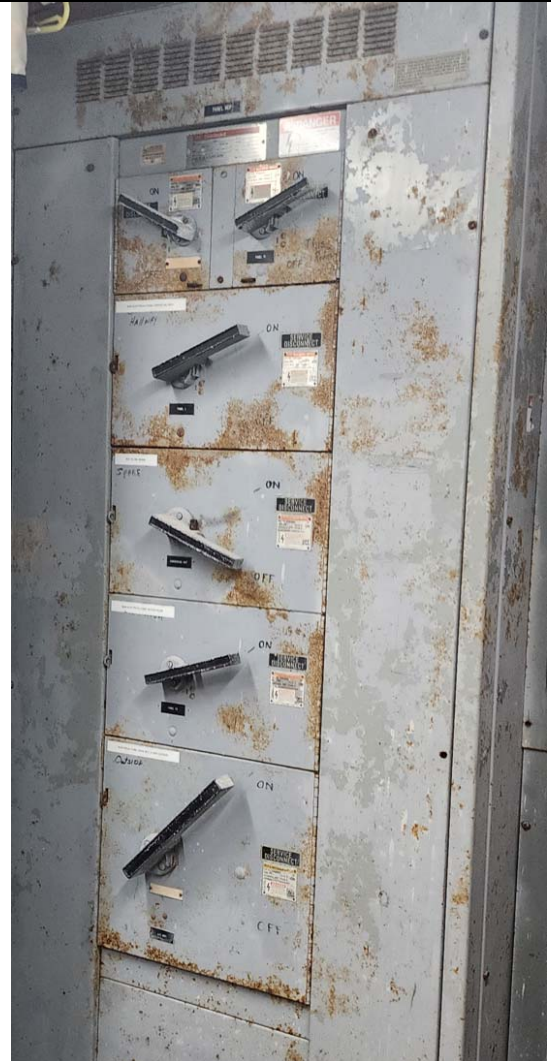
Main Distribution Board is past the standard life expectancy of 30 years. Full replacement and potential upgrades to capacity. Main Distribution board and raceway shall be suitable for the environment NEC 680.14, 680.12 & 300.6.

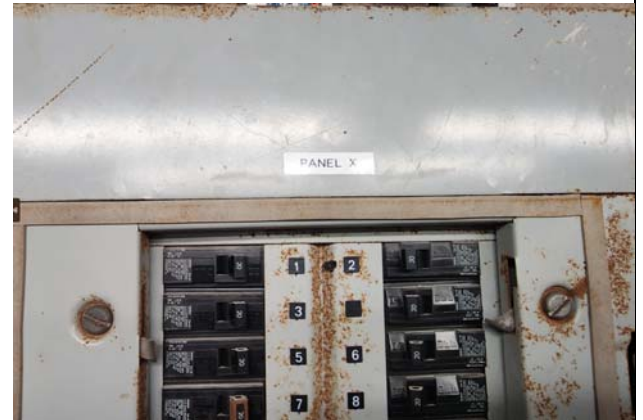
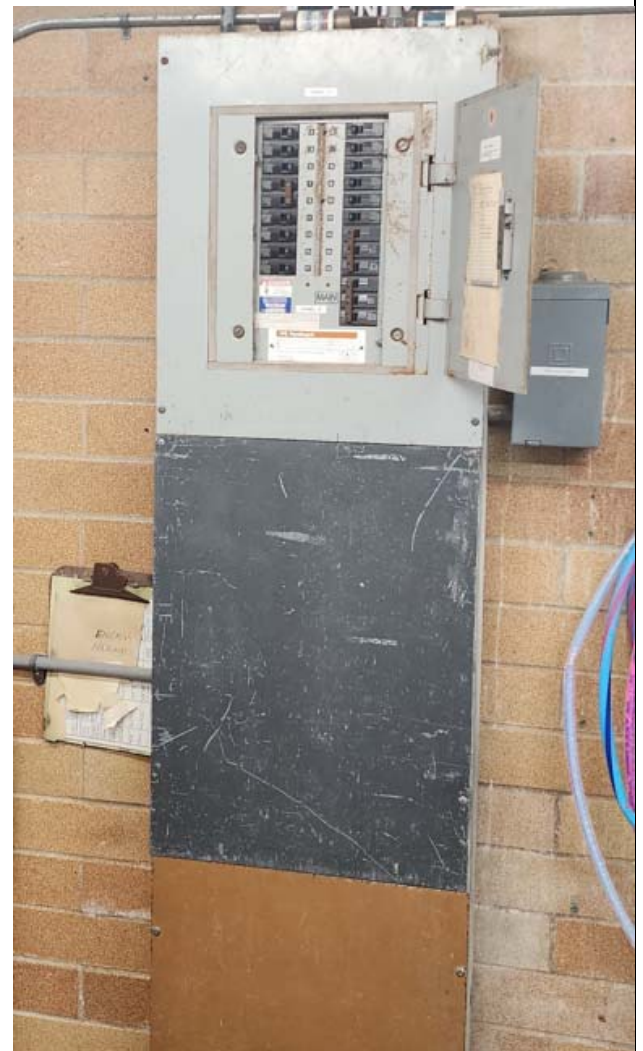
20. – Panel X - 100A, 120/208V, 3 phase

Panelboard is past the standard life expectancy of 30 years. Full replacement and potential upgrades to capacity. Panel and raceway shall be suitable for the environment NEC 680.14, 680.12 & 300.6. Panel will need to be located to meet working space clearances and heights per NEC and local jurisdiction.

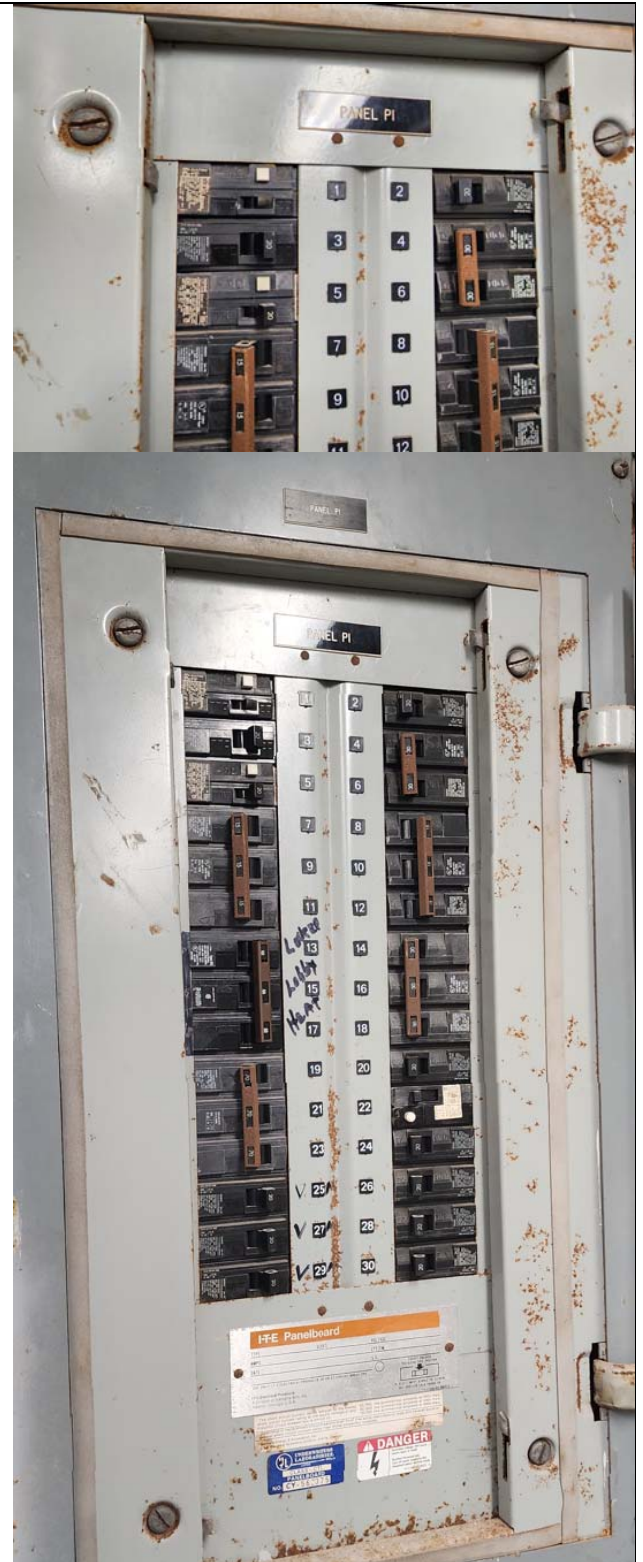
21. – Panel P1 - 225A, 120/208V, 3-Phase

Panelboard past the standard life expectancy of 30 years. Full replacement and potential upgrades to capacity. Panel and raceway shall be suitable for the environment NEC 680.14, 680.12 & 300.6.

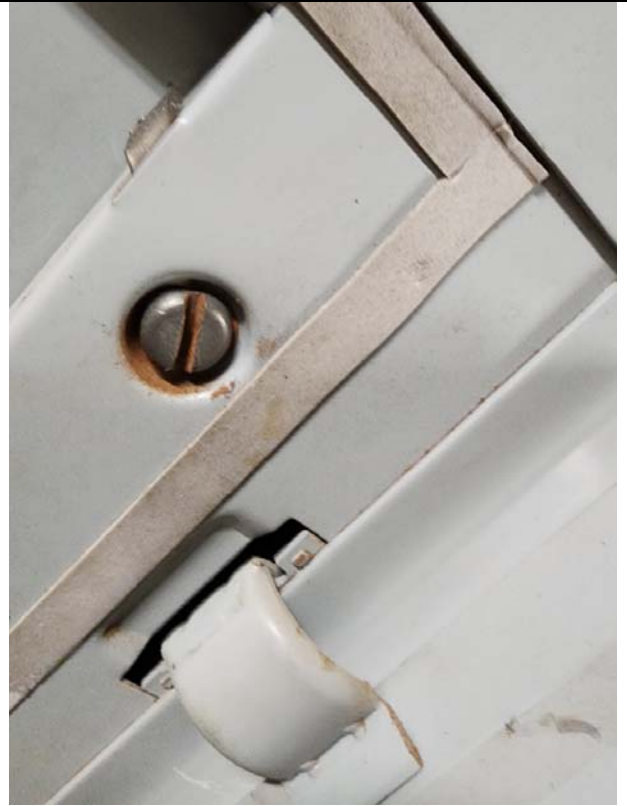
22. – Panel P2 - 225A, 120/208V, 3-Phase

Panelboard is past the standard life expectancy of 30 years. Full replacement and potential upgrades to capacity. Panel and raceway shall be suitable for the environment NEC 680.14, 680.12 & 300.6.
