Des Moines Pool Metropolitan Park District

**MOUNT RAINIER POOL CONDITION ASSESSMENT
DES MOINES POOL METROPOLITAN DISTRICT
PROJECT NO.: 2104.3 – 65% DRAFT**

**DES MOINES POOL METROPOLITAN PARK DISTRICT
MOUNT RAINIER POOL
COMPREHENSIVE CONDITION REPORT
(65% DRAFT)**

DES MOINES POOL METROPOLITAN PARK DISTRICT
PART 1 – MOUNT RAINIER POOL
COMPREHENSIVE CONDITION
ASSESSMENT

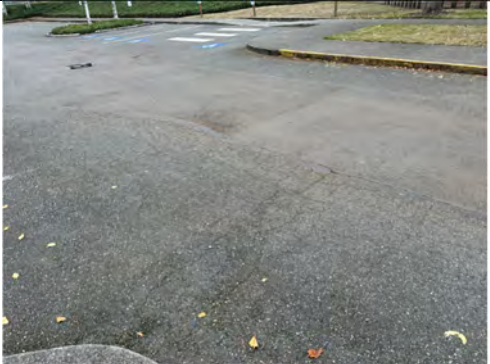
Description	Photo
1. Existing Asphalt <i>Deficiency/Observation:</i> The majority of the asphalt has appeared to be near the end of its useful life. There is significant alligatoring and cracking. There is a patch down the drive aisle that is in better location, but still has some failure occurring. <i>Recommendation:</i> Provide square patch removal at the worst areas, and attempt to install a Petromat or equal over the surface of the parking lot and overlay with a new 2" lift.

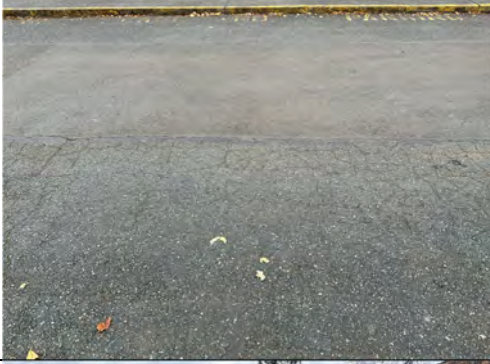
2. Existing Asphalt – See Item 1 <i>Note:</i> The typical maximum threshold to replace asphalt prior to drainage improvements is 5,000 sf. Beyond this amount Water Quality treatment and Flow Control (Detention) could be required. Jurisdictions have different interpretations of maintenance and how and when this threshold is triggered.

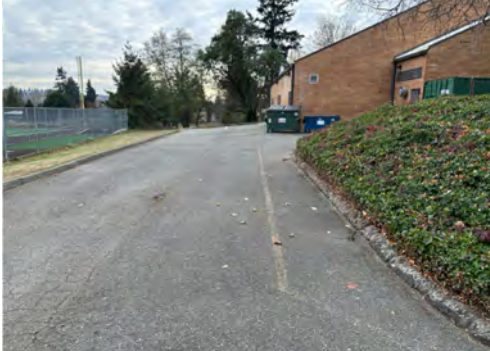
3. Existing Asphalt – See Item 3

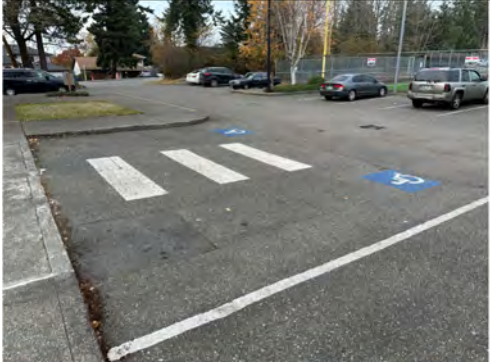
<p>4. ADA Parking</p> <p><u>Deficiency/Observation:</u> The existing ADA is non-compliant and over the maximum ADA slope of 2% in any direction.</p> <p><u>Recommendation:</u> Remove existing asphalt and replace with concrete as it is more durable and tolerant to set precise and flatter slopes.</p>

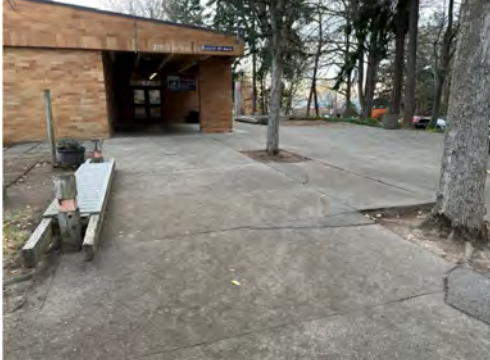
<p>4. Replace ADA Pathway from Parking</p> <p><u>Deficiency/Observation:</u> The existing ADA pathway from the ADA parking stalls to the front door is not complete compliant, and portions exceed the allowable 2% cross slope.</p> <p><u>Recommendation:</u> Remove and replace non-conforming portions of the existing concrete sidewalk ADA Pathway.</p>

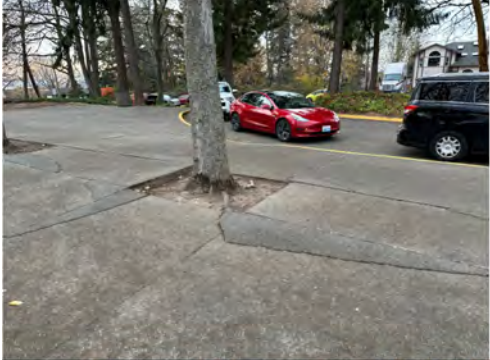
<p>5. Replace Cracking and Lifting Concrete</p> <p><u>Deficiency/Observation:</u> Portions of the existing concrete sidewalks and plazas are lifting due to tree roots or other issues related to life expectancy of the improvements.</p> <p><u>Recommendation:</u> Replace existing concrete to eliminate pedestrian safety concerns.</p>

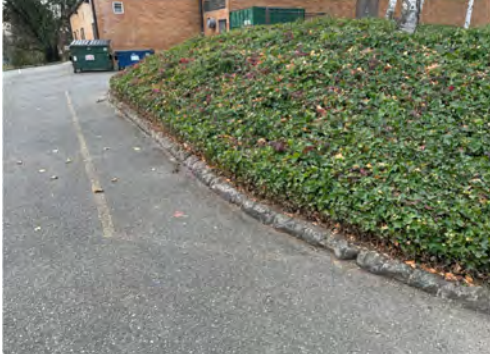
<p>6. Replace Extruded Curbs</p> <p><u>Deficiency/Observation:</u> The majority of the existing extruded curbs are disintegrating.</p> <p><u>Recommendation:</u> Replace existing extruded curbs.</p>

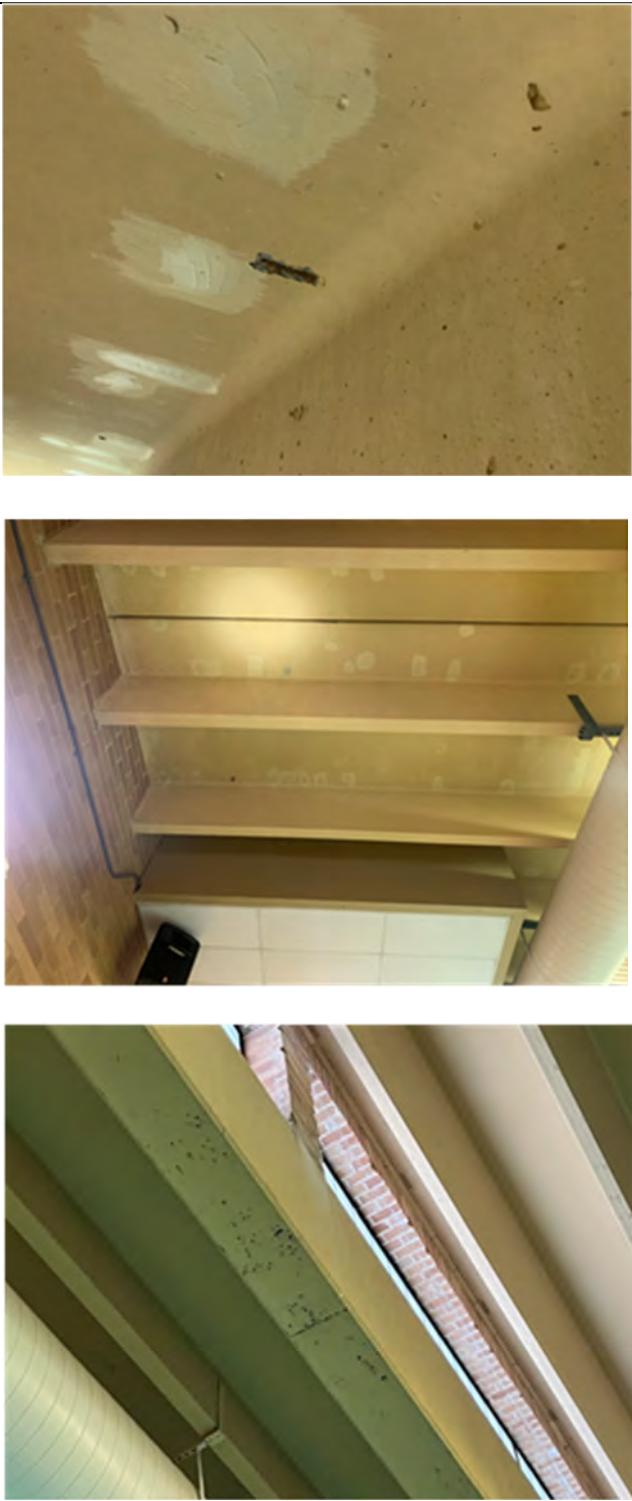
Description	Photo
<p>1. Pitting and spalling in precast concrete roof system</p> <p><u>Deficiency/Observation:</u> Pitting and local spalling exposing sections of reinforcing is common on the underside of the precast roof system.</p> <p><u>Recommendation:</u> Clean areas where pitting and spalling are observed, including any exposed reinforcing. Coat exposed steel and patch the spall area.</p>

<p>The first photograph shows a close-up of a concrete ceiling with several small, dark, irregular pits and a larger area of spalling where the concrete surface has been removed, exposing a dark, embedded steel reinforcing bar. The second photograph shows a wider view of the ceiling, with multiple horizontal concrete slabs separated by vertical supports. Several similar pitting and spalling defects are visible across the surface of the slabs. The third photograph shows a corner or edge of the roof system, where the concrete is crumbling and the steel reinforcement is exposed and rusted. A brick wall is visible in the background of this shot.</p>

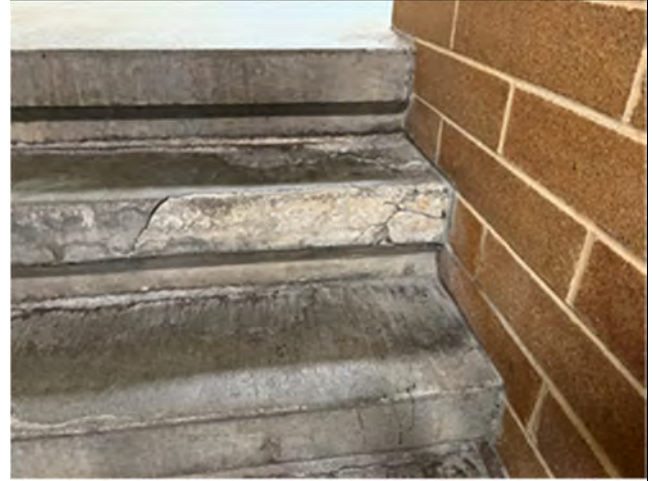
3. Concrete stair tread deterioration

Deficiency/Observation: Cracking and deterioration observed in concrete stair treads at the seating area west access stairs.

Recommendation: Remove any loose material, clean base concrete and any exposed reinforcing, and apply patch using appropriate methods. Inject cracks that are greater than 0.1 inches in width with high pressure epoxy.

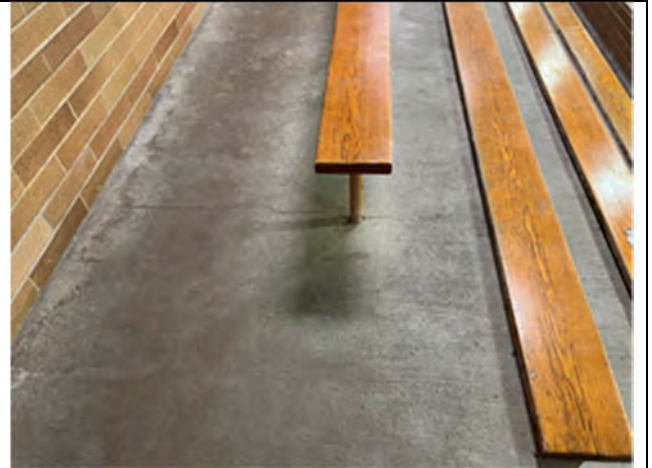
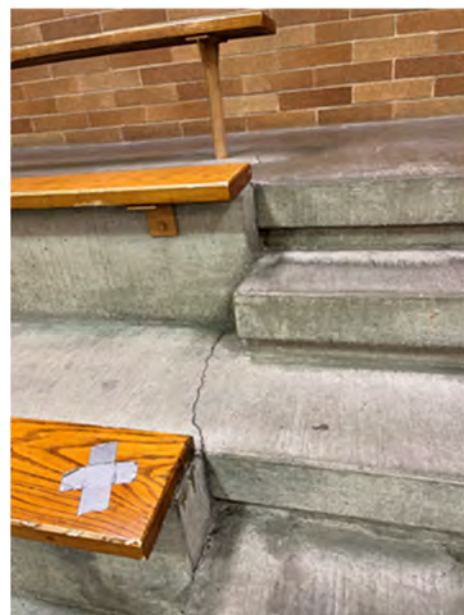
4. Concrete cracks at seating area

Deficiency/Observation: Cracking observed in the concrete in the bleacher seating area at every bench post penetration through the slab and at each side of the intermediate concrete stairs.

Recommendation: Inject cracks that are greater than 0.1 inches in width with high pressure epoxy.

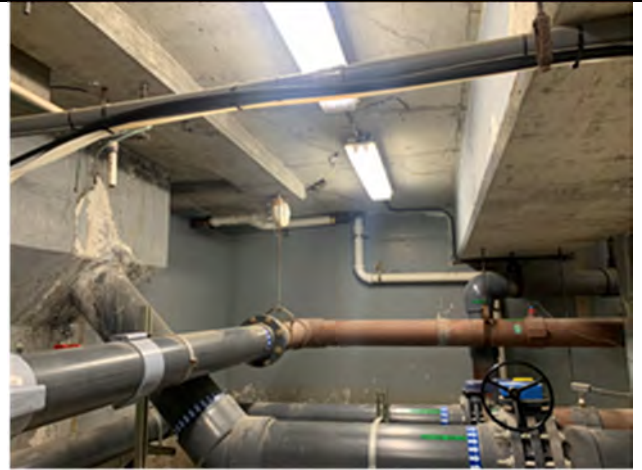
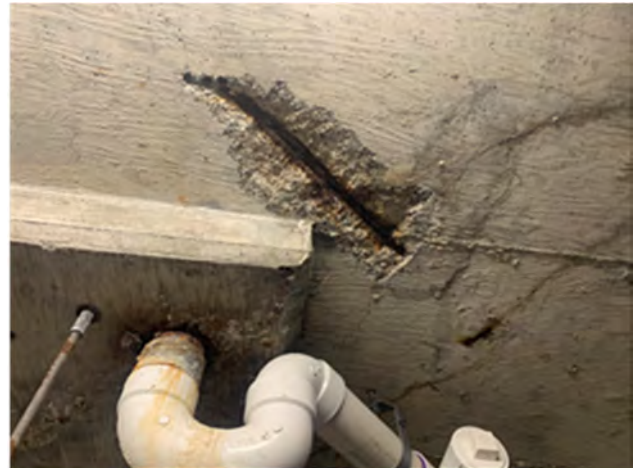
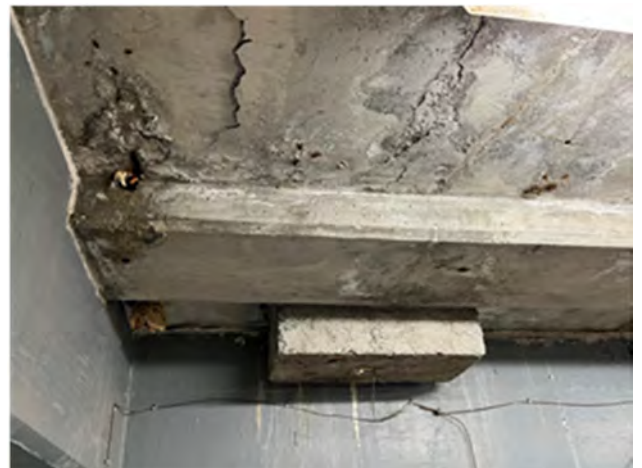
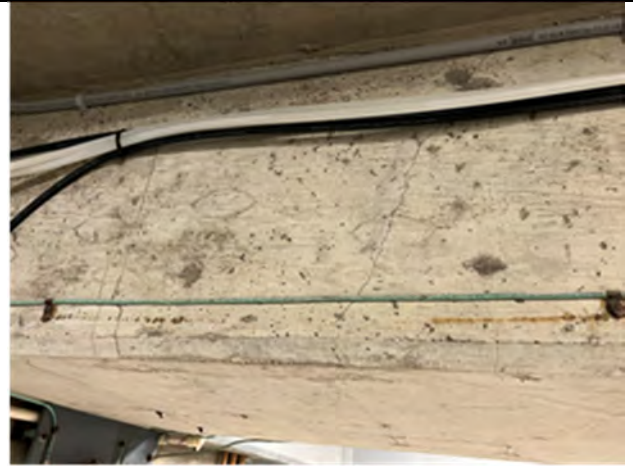
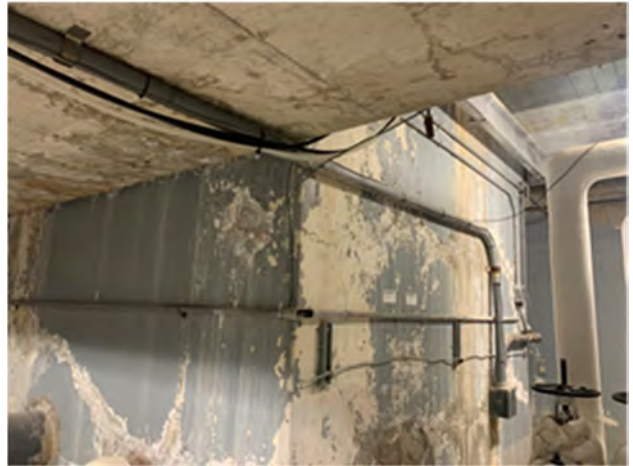
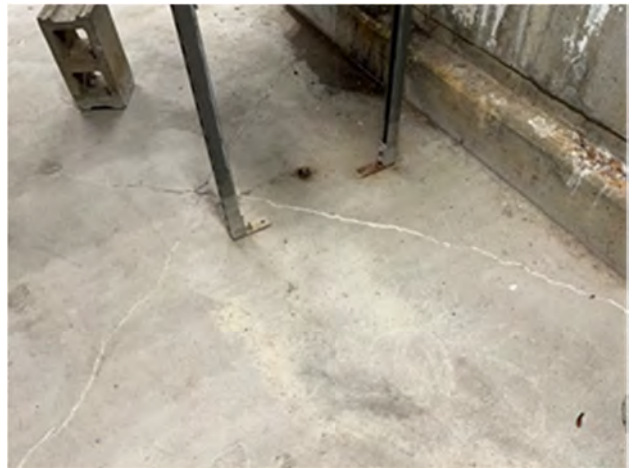
5. Filter Room basement concrete deterioration

Deficiency/Observation: Significant issues observed in the cast-in-place concrete. Delamination and spalling on the underside of the suspended slab exposing reinforcing, cracking in concrete beams, tank walls, and slab-on-grade.

Recommendation: Remove all delaminated concrete from the suspended slab. Clean and coat all exposed reinforcing, and rebuilt suspended slab and fill spalls with new reinforcing added where required. Inject cracks that are greater than 0.1 inches in width with high pressure epoxy.

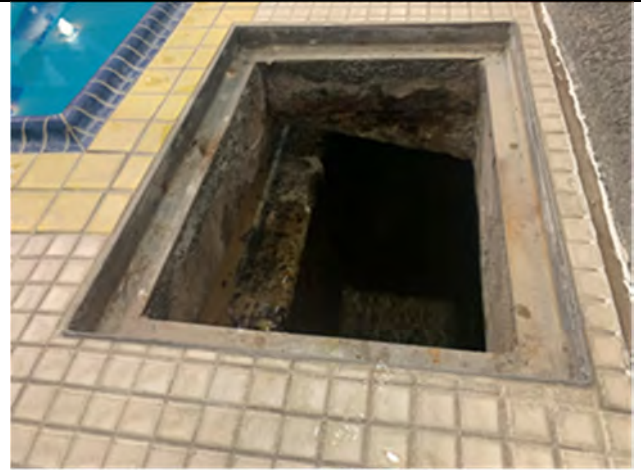
6. Cracking/corrosion at perimeter of pool

Deficiency/Observation: Concrete cracking and reinforcing corrosion are visible in the cantilevered slab section over the pool perimeter skimmer/drain.

Recommendation: Remove all delaminated concrete from the upper surface of the cantilevered slab down to sound concrete, clean and coat any exposed reinforcing, and apply patch using appropriate methods. Inject cracks that are greater than 0.1 inches in width with high pressure epoxy.

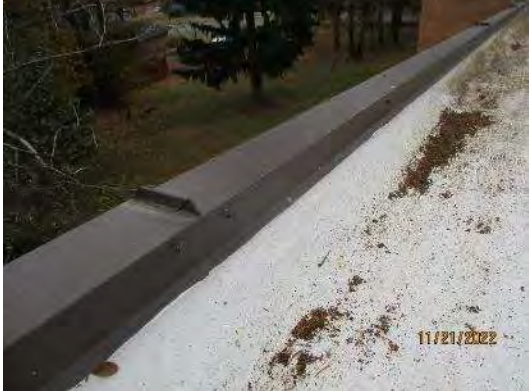
Description	Photo
<p>1. Overview of the low parapet wall and standing seam coping metal. Coating terminates at bottom edge of coping, indicating coping was not removed as part of the coating application. <i>Recommendation: Leave as-is and monitor for now. This condition can be addressed when reroofing, as there appear to be no current problematic conditions from this application.</i></p>

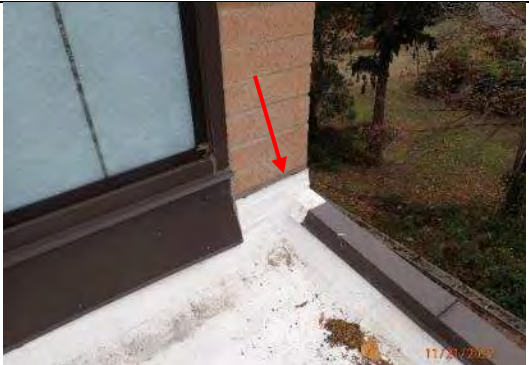
<p>2. Overview of the parapet to rising wall transition at the southeast corner of the main roof. The top edge of the baseflashing is not sealed (arrow). <i>Recommendation: Seal top edge of coating, install soldered saddle flashing that returns outside corner, and install sheet metal in saw cut to counterflash the saddle flashing.</i></p>

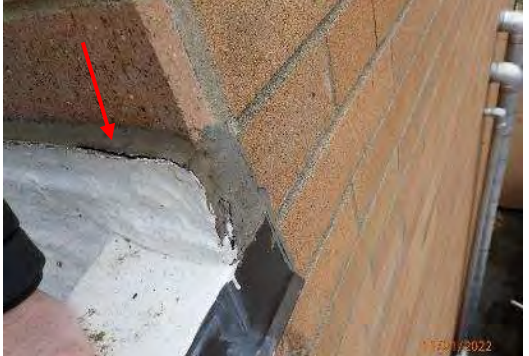
<p>3. Closer view of previous photo showing unsealed coating and lack of return around corner.</p>

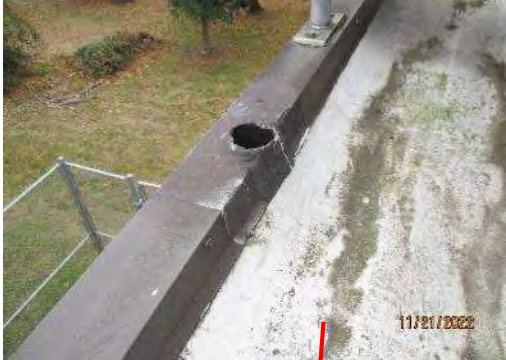
<p>4. Low pipe penetration through parapet at south side of roof adjacent roof access ladder. <i>Recommendation: Raise pipe penetration with extension and flash with reinforced liquid flashing, such as PMMA, or similar.</i></p>

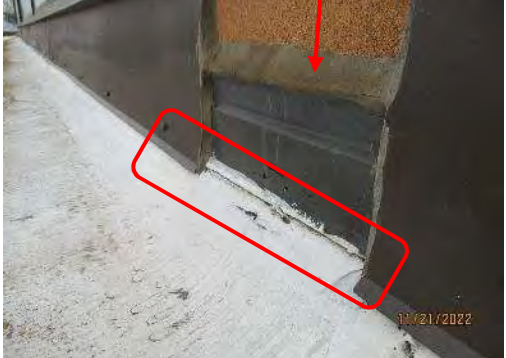
<p>5. Overview of the one-piece counterflashing at the roof to wall transition at the east end of the main roof. The sealant along the top edge of the counterflashing is cracking (arrow) and the roof membrane (and coating) does not terminate behind the counterflashing (highlighted). <i>Recommendation: Remove counterflashing, extend roof membrane further up vertical surface, termination bar at top edge, and install new counterflashing set in a saw cut.</i></p>

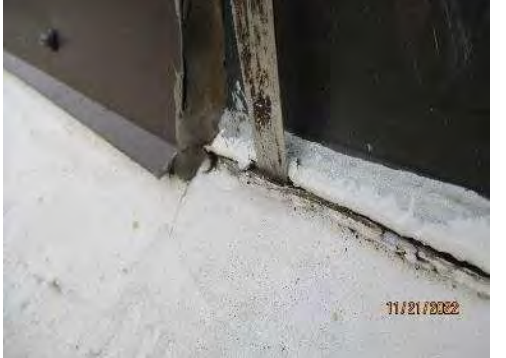
<p>6. Closer view of previous photo showing roof membrane and coating not installed behind metal flashing.</p>

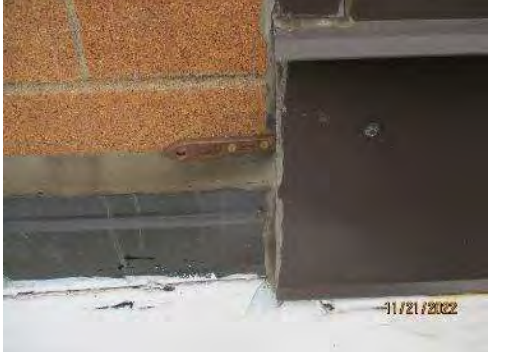
<p>7. Sealant no longer adhered between brick and metal flashing at the base of the clerestory window at the east end of the main roof. <i>Recommendation: Reseal joints after lower counterflashing is replaced, per item #5 & 6.</i></p>

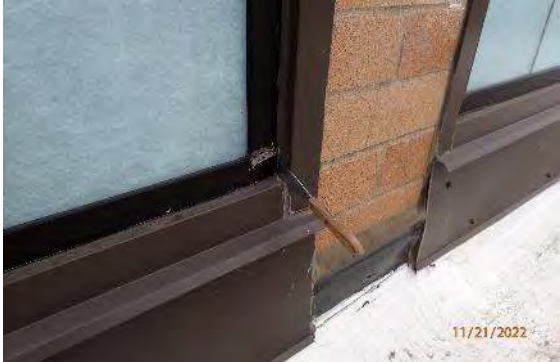
<p>8. Unadhered perimeter sealant joints at clerestory Kalwall windows at the east end of the main roof. <i>Recommendation: Remove existing sealant joints and replace with new sealant and backer rod, full perimeter of clerestory windows.</i></p>

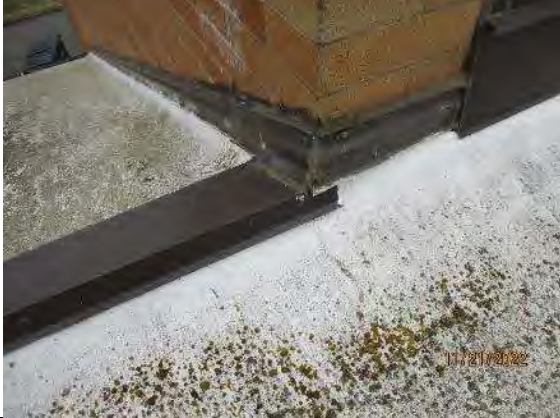
<p>11/21/2022</p>
<p>9. Overview of the transition from the main roof to the smaller steep sloped roof at the northeast corner of the building. The sealant applied along the counterflashing and coping metal is cracked and deteriorating. <i>Recommendation: Remove existing sealant and replace with new sealant, tooled in. Other options include stepped saw-cut counterflashing, a second layer of surface mounted counterflashing, or installation of cladding over the brick to counterflashing the flashing.</i></p>

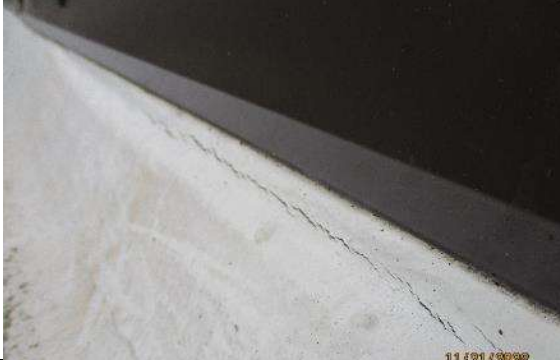
<p>11/21/2022</p>
<p>10. Cracking of the coating at the transition from roof-to-wall at the base of the clerestory windows. <i>Recommendation: Patch cracked areas with additional coating/reinforcing.</i></p>

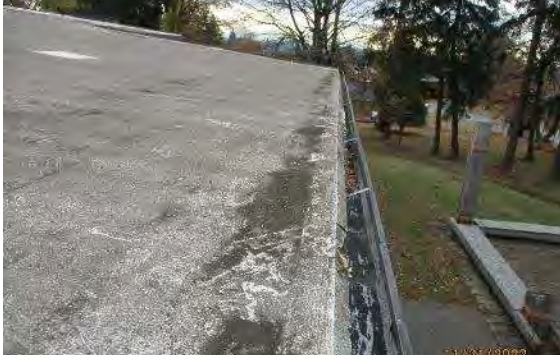
<p>11. Overview of the metal drip edge along the west perimeter of the roof. Drip edge metal has open lap seams, the drip edge does not return sufficiently into the gutter and appears to be installed over existing metal drip flashing. <i>Recommendation: Seal joints in flashing with additional reinforced coating and monitor until reroofing occurs.</i></p>

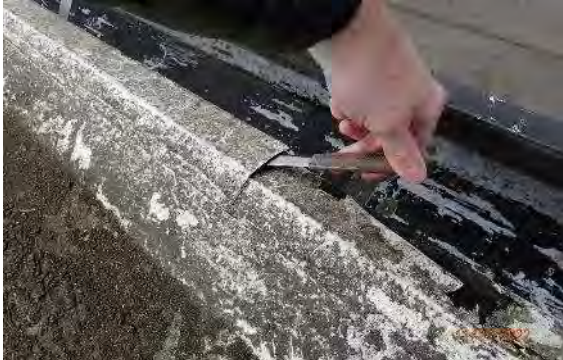
<p>12. View of open lap joints in drip edge metal, as indicated in previous item. <i>Recommendation: See item #11.</i></p>

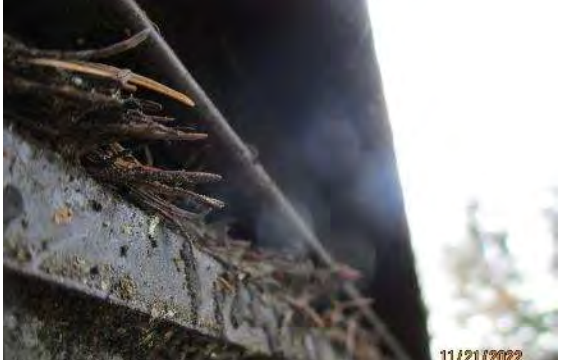
<p>13. View of the underside of the drip edge metal as shown in the two previous photos. Note the second layer of metal drip edge and organic debris collecting under the drip flashing. <i>Recommendation: Remove debris.</i></p>

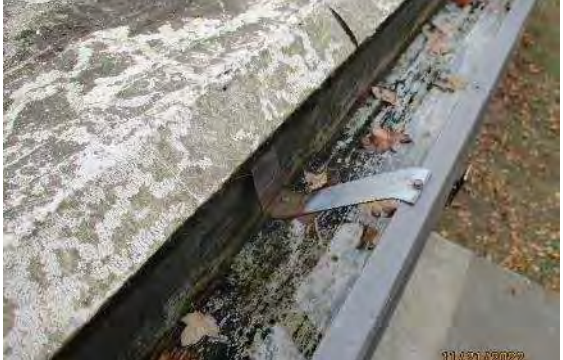
<p>14. Broken gutter straps at the west end of the main roof. <i>Recommendation: Replace gutters when reroofing occurs.</i></p>

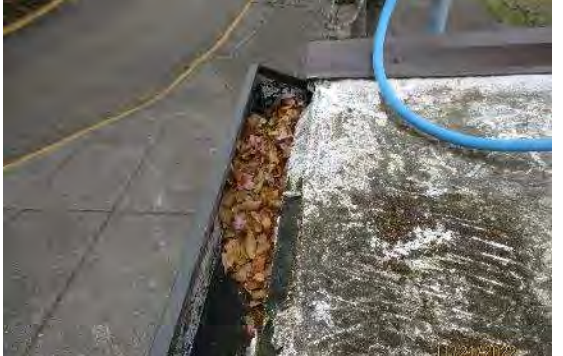
<p>15. Front edge of gutter appears to be higher than drip edge metal which creates a condition where water can backup under drip edge metal and into roof assembly. <i>Recommendation: Replace gutters when reroofing occurs. Front edge of new gutter should be lower than back and gutters sized appropriate for roof area.</i></p>

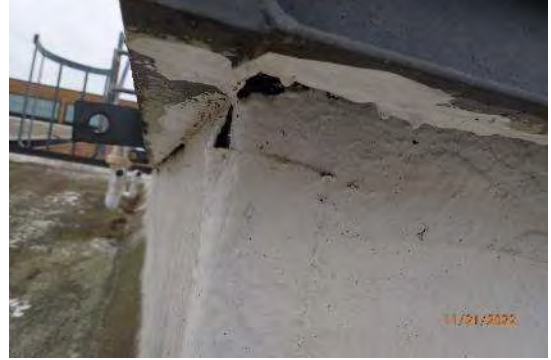
<p>19. Overview of the curb mounted mechanical unit at the south edge of the main roof. There is a breach in the baseflashing membrane at the corner (highlighted).</p>	  <p>A photograph of a curb-mounted mechanical unit on a roof. A red square highlights a breach in the baseflashing membrane at the corner where the unit meets the roof edge. A date stamp '11/21/2022' is visible in the bottom right corner.</p>

20. Closer view of the breach in the curb baseflashing highlighted in the previous photo.
Recommendation: Seal corner and/or attempt to insert sheet metal skirt flashing up behind flange of unit, lapping over roof membrane/coating. When reroofing, unit will likely need to be lifted to allow installation of new roofing and sheet metal flashing.

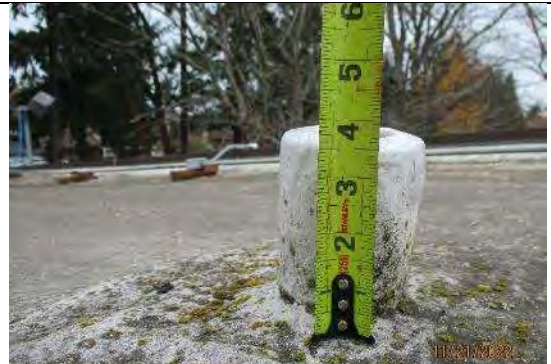
21. Pipe penetration in the field of the roof is too short.
Recommendation: When reroofing, raise pipe penetrations to a minimum of 8 inches off the finished roof surface at all locations and properly flashing penetrations.

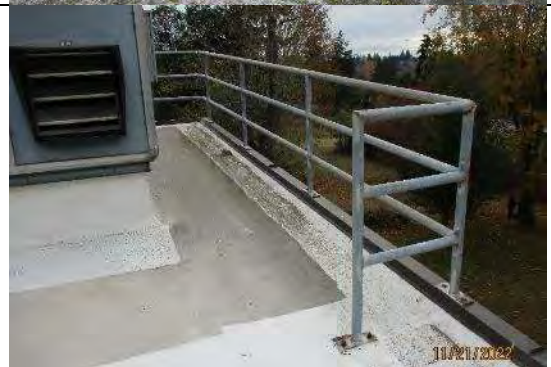
22. Railing installed around mechanical unit at the south end of the roof is mounted with fasteners driven directly through the coping and roofing membrane, without flashing.
Recommendation: Install reinforced liquid flashing membrane up pipe penetrations, covering bolts and base plates. Verify there are no open holes in pipe rails

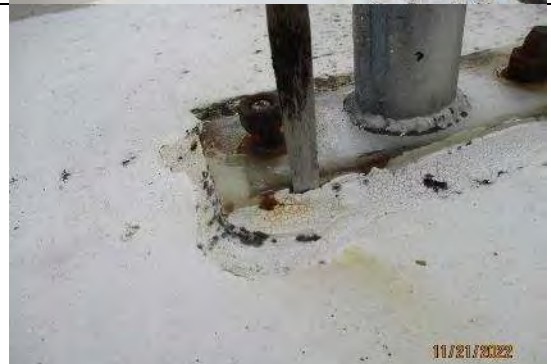
23. Showing void around base plate of railing attached through roofing.
Recommendation: See item 22.

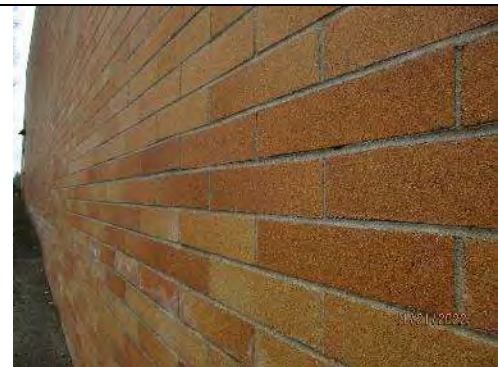
1. View of the north elevation, looking west. Voids in the mortar were observed at the north elevation, although less than observed at other elevations.
Recommendation: Repair voids in the mortar with the additional mortar after tuckpointing to remove existing mortar, as necessary. Install water repellent over surface of brick and mortar.

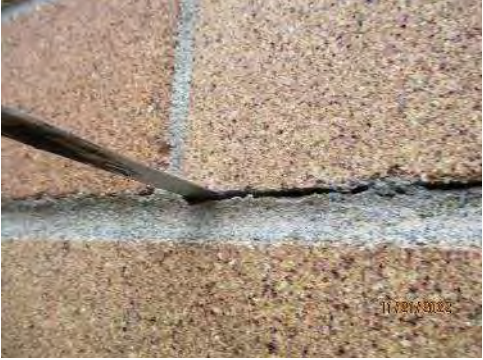
<p>2. Closer view of the previous photo at the north elevation, showing unadhered mortar. <i>Recommendation: See item #1.</i></p>

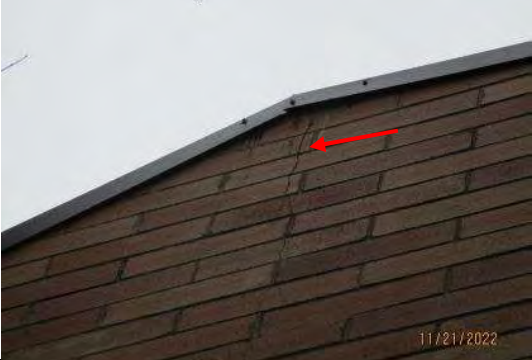
A close-up photograph of a brick wall joint. A metal tool is shown pointing to a crack in the mortar between two bricks. The mortar appears loose and unadhered. A date stamp '11/21/2022' is visible in the bottom right corner.
<p>3. Overview of cracks through brick and mortar at the north elevation below the ridge between the main roof and small roof at the northeast corner. <i>Recommendation: Structural repair appears necessary to prevent future cracking, followed by replacement of the brick. Another option is to install new cladding, insulation, and weather barrier over the brick after structural repairs.</i></p>

A photograph of a brick wall at the northeast corner of a building. A red arrow points to a vertical crack that runs through the brick and mortar. The crack is located below the ridge between the main roof and a smaller roof section. A date stamp '11/21/2022' is visible in the bottom right corner.

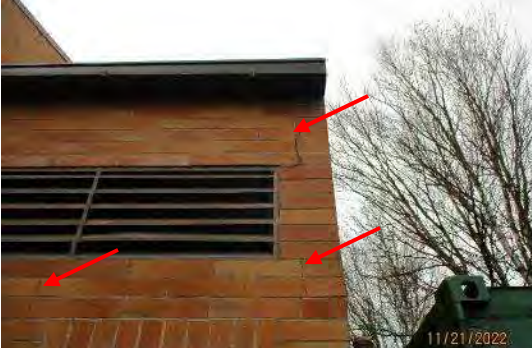
A wide-angle photograph of the east elevation of the building. The building is a long, single-story structure made of brick with a gabled roof. There are several dark doors and windows. A date stamp '11/21/2022' is visible in the bottom right corner.
<p>5. Overview of cracks in the brick at the northeast corner of the building, east elevation. <i>Recommendation: Structural repair appears necessary to prevent future cracking, followed by replacement of the brick. Another option is to install new cladding, insulation, and weather barrier over the brick after structural repairs.</i></p>

A photograph of the northeast corner of the building. Two red arrows point to cracks in the brickwork. One arrow points to a crack in the mortar joint, and the other points to a crack in the brick itself. A date stamp '11/21/2022' is visible in the bottom right corner.

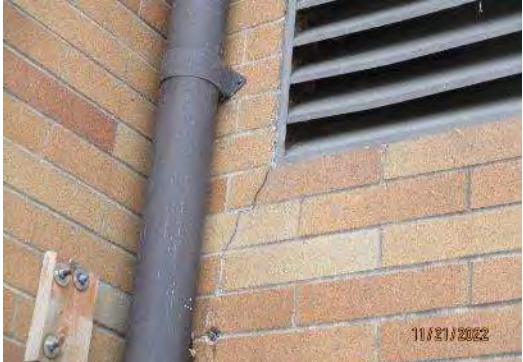
<p>6. Additional cracks at the east elevation. <i>Recommendation: see previous.</i></p>

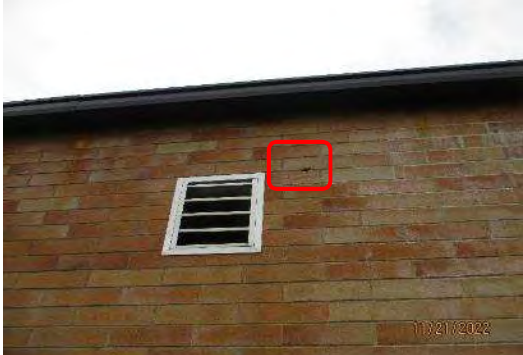
<p>7. Damaged brick, or brick with a hole from a previous penetration at the east elevation (highlighted). <i>Recommendation: Patch with mortar or clad over brick as indicated above.</i></p>

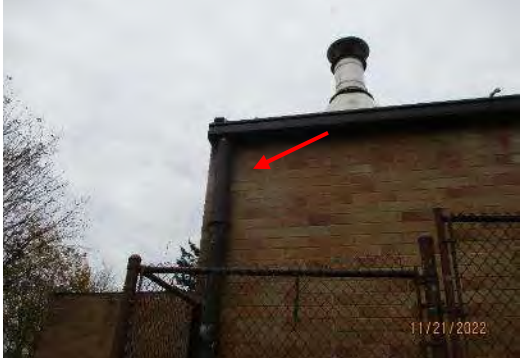
<p>8. Cracked brick at the southeast corner, east elevation (arrow).</p>

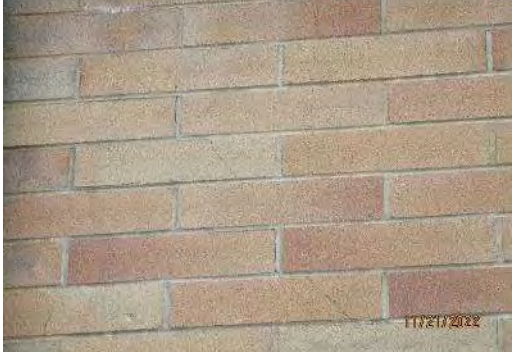
<p>9. Closer view of previous photo showing crack through brick and mortar. <i>Recommendation: Structural repair appears necessary to prevent future cracking, followed by replacement of the brick. Another option is to install new cladding, insulation, and weather barrier over the brick after structural repairs.</i></p>

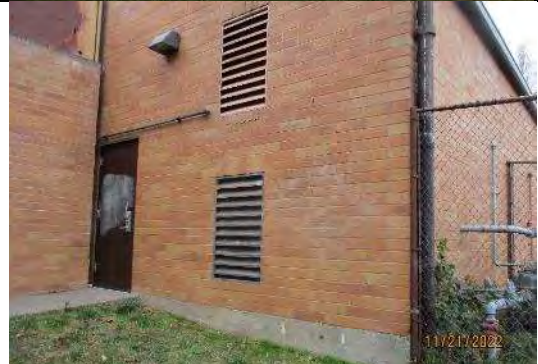
11. Cracked brick and spalling mortar is present below upper louver, as well as cracks in the brick. Location at the southeast corner, south elevation.

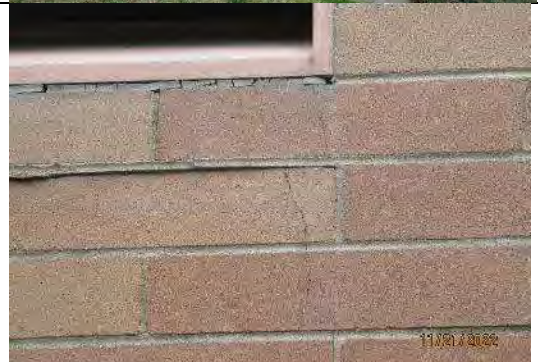
12. Closer view of raked brick and spalling mortar indicated in previous photo.
Recommendation: Structural repair appears necessary to prevent future cracking, followed by replacement of the brick. Another option is to install new cladding, insulation, and weather barrier over the brick after structural repairs.

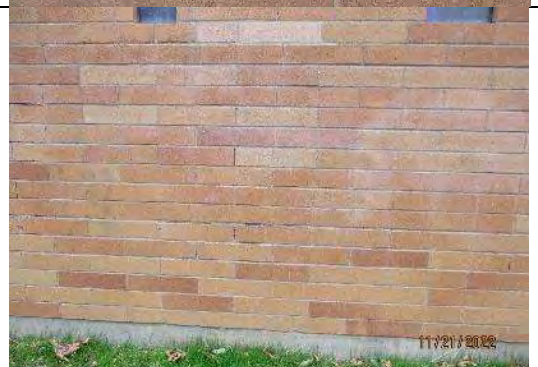
13. Overview of damaged mortar and brick where power washing has occurred to remove graffiti at the south elevation.
Recommendation: Repair voids in the mortar with the additional mortar after tuckpointing to remove existing mortar, as necessary. Install water repellent and anti-graffiti coating, over surface of brick and mortar. Another option is to install new cladding, insulation, and weather barrier over the brick.

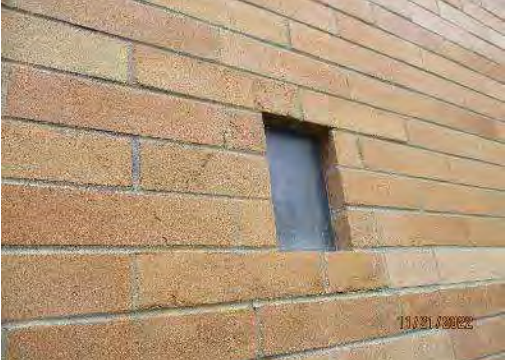
<p>14. Cracked brick around small windows at the south elevation, towards the west end of the building. <i>Recommendations: Structural repair appears necessary to prevent future cracking, followed by replacement of the brick. Another option is to install new cladding, insulation, and weather barrier over the brick after structural repairs.</i></p>

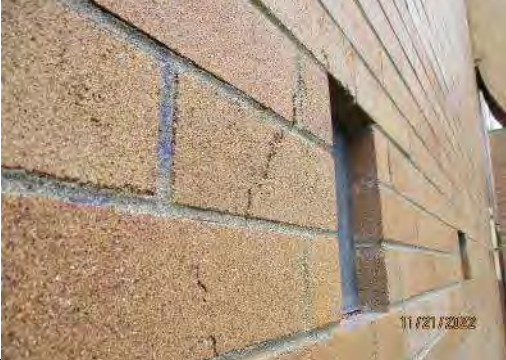
<p>16. Overview of cracking/spalled brick below louver adjacent the roof access ladder at the south elevation. <i>Recommendations: Structural repair appears necessary to prevent future cracking, followed by replacement of the brick. Another option is to install new cladding, insulation, and weather barrier over the brick after structural repairs.</i></p>

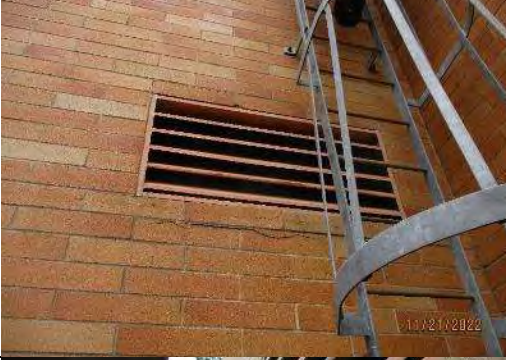
<p>17. Closer view of cracks in brick as noted in previous photo. <i>Recommendations: See previous.</i></p>

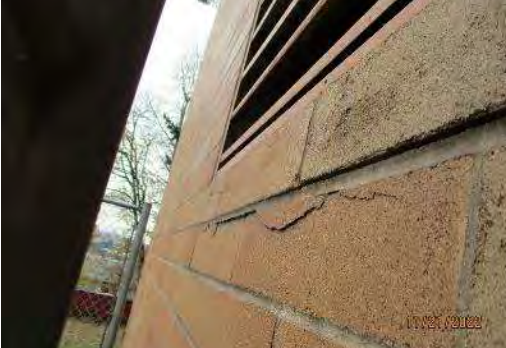
18. Looking down from the roof at the south elevation, where the main roof transitions to the clerestory structure. There is a large crack in the brick and mortar.
- Recommendations: Structural repair appears necessary to prevent future cracking, followed by replacement of the brick. Another option is to install new cladding, insulation, and weather barrier over the brick after structural repairs.*

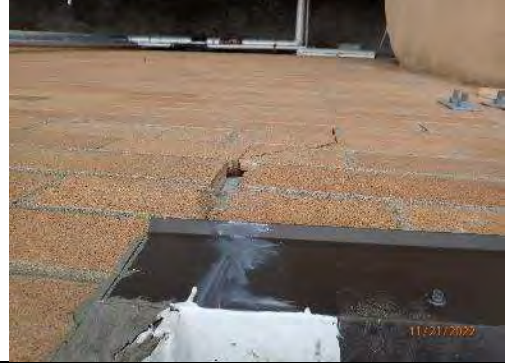
19. Closer view of cracks in brick as noted in previous photo.
- Recommendations: See previous.*

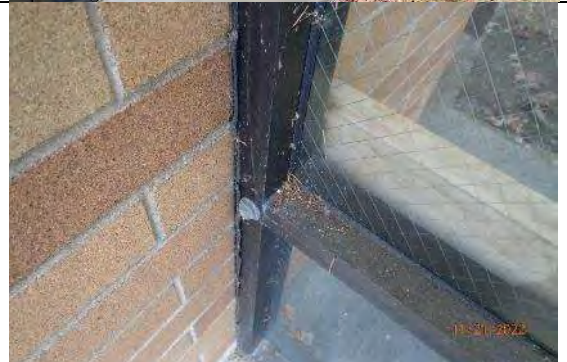
21. Unadhered sealant joint at the perimeter joint of the storefront windows-to-brick.
- Recommendations: Remove existing sealant and replace with new sealant and backer rod.*

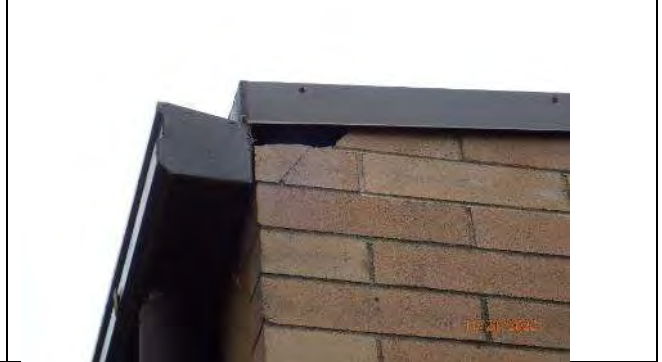
22. Missing masonry at the southwest corner of the building, behind the gutter.
Recommendations: Temporary solution would be to install sheet metal counterflashing tucked under the outer leg of the coping metal. More permanent repair would require replacement of cracked brick with new brick to infill to roof line. Another option is to install new cladding over new weather barrier.

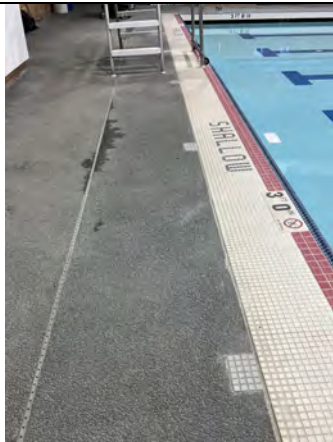
Description	Photo
<p>1. Pool deck surface</p> <p><u>Deficiency/Observation:</u> Pool deck, as well as the entire floor surfaces of the building interior is heavy aggregate concrete; at the pool deck, various areas are worn away and pitting. Additional hairline cracks and minor spalling is occurring. The uneven texture is allowing for pooling to occur which can cause slippery conditions when wet; the general pool drainage is functioning.</p> <p><u>Recommendation:</u> cracks and deterioration will continue if untreated; repair cracks and treat surface of deck by replacing the top inch or utilizing a skid resistant coating.</p> <p>Note: cracks noted at stairs for seating area; structural cracks in the concrete platform at seating area. Refer to structural report.</p>

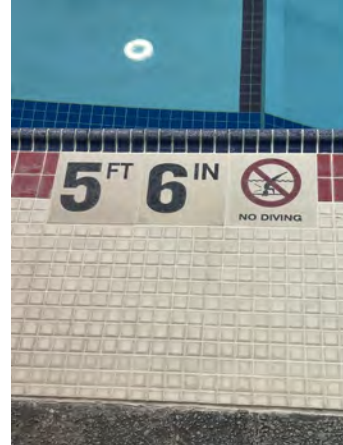
2. Pool tile and grout

Deficiency/Observation: Pool tile and grout is aged and worn; pool markers are still legible, but the 'no diving' sign is small and difficult to read; perimeter tile is in fair condition

Recommendation: replace the pool markers and signage with larger font and symbol; consider replacing the tile for an updated appearance

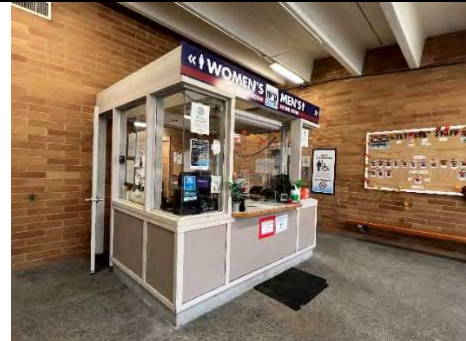
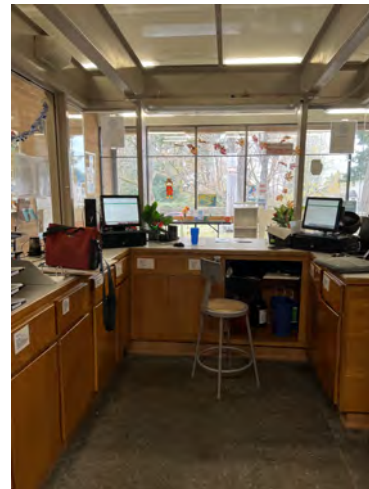
Deficiency/Observation: the reception booth is not accessible at it's entry door (28.5") and does not provide an accessible path to the main counter area; the counter area is not in compliance with accessible requirements (39"aff) and does not provide accessible access for general public; the existing booth also has a wire glass skylight with one panel damaged and cracked.

Recommendations: reconfigure the booth to be accessible or replace the booth in its entirety to be an open reception desk and counter area

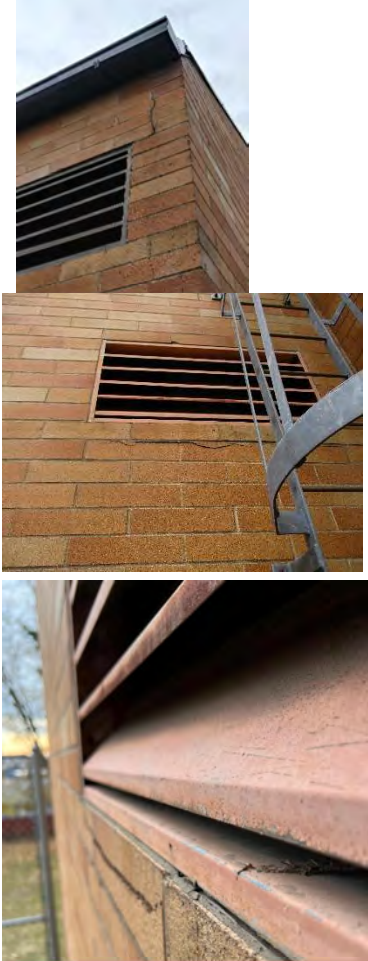
Description	Photo
<p>1. Exterior louvers</p> <p><u>Deficiency/Observation:</u> At several exterior vent / louver locations, these louvers were observed to have deteriorated finishes and rough opening flashings.</p> <p><u>Recommendation:</u> Remove all existing louvers to confirm acceptable venting operation. Furnish and Install self-adhered or liquid applied rough opening membrane flashing. Furnish and install head, jamb, and sill flashing. Paint existing louver with special coatings and re-install.</p>

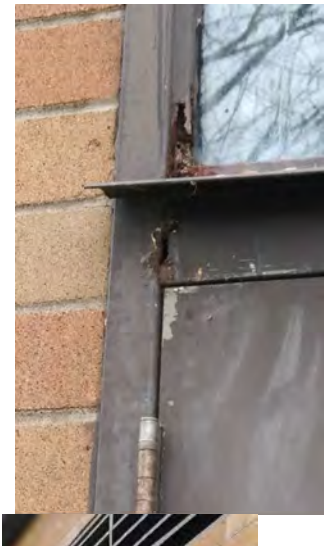
3. Exterior windows

Deficiency/Observation: Existing exterior windows are in fair condition but may be near the end of their service life.

Recommendation: Replace existing windows with thermally broken, energy efficient, aluminum windows.

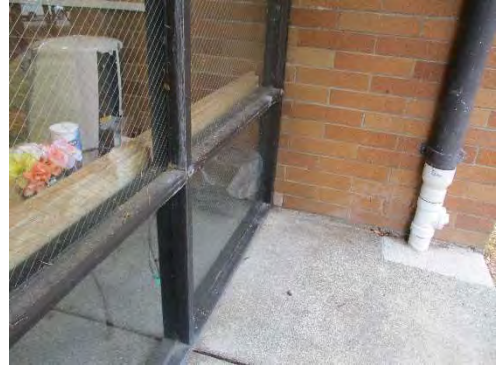
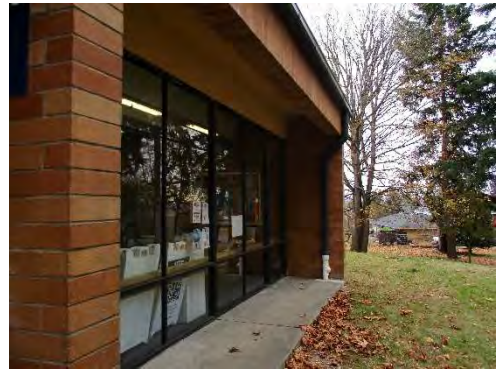
4. Decorative exterior windows

Deficiency/Observation: The existing decorative, colored, windows are broken in many locations. Deficiencies were also noted at the window rough openings and surrounding masonry.

Recommendation: Replace windows with new installation that recognizes and reflects the original design intent.

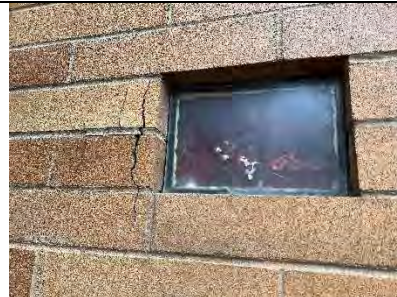
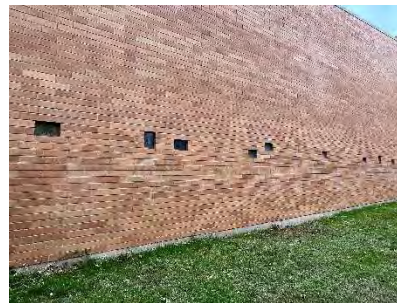
5. Exterior clerestory windows

Deficiency/Observation: Exterior clerestory windows are aged. It appears that there have been attempts to make frame repairs, and sealant repairs to prevent water intrusion.

Recommendation: Remove existing clerestory windows. Furnish and Install self-adhered or liquid applied rough opening membrane flashing. Furnish and install head, jamb, and sill flashing. Replace clerestory panels with translucent clerestory windows

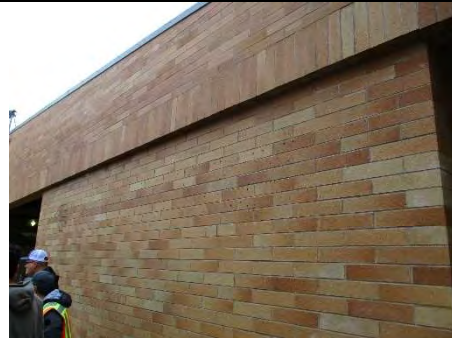
7. Exterior masonry

Deficiency/Observation: Several areas of masonry appear to be deteriorated and cracked due to building movement and extensive power-washing.

Recommendation: Clean brick and replace all brick that has extensive pitting or cracking. Rout and re-point at many of the masonry areas. Apply water repellent and anti-graffiti coating at all masonry elevations.

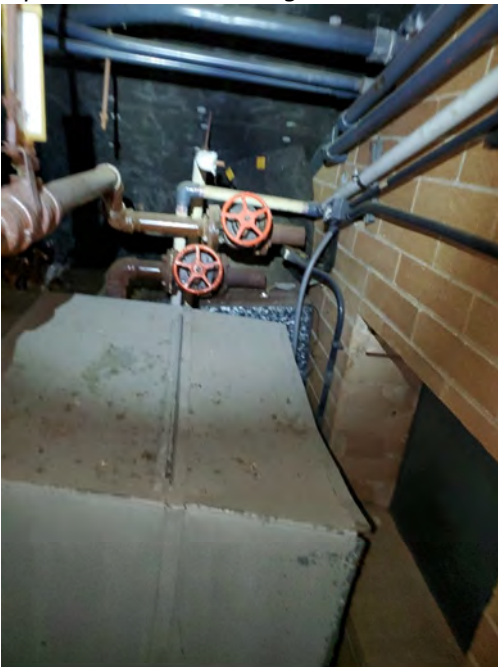
Description	Photo
<p>1. Pool heating tube bundle (Critical-1, wear and tear)</p> <p><u>Deficiency/Observation:</u> M001</p> <p><u>Recommendation:</u> The connection between the hydronic piping and the pool heating tube bundle leaks. It might be a failed gasket or possibly a tube-to-flange failure. The design of a tube bundle within the open surge tank has disadvantages in the ability to easily repair or replace the heat exchanger.</p>

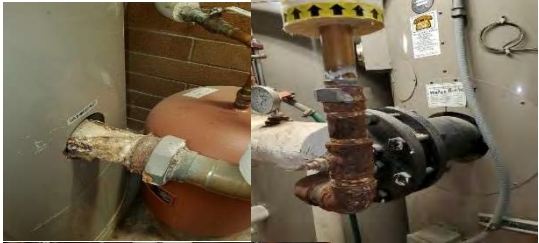
Description	Photo
<p>4. Replace di-electric unions (Critical 1, wear and tear) <u>Deficiency/Observation:</u> M004 <u>Recommendation:</u> Replace all di-electric unions with proper di-electric waterway fittings. Replace corroded sections of piping and damaged insulation.</p>

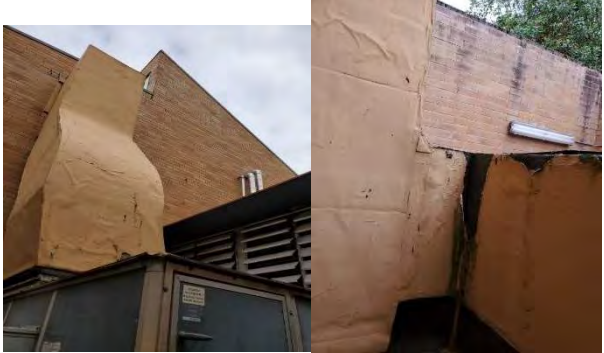
<p>6. Exterior insulated supply and exhaust ductwork (Critical-1: wear and tear) <u>Deficiency/Observation:</u> M006 <u>Recommendation:</u> Existing fabric exterior duct insulation has failed. Remove existing insulation and replace sections of rusted ductwork. Install new duct insulation and provide sheet metal jacketing.</p>

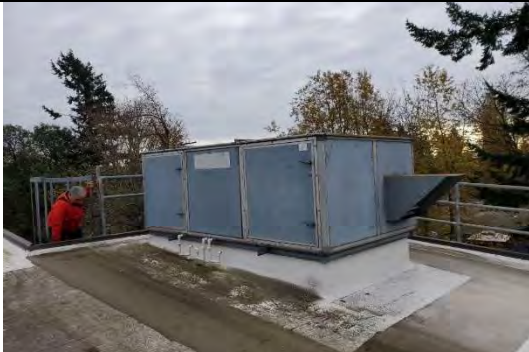
Description	Photo
<p>8. Lobby/Locker room rooftop unit (Critical-1, wear and tear) <u>Deficiency/Observation:</u> M008 <u>Recommendation:</u> Replace Roof mounted HV unit. Re-configure ductwork from lobby and office as return ductwork. Install heat reclaim ventilator to pre-condition outside air stream.</p>

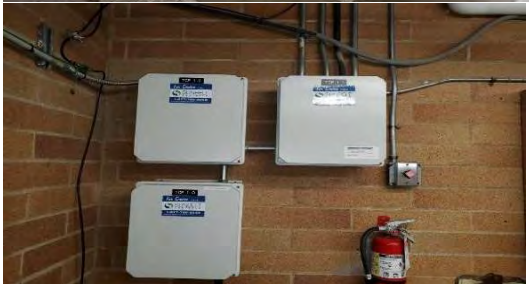
A photograph of a large, blue, rectangular rooftop HVAC unit mounted on a flat roof. A person in a red jacket is visible on the roof near the unit. The background shows trees and a cloudy sky.
<p>9. DDC system (Critical-2, wear and tear) <u>Deficiency/Observation:</u> M009 <u>Recommendation:</u> Replace proprietary DDC system with BACnet DDC system, including upgrade of existing damper actuators and conversion of 3-way valves to 2-way valves to provide variable speed pumping.</p>

A photograph of three white DDC control panels mounted on a brick wall. A fire extinguisher is visible on the wall to the right of the panels.

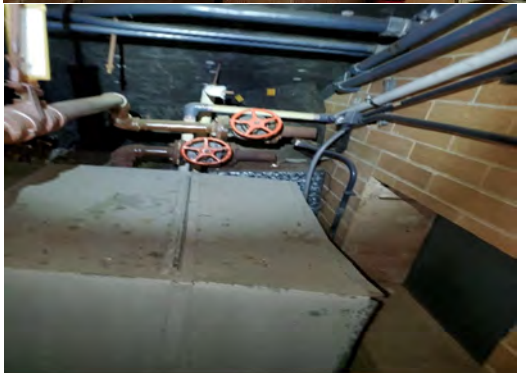
<p>10. Abandoned attic HV equipment (Optional, wish list) <u>Deficiency/Observation:</u> M010 <u>Recommendation:</u> Replace existing attic hatch and ladder to provide better attic access. Remove abandoned HVAC equipment through new hatch.</p>

A photograph of abandoned HVAC equipment in an attic space. The equipment includes pipes, valves, and a large metal unit. A fire extinguisher is visible on the wall to the right.

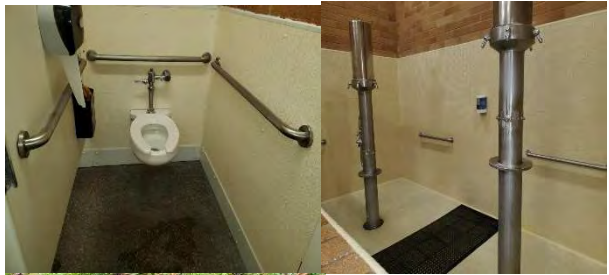
<p>13. Locker room plumbing fixtures (General-3; Wear and tear) <u>Deficiency/Observation:</u> M013 <u>Recommendation:</u> Replace all existing plumbing fixtures with modern, low flow fixtures. Replace existing gang showers with individual temperature control shower valves and heads.</p>

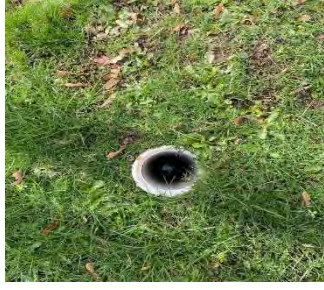
<p>14. Exterior clean-out caps (General-3; Wear and Tear) <u>Deficiency/Observation:</u> M014 <u>Recommendation:</u> Install new hub and cap on existing open clean-out south of the building.</p>
