Des Moines Pool Metropolitan Park District

**MOUNT RAINIER POOL CONDITION ASSESSMENT
DES MOINES POOL METROPOLITAN DISTRICT
PROJECT NO.: 2104.3 – 65% DRAFT**

**DES MOINES POOL METROPOLITAN PARK DISTRICT
MOUNT RAINIER POOL
COMPREHENSIVE CONDITION REPORT
(65% DRAFT)**

DES MOINES POOL METROPOLITAN PARK DISTRICT
PART 1 – MOUNT RAINIER POOL
COMPREHENSIVE CONDITION
ASSESSMENT

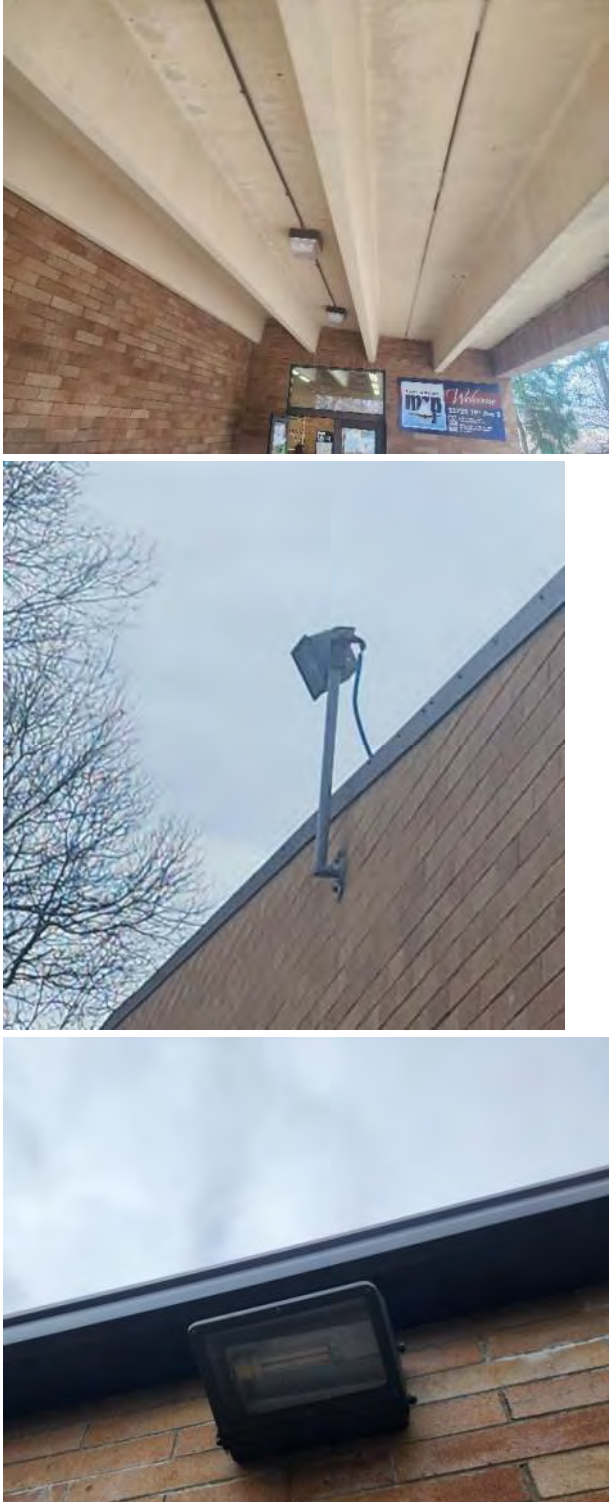
<i>Description</i>	<i>Photo</i>
<p>1. Exterior Lighting</p> <p><u>Deficiency/Observation:</u> Exterior lighting is either Metal Halide or High-pressure sodium or fluorescent.</p> <p><u>Recommendation:</u> Replace exterior building lighting with new LED fixtures listed for outdoor location.</p>

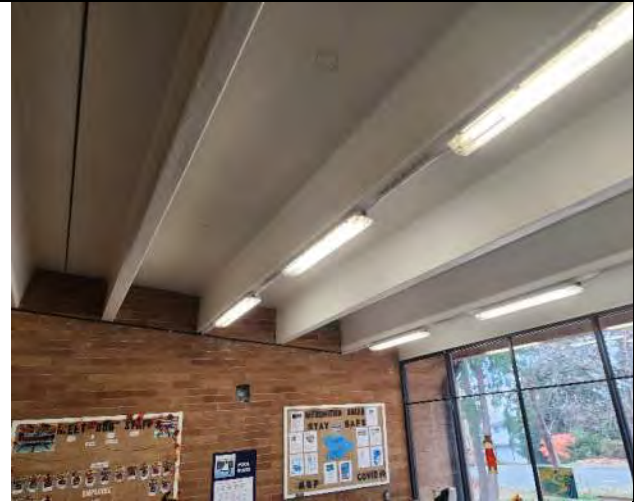
For maintenance and energy savings purposes, it is recommended to upgrade to LED. Fixtures shall be listed for environment.

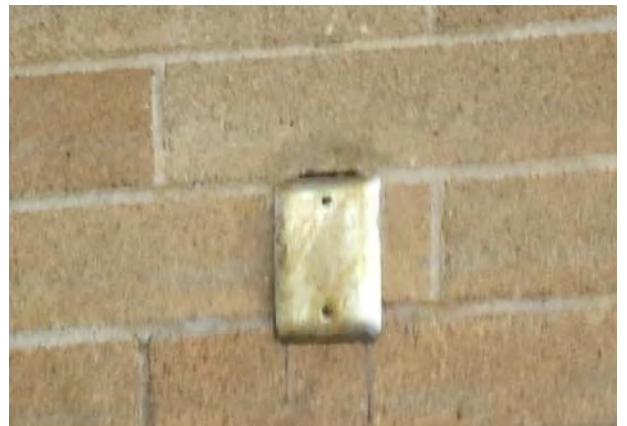
12. – Pool Area Receptacle

Deficiency/Observation: Pool area receptacles don't have in use covers. Pool area receptacles are a mix of GFCI and Non-GFCI. Some non GFCI receptacles may be GFCI protected however there are missing labels. Some appear to show corrosion.

Replace with corrosive resistant conduits, elbows, couplings and fittings in pool area per NEC 680.12 & 300.6.

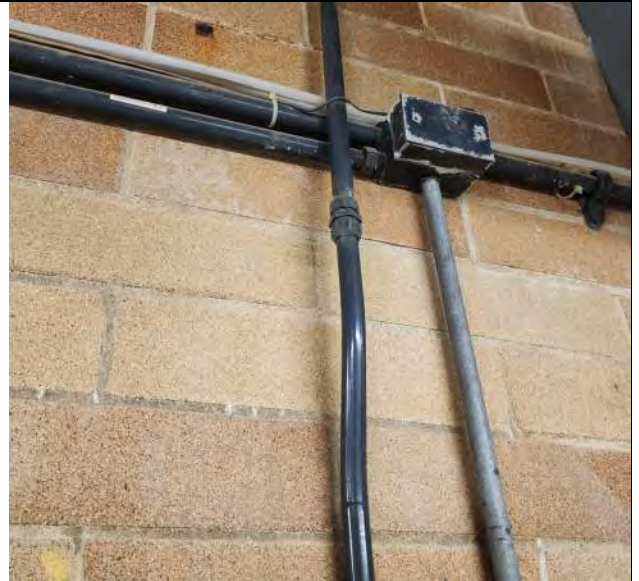
14. – Mechanical Room

Deficiency/Observation: Some junction boxes do not have appropriate cover plates for environment or are missing completely.

Provide cover plates suitable for corrosive resistant per NEC 680.12 & 300.6.

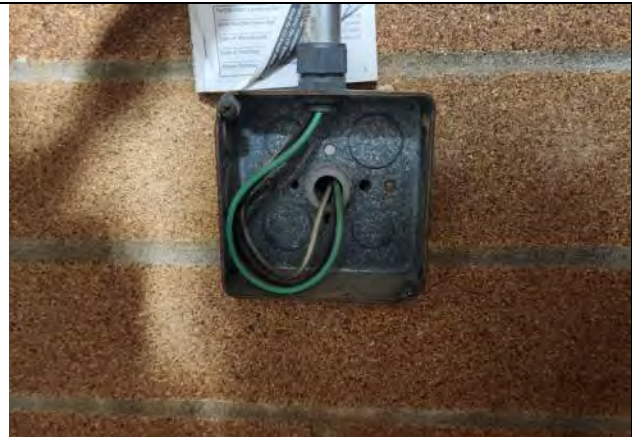
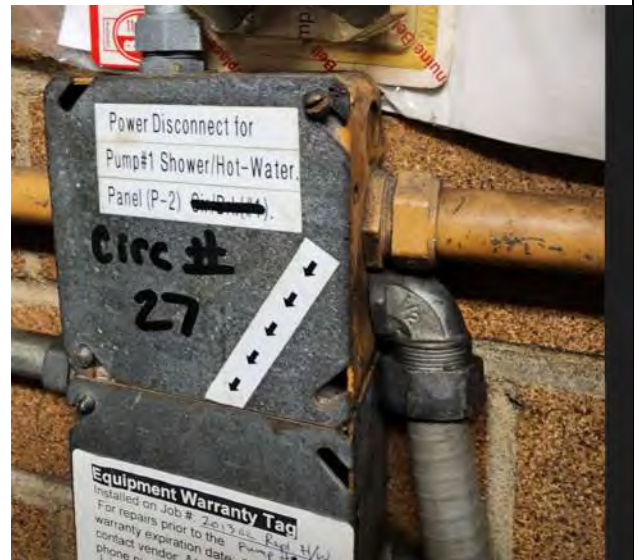
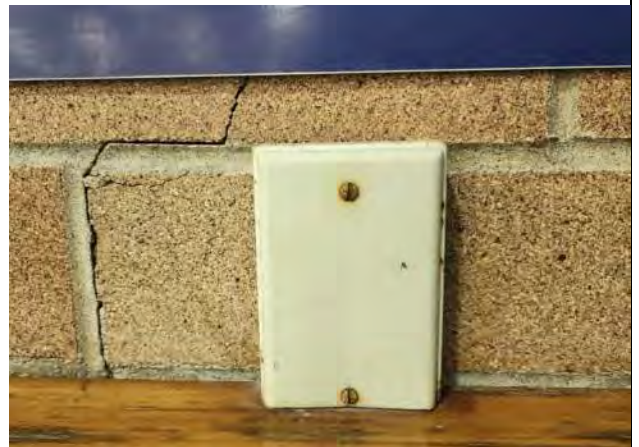
15. – Chlorine Room Devices and Conduit

Deficiency/Observation: – Some devices and conduits are corroding and should be replaced.

Replace with corrosive resistant conduit and devices per NEC 680.14, 680.12 & 300.6.

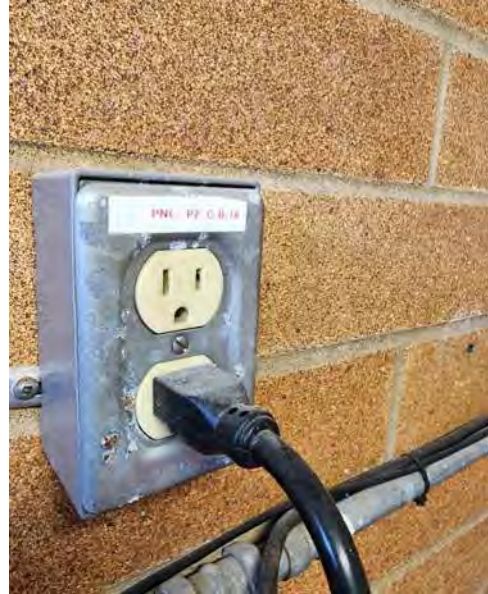
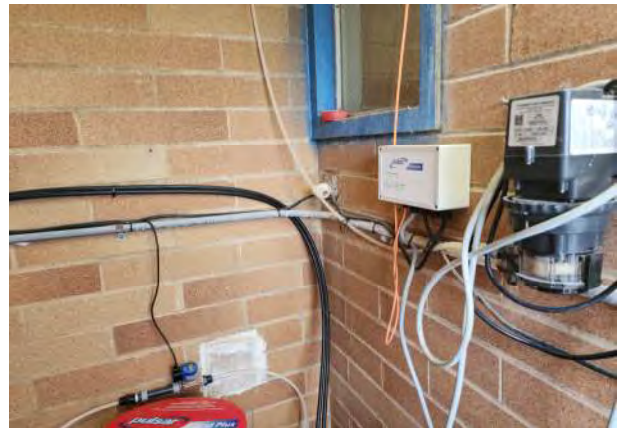
16. – Chlorine Room

Deficiency/Observation: Florescent T8 Light fixtures show discoloration.

Replace with LED light fixtures with 10% up-light and listed for wet or damp location. All supports shall be suitable for location per NEC 300.6. Replace conduit suitable for location NEC 680.12, & 300.6.

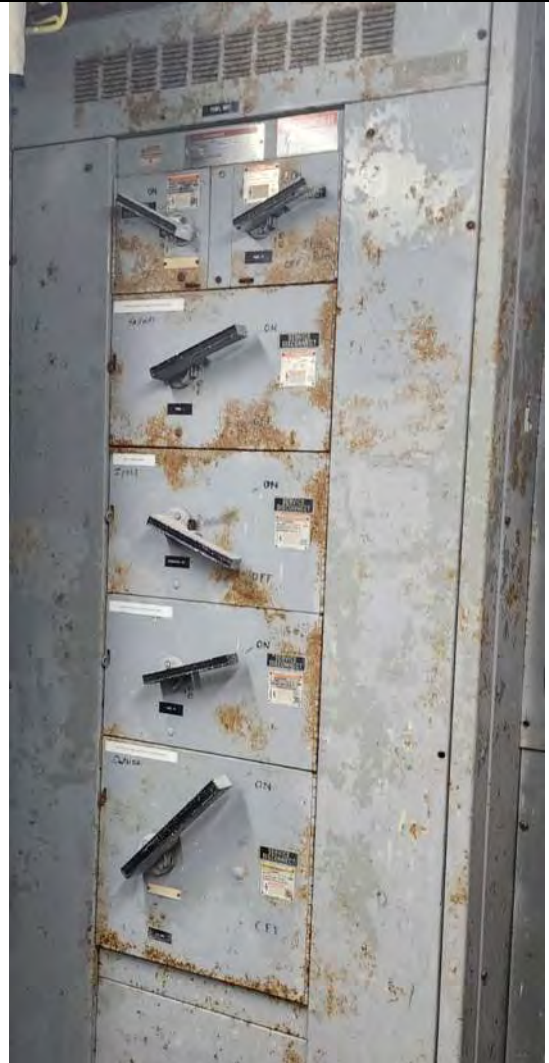
19. –Main electrical distribution - 600A, 120/208, 3-Phase, 4-Wire

Main Distribution Board is past the standard life expectancy of 30 years. Full replacement and potential upgrades to capacity. Main Distribution board and raceway shall be suitable for the environment NEC 680.14, 680.12 & 300.6.

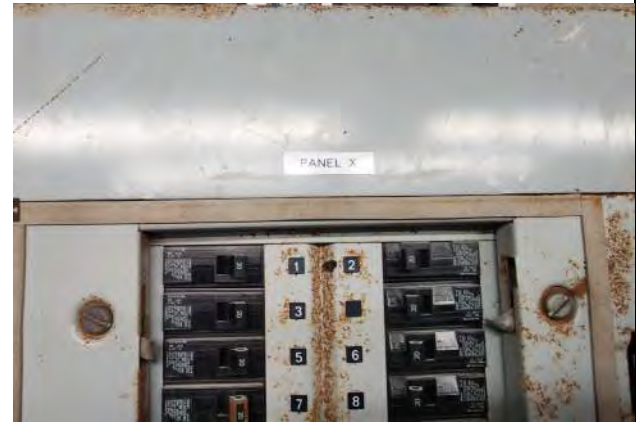
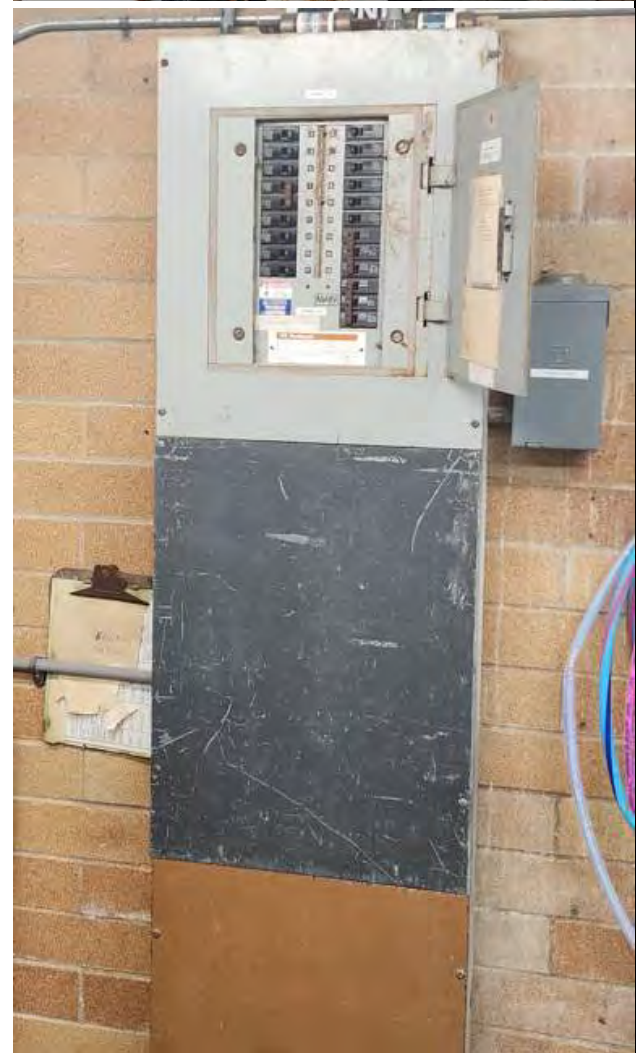
20. – Panel X - 100A, 120/208V, 3 phase

Panelboard is past the standard life expectancy of 30 years. Full replacement and potential upgrades to capacity. Panel and raceway shall be suitable for the environment NEC 680.14, 680.12 & 300.6. Panel will need to be located to meet working space clearances and heights per NEC and local jurisdiction.

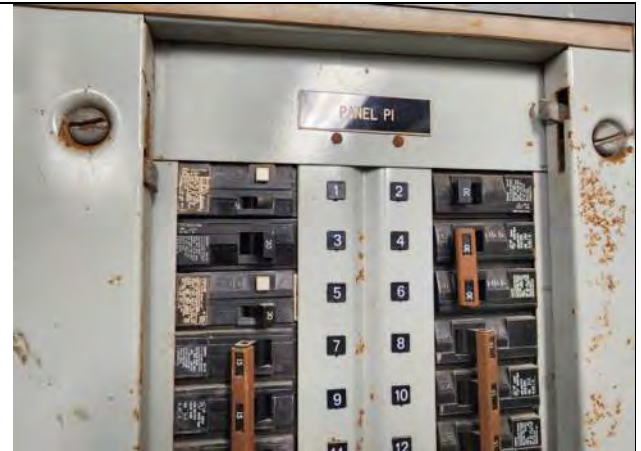
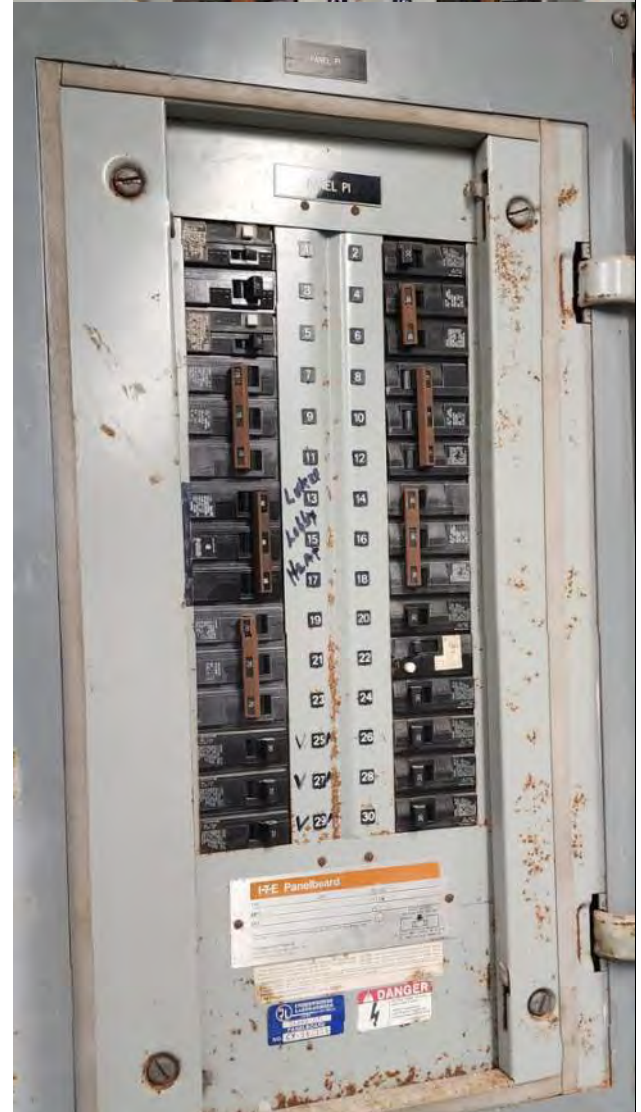
21. – Panel P1 - 225A, 120/208V, 3-Phase

Panelboard past the standard life expectancy of 30 years. Full replacement and potential upgrades to capacity. Panel and raceway shall be suitable for the environment NEC 680.14, 680.12 & 300.6.

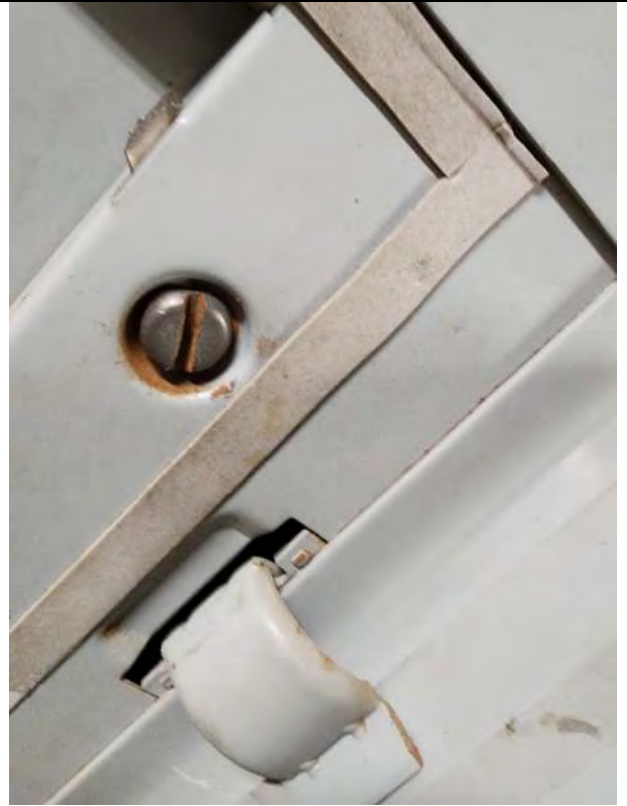
22. – Panel P2 - 225A, 120/208V, 3-Phase

Panelboard is past the standard life expectancy of 30 years. Full replacement and potential upgrades to capacity. Panel and raceway shall be suitable for the environment NEC 680.14, 680.12 & 300.6.

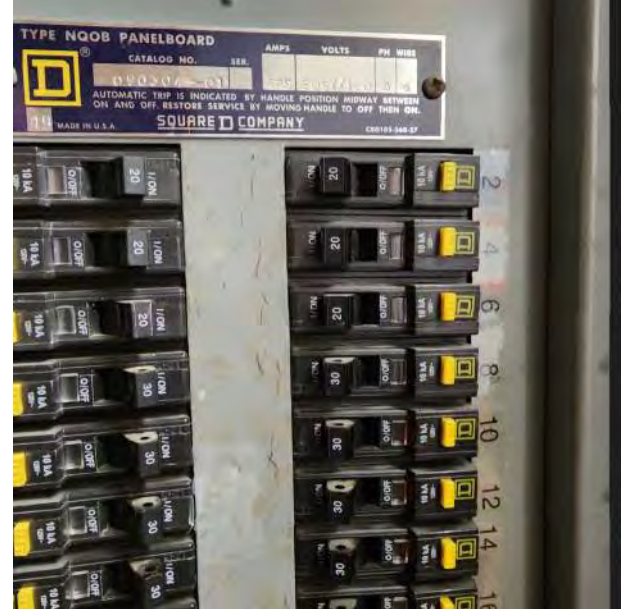
23. – Panel A - 225A, 120/208V, 3-Phase

Full replacement and potential upgrades to capacity. Panel and raceway shall be suitable for the environment NEC 680.14, 680.12 & 300.6.

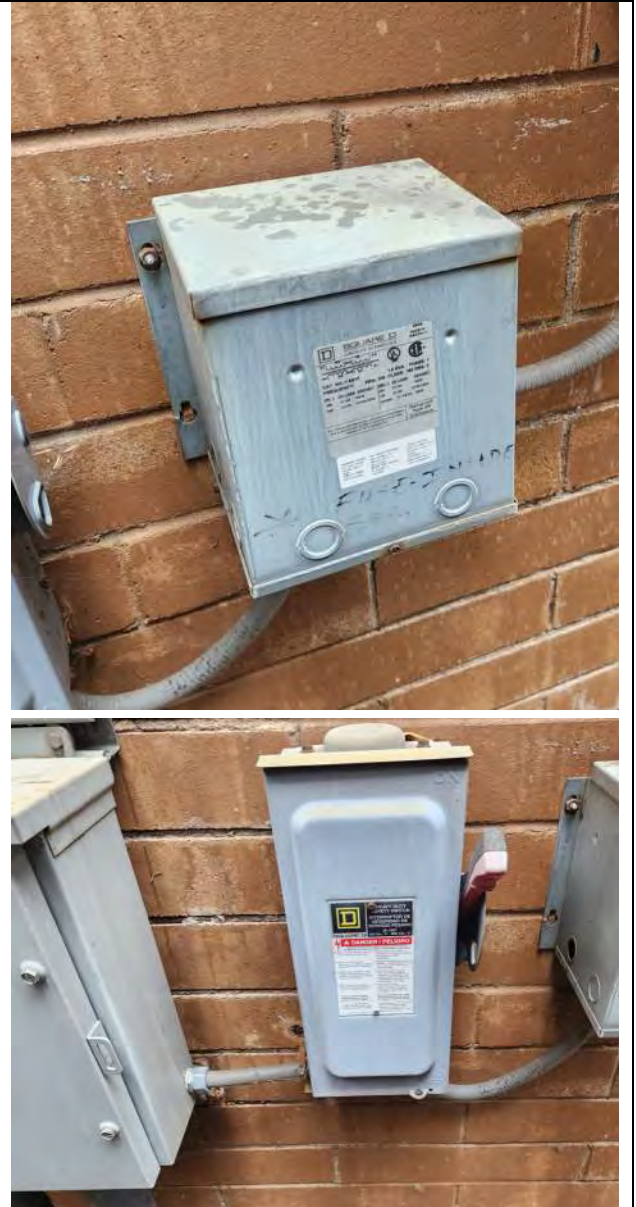
25. – Exterior CT

Deficiency/Observation: Exterior CT boxes – most marking have faded and rust is present.

Replace service enclosure boxes with weatherproof NEMA-3R enclosure.
