## Des Moines Pool Metropolitan Park District

**MOUNT RAINIER POOL  
EXISTING CONDITION ASSESSMENT  
and FEASIBILITY STUDY**

## III PART 1 - EXISTING CONDITION ASSESSMENT

## PART 1: COMPREHENSIVE CONDITION ASSESSMENT

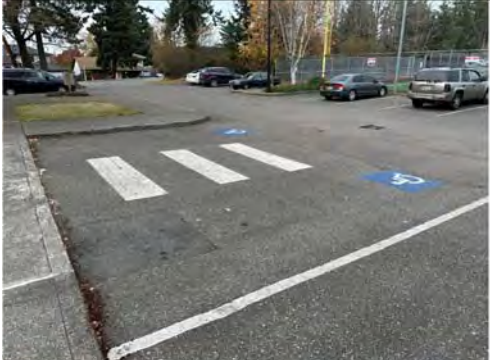
<p>4. ADA Parking</p> <p><u>Deficiency/Observation:</u> The existing ADA is non-compliant and over the maximum ADA slope of 2% in any direction.</p> <p><u>Recommendation:</u> Remove existing asphalt and replace with concrete as it is more durable and tolerant to set precise and flatter slopes.</p>

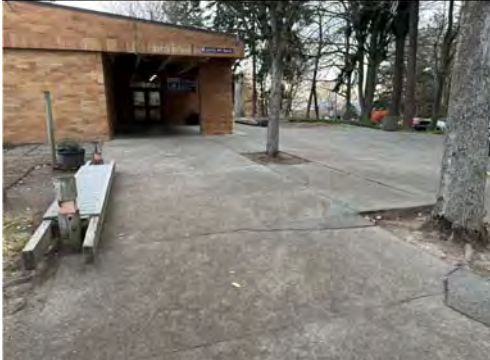
<p>4. Replace ADA Pathway from Parking</p> <p><u>Deficiency/Observation:</u> The existing ADA pathway from the ADA parking stalls to the front door is not complete compliant, and portions exceed the allowable 2% cross slope.</p> <p><u>Recommendation:</u> Remove and replace non-conforming portions of the existing concrete sidewalk ADA Pathway.</p>

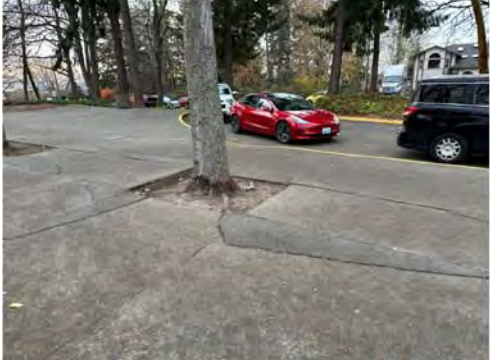
<p>5. Replace Cracking and Lifting Concrete</p> <p><u>Deficiency/Observation:</u> Portions of the existing concrete sidewalks and plazas are lifting due to tree roots or other issues related to life expectancy of the improvements.</p> <p><u>Recommendation:</u> Replace existing concrete to eliminate pedestrian safety concerns.</p>

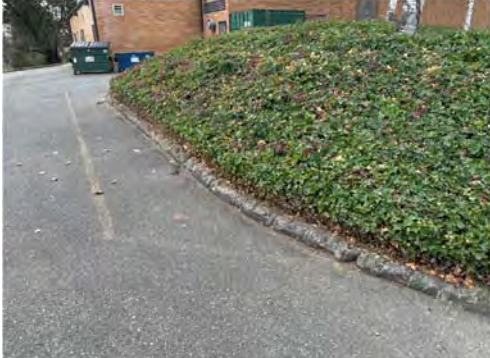
<p>6. Replace Extruded Curbs</p> <p><u>Deficiency/Observation:</u> The majority of the existing extruded curbs are disintegrating.</p> <p><u>Recommendation:</u> Replace existing extruded curbs.</p>

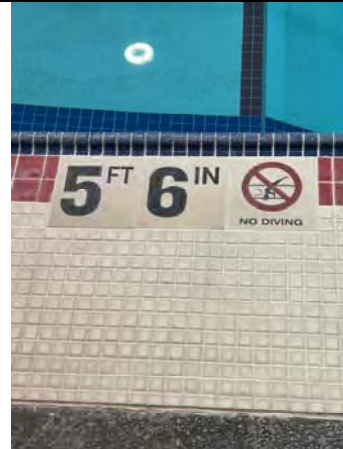
Deficiency/Observation: Pool tile and grout looks aged and worn; pool markers are still legible, but the 'no diving' sign is small and difficult to read; perimeter tile is in fair condition. DMPMPD indicates that the pool tile was replaced in 2017.

Recommendation: the existing pool tile can remain in place, though it should be cleaned. Replacing the pool markers and tile should be replaced if significant deck work occurs.

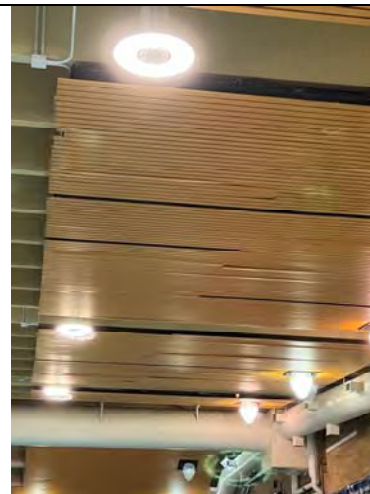
Deficiency/Observation: existing ceiling clouds are showing damage, are unseated or missing in multiple locations;

Recommendation: remove the ceiling clouds and replace with a more durable ceiling system such as an Armstrong Serpentina grid system, or possibly leave exposed to structure.

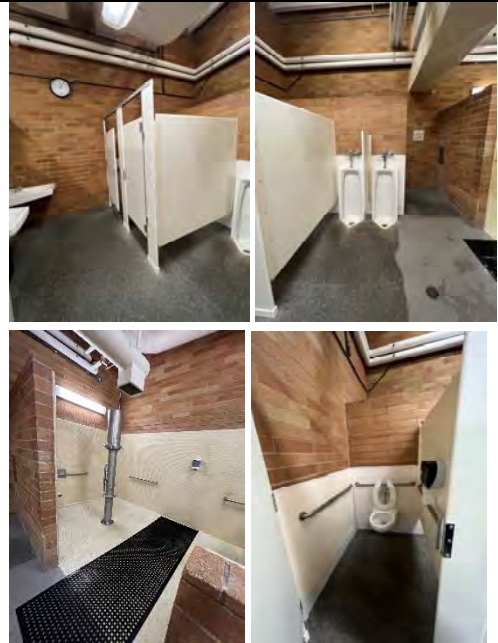
14. Lobby – Brick Veneer

Deficiency/Observation: existing brick veneer throughout the building has various hairline cracks and is effervescing.

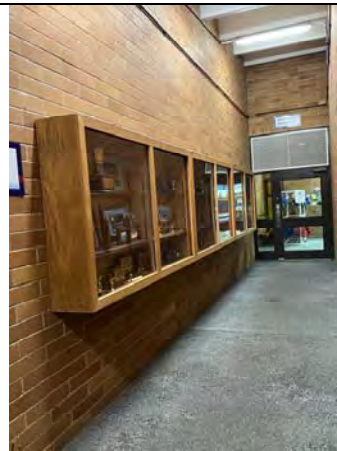
Deficiency/Observation: the existing awards casework protrudes in to the main egress pathway to the natatorium, preventing full use of a heavy-use corridor.

Recommendations: relocate the awards casework to another location to maximize usage of the corridor (or replace the awards cases with slimmer profile casework).

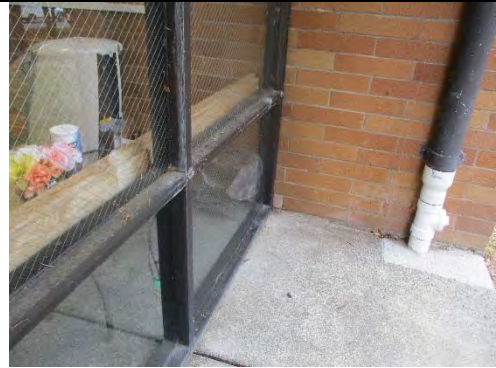
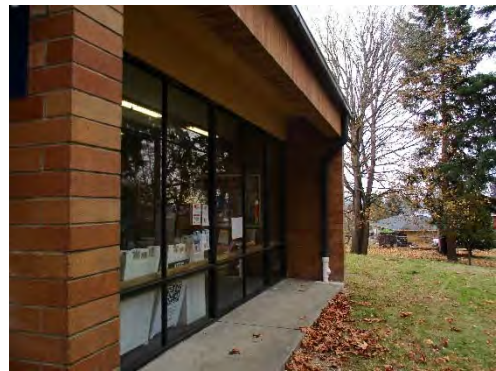
Deficiency/Observation: Existing exterior storefront windows are in fair condition but may be near the end of their service life.

Recommendation: Replace existing storefront windows with thermally broken, energy efficient, aluminum storefront windows.

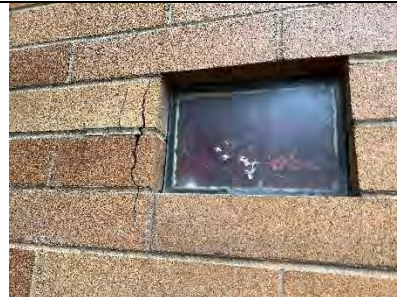
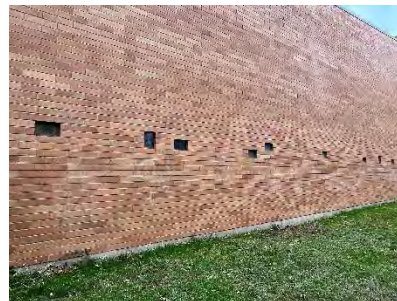
4. Decorative exterior windows

Deficiency/Observation: The existing decorative, colored, windows are broken in many locations. Deficiencies were also noted at the window rough openings and surrounding masonry.

Recommendation: Replace windows with new installation that recognizes and reflects the original design intent. Coordinate with DMPMPD prior to replacement as these appear to be a public art item.

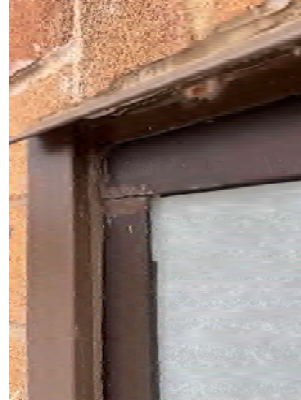
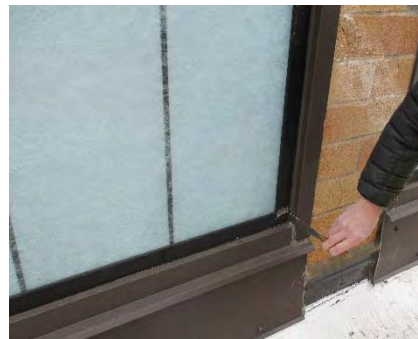
5. Exterior clerestory windows

Deficiency/Observation: Exterior clerestory windows are aged. It appears that there have been attempts to make frame repairs, and sealant repairs to prevent water intrusion.

Recommendation: Remove existing clerestory windows. Furnish and Install self-adhered or liquid applied rough opening membrane flashing. Furnish and install head, jamb, and sill flashing. Replace clerestory panels with translucent clerestory windows or a translucent insulated panel system for energy efficiency.

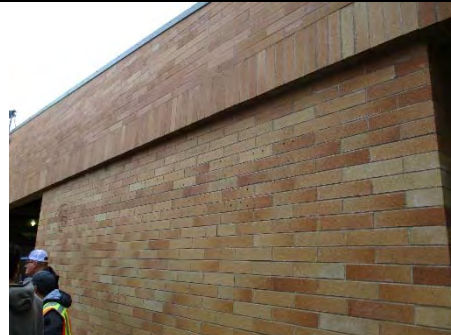
6. Exterior masonry

Deficiency/Observation: Abandoned signage mounting leaves many damaged bricks, with holes.

Recommendation: Masonry needs to be patched / replaced at locations.

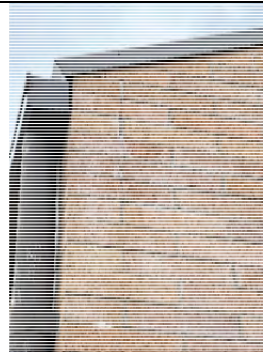
7. Exterior masonry

Deficiency/Observation: Several areas of masonry appear to be deteriorated and cracked due to building movement and extensive power-washing.

Recommendation: Clean brick and replace all brick that has extensive pitting or cracking. Rout and re-point at many of the masonry areas. Apply water repellent and anti-graffiti coating at all masonry elevations.

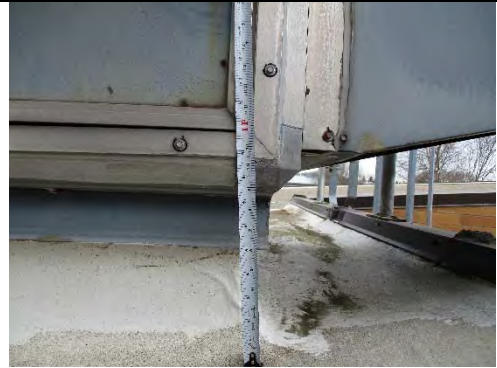
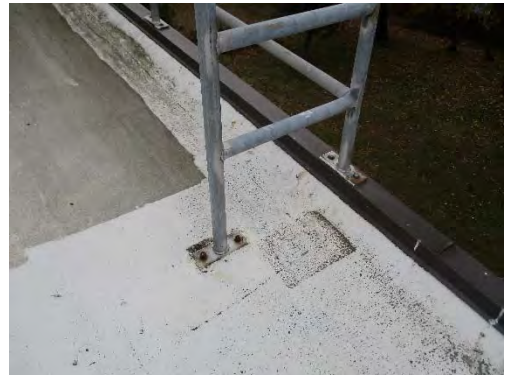
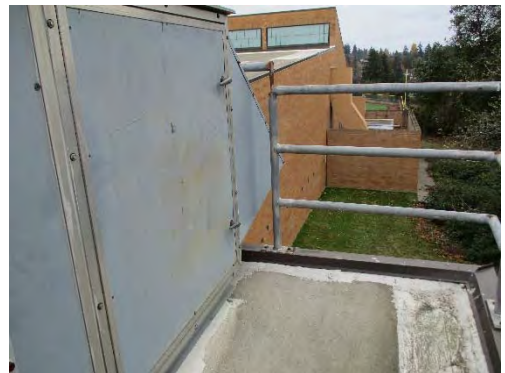
8. Roof-mounted mechanical equipment

Deficiency/Observation: This roof-mounted mechanical unit is in good proximity to the roof access ladder. At the upslope location, the curb does not meet the required height of 8" above adjacent finished roof surface. At the downslope location, the mech curb height is sufficient.

The rail surrounding the roof mounted mech unit is in fair condition. It is corroded at some joint locations. The rail attachment is at the roof surface and parapet, which is not recommended.

Recommendation: Coordinate with mechanical for use of mechanical unit. Any mechanical units installed at the roof must be installed with a curb height of 8" above adjacent roof surface. The existing rail should be replaced and railing attachments should be flashed to prevent water intrusion.

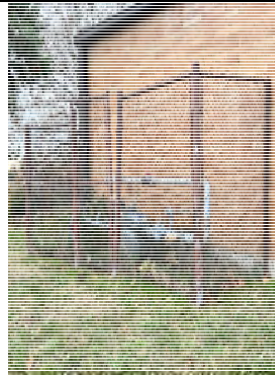
Deficiency/Observation: Exterior fencing at riser is severely corroded.

Recommendation: replace the fencing in it's entirety with vinyl slatted fencing.

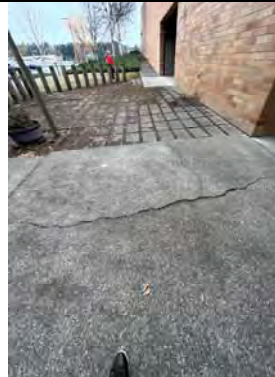
11. Exterior concrete walk and bicycle yard

Deficiency/Observation: existing sidewalk at building entry is cracking and spalling; the bicycle yard is underutilized and pavers are in various stages of deterioration.

Recommendation: repair the sidewalk cracks and spalls by shaving down uneven areas and sealing the cracks; clean the bicycle yard and pressure wash the pavers; replace pavers that are cracked or broken. For areas where major spalling is occurring, break out the concrete and replace the concrete panel.

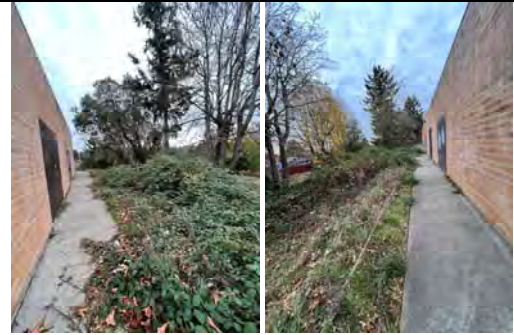
11. Foliage overgrowth

Deficiency/Observation: at exterior south wall, there is overgrowth of foliage and existing terracing that is adjacent to the sidewalk that is almost concealed by the overgrowth; this potentially is a safety issue as the south property slopes down in from the existing sidewalk

Recommendation: remove the overgrowth of foliage so the terracing is visible.

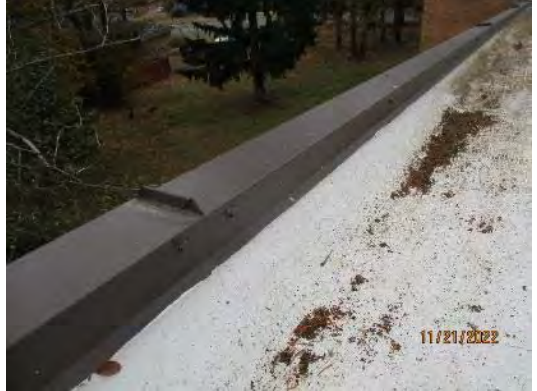
<b>Description</b>	<b>Photo</b>
<p>1. Overview of the low parapet wall and standing seam coping metal. Coating terminates at bottom edge of coping, indicating coping was not removed as part of the coating application. <i>Recommendation: Leave as-is and monitor for now. This condition can be addressed when reroofing, as there appear to be no current problematic conditions from this application.</i></p>

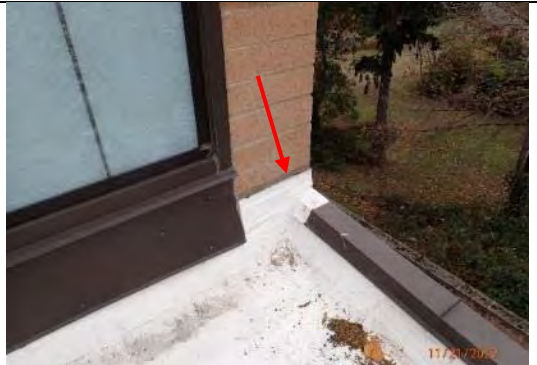
<p>2. Overview of the parapet to rising wall transition at the southeast corner of the main roof. The top edge of the baseflashing is not sealed (arrow). <i>Recommendation: Seal top edge of coating, install soldered saddle flashing that returns outside corner, and install sheet metal in saw cut to counterflash the saddle flashing.</i></p>

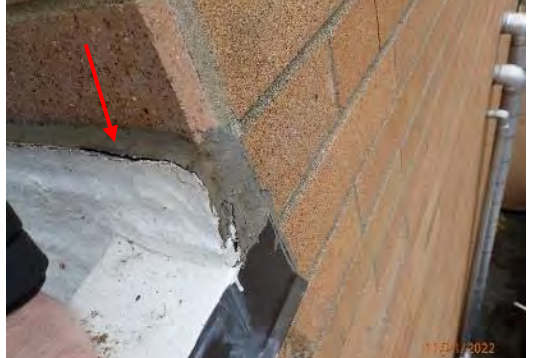
<p>3. Closer view of previous photo showing unsealed coating and lack of return around corner.</p>

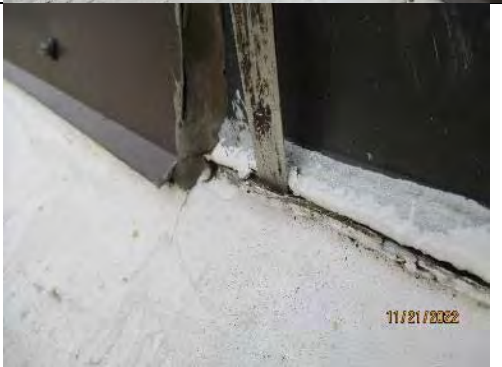
<p>6. Closer view of previous photo showing roof membrane and coating not installed behind metal flashing.</p>

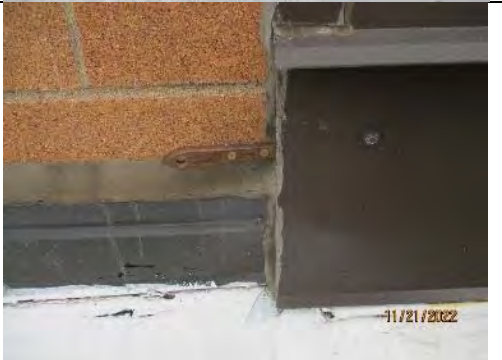
<p>7. Sealant no longer adhered between brick and metal flashing at the base of the clerestory window at the east end of the main roof. <i>Recommendation: Reseal joints after lower counterflashing is replaced, per item #5 &amp; 6.</i></p>

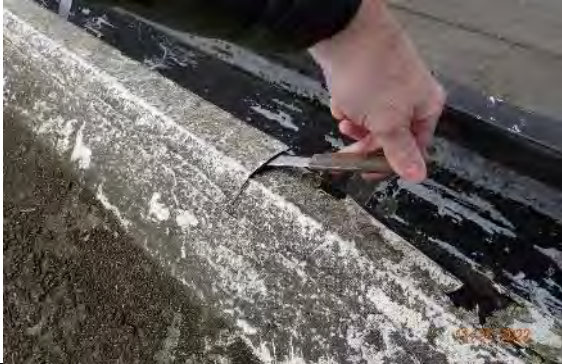
<p>12. View of open lap joints in drip edge metal, as indicated in previous item. <i>Recommendation: See item #11.</i></p>

<p>11. Overview of the metal drip edge along the west perimeter of the roof. Drip edge metal has open lap seams, the drip edge does not return sufficiently into the gutter and appears to be installed over existing metal drip flashing. <i>Recommendation: Seal joints in flashing with additional reinforced coating and monitor until reroofing occurs.</i></p>	  <p>11/21/2022</p>

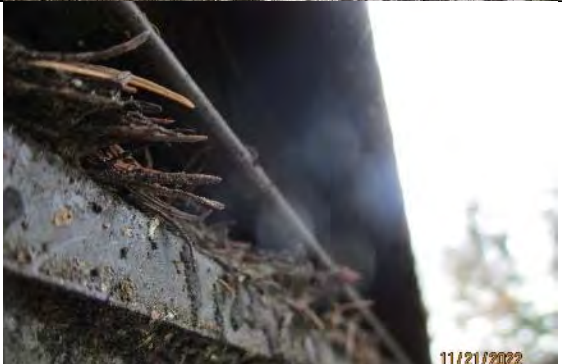
<p>13. View of the underside of the drip edge metal as shown in the two previous photos. Note the second layer of metal drip edge and organic debris collecting under the drip flashing. <i>Recommendation: Remove debris.</i></p>

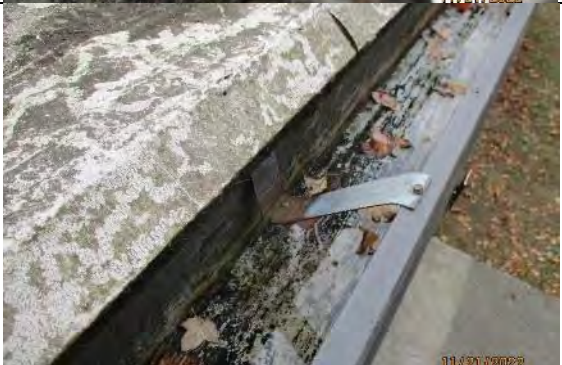
<p>14. Broken gutter straps at the west end of the main roof. <i>Recommendation: Replace gutters when reroofing occurs.</i></p>

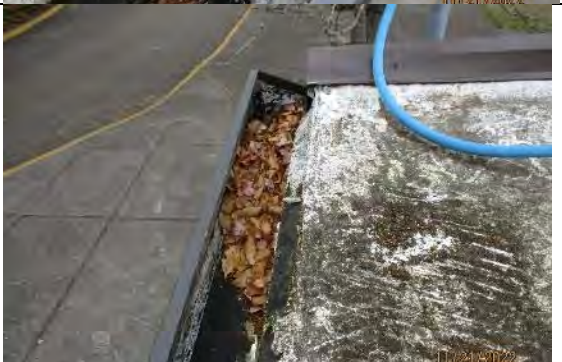
<p>15. Front edge of gutter appears to be higher than drip edge metal which creates a condition where water can backup under drip edge metal and into roof assembly. <i>Recommendation: Replace gutters when reroofing occurs. Front edge of new gutter should be lower than back and gutters sized appropriate for roof area.</i></p>

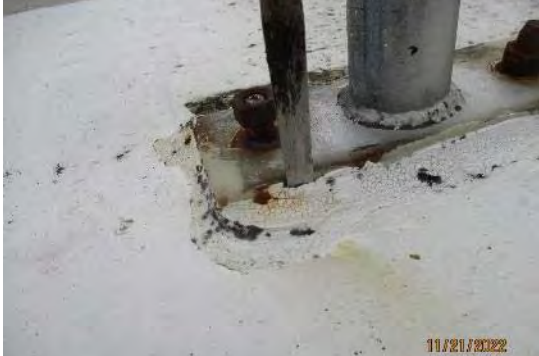
A photograph showing a metal railing installed around a mechanical unit on a flat roof. The railing is mounted with fasteners that go directly through the roof coping and membrane without any flashing.
<p>23. Showing void around base plate of railing attached through roofing. <i>Recommendation: See item 22.</i></p>

A close-up photograph of the base plate of a railing where it is attached to the roof. There is a visible void or gap between the base plate and the roof surface, indicating water infiltration.

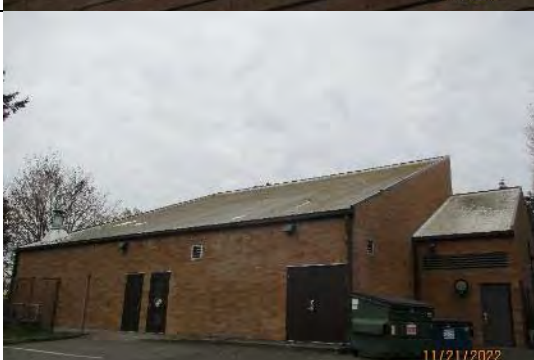
<p>2. Closer view of the previous photo at the north elevation, showing unadhered mortar. <i>Recommendation: See item #1.</i></p>	 
<p>3. Overview of cracks through brick and mortar at the north elevation below the ridge between the main roof and small roof at the northeast corner. <i>Recommendation: Structural repair appears necessary to prevent future cracking, followed by replacement of the brick. Another option is to install new cladding, insulation, and weather barrier over the brick after structural repairs.</i></p>	 
<p>4. East elevation of the building.</p>

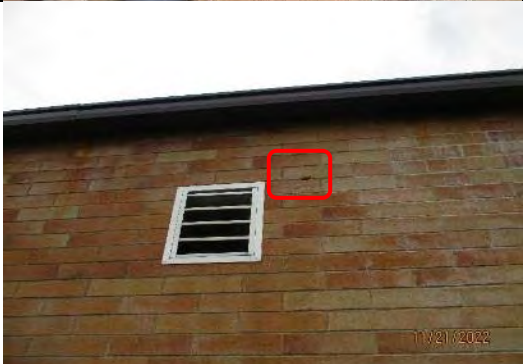
<p>7. Damaged brick, or brick with a hole from a previous penetration at the east elevation (highlighted). <i>Recommendation: Patch with mortar or clad over brick as indicated above.</i></p>

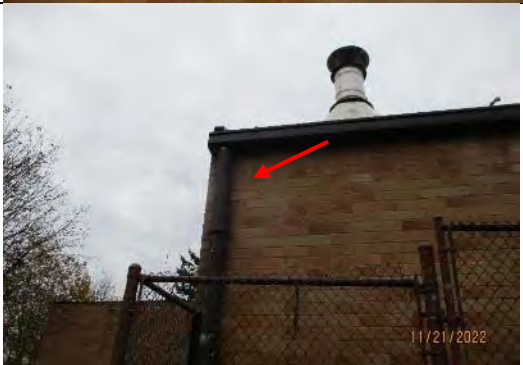
<p>8. Cracked brick at the southeast corner, east elevation (arrow).</p>

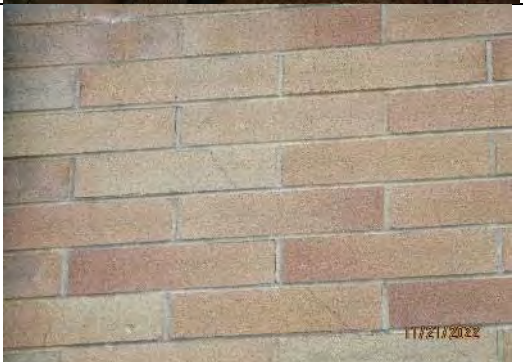
<p>9. Closer view of previous photo showing crack through brick and mortar. <i>Recommendation: Structural repair appears necessary to prevent future cracking, followed by replacement of the brick. Another option is to install new cladding, insulation, and weather barrier over the brick after structural repairs.</i></p>

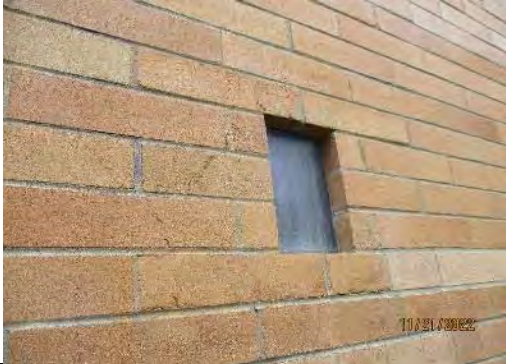
<p>14. Cracked brick around small windows at the south elevation, towards the west end of the building. <i>Recommendations: Structural repair appears necessary to prevent future cracking, followed by replacement of the brick. Another option is to install new cladding, insulation, and weather barrier over the brick after structural repairs.</i></p>

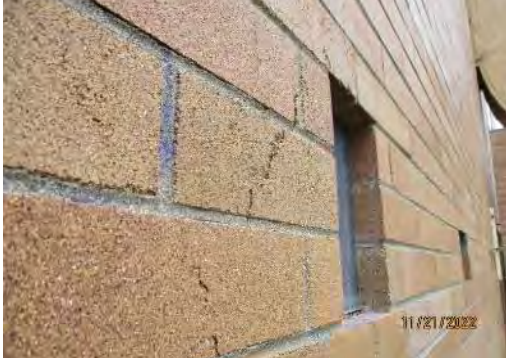
<p>15. Closer view of cracks in brick as noted in previous photo. <i>Recommendations: See previous.</i></p>

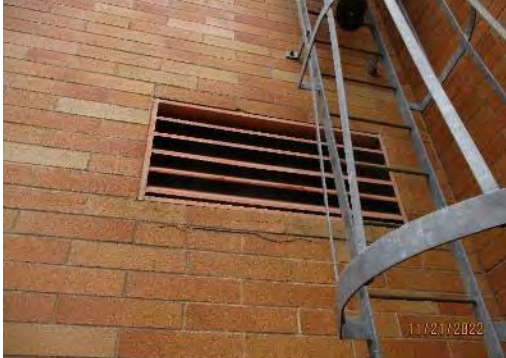
<p>16. Overview of cracking/spalled brick below louver adjacent the roof access ladder at the south elevation. <i>Recommendations: Structural repair appears necessary to prevent future cracking, followed by replacement of the brick. Another option is to install new cladding, insulation, and weather barrier over the brick after structural repairs.</i></p>

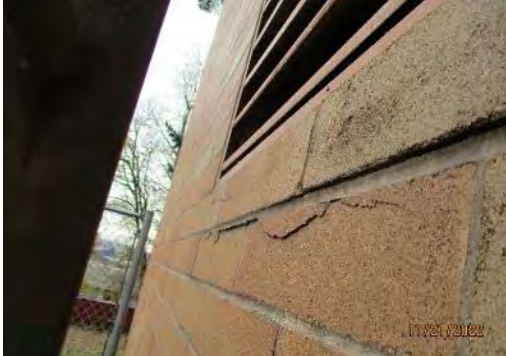
<p>17. Closer view of cracks in brick as noted in previous photo. <i>Recommendations: See previous.</i></p>

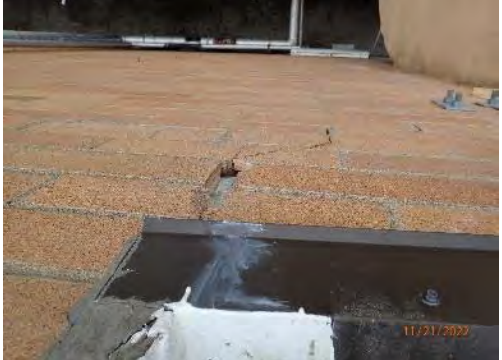
<p>18. Looking down from the roof at the south elevation, where the main roof transitions to the clerestory structure. There is a large crack in the brick and mortar.</p> <p><i>Recommendations: Structural repair appears necessary to prevent future cracking, followed by replacement of the brick. Another option is to install new cladding, insulation, and weather barrier over the brick after structural repairs.</i></p>

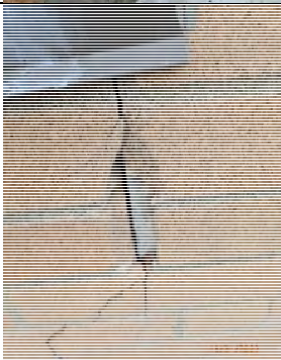
<p>19. Closer view of cracks in brick as noted in previous photo.</p> <p><i>Recommendations: See previous.</i></p>

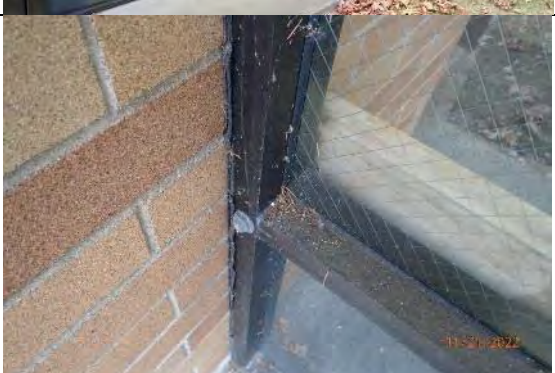
<p>21. Unadhered sealant joint at the perimeter joint of the storefront windows-to-brick.</p> <p><i>Recommendations: Remove existing sealant and replace with new sealant and backer rod.</i></p>

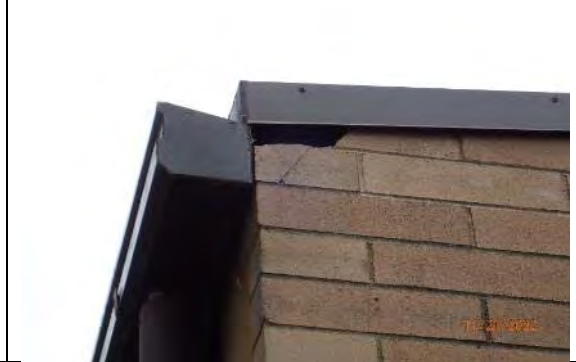
22. Missing masonry at the southwest corner of the building, behind the gutter.  
*Recommendations: Temporary solution would be to install sheet metal counterflashing tucked under the outer leg of the coping metal. More permanent repair would require replacement of cracked brick with new brick to infill to roof line. Another option is to install new cladding over new weather barrier.*

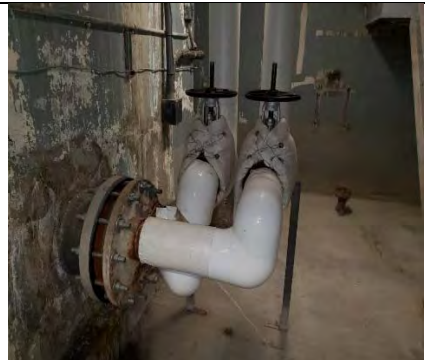
Description	Photo
<p>1. Pool heating tube bundle (Critical-1, wear and tear) <u>Deficiency/Observation:</u> M001 <u>Recommendation:</u> The connection between the hydronic piping and the pool heating tube bundle leaks. According to staff, the bundle was replaced in 2020 and the leak is due to a failure in the penetration itself. Re-installation of the tube bundle is required and needs to be coordinated with any surge tank repairs.</p>

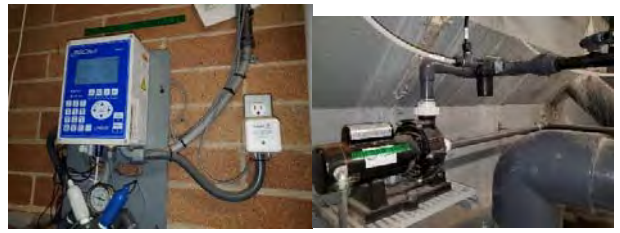
<p>3. Disinfecting Chemical Conversion. (Optional-wish list) <u>Deficiency/Observation:</u> M003 (Optional- wish list) <u>Recommendation:</u> Replace existing solid Chlorine injection system to a Bromine or Saline electrolysis system.</p>

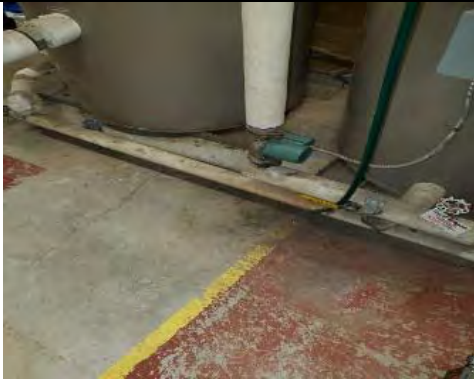
Description	Photo
<p>4. Domestic Water Heaters (Critical -1, life safety)  <u>Deficiency/Observation:</u> M004  <u>Recommendation:</u> Domestic water heaters are not seismically restrained. While this is a life-safety issue, the age of the tanks indicates replacement. If replacement is undertaken, the entire domestic hot water design needs to be evaluated and alternatives designs considered. The major hot water load (locker rooms, showers) is on the opposite end of the building. Alternative heat sources and configuration should be considered.</p> <p>5. Lobby public restrooms (General -3; ADA violations)  <u>Deficiency/Observation:</u> M005  <u>Recommendation:</u> Existing public restrooms need to be re-configured to meet ADA requirements. Replace fixtures with code compliant fixtures. Staff suggests low flow fixtures not be used, due to frequent clogging. A code variance should be considered to use blow-out type water closets.</p> <p>6. Locker room plumbing fixtures (General-3; Wear and tear)  <u>Deficiency/Observation:</u> M006  <u>Recommendation:</u> Replace all existing plumbing fixtures with modern, code compliant fixtures. Replace existing gang showers with individual temperature control shower valves and heads.</p> <p>7. Exterior clean-out caps (General-3; Wear and Tear)  <u>Deficiency/Observation:</u> M007  <u>Recommendation:</u> Install new hub and cap on existing open clean-out south of the building.</p>

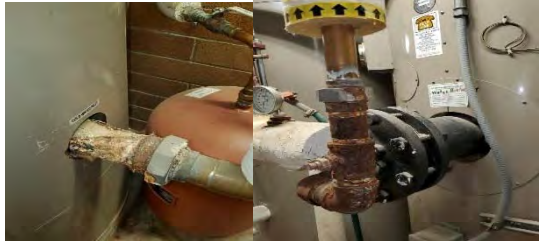
Description	Photo
<p>8. Replace di-electric unions (Critical 1, wear and tear)  <u>Deficiency/Observation:</u> M008  <u>Recommendation:</u> Replace all di-electric unions with proper di-electric waterway fittings. Replace corroded sections of piping and damaged insulation. This should be coordinated with the boiler system replacement.</p>

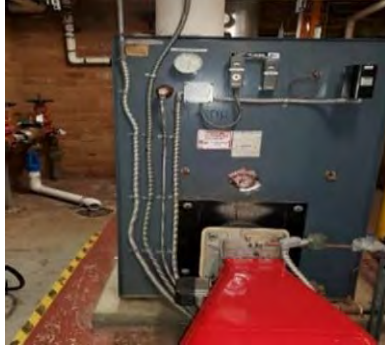
<p>9. Cast iron boiler system (Critical -2; wear and tear)  <u>Deficiency/Observation:</u> M009  <u>Recommendation:</u> The existing cast iron boiler system has no redundancies. The boiler was recently (2013) retrofit with a variable-fire burner, which reduced energy use, however, the cast iron boiler has limited thermal efficiency. We suggest replacement of the single boiler with two 50% load sized, condensing boilers, and revise/replace piping and pumps to accommodate a conventional variable speed pumping design.</p>

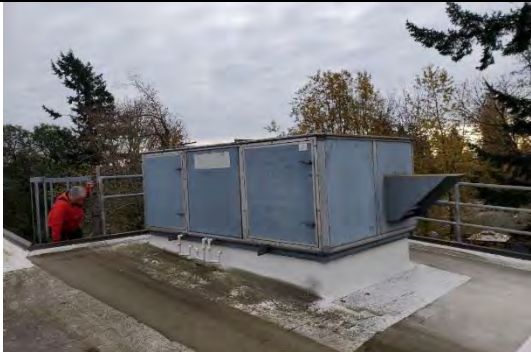
Description	Photo
<p>12. Lobby/Locker room rooftop unit (Critical-1, wear and tear)</p> <p><u>Deficiency/Observation:</u> M012</p> <p><u>Recommendation:</u> Replace Roof mounted HV unit. Re-configure ductwork from lobby and office as return ductwork. Install a new heat reclaim ventilator to pre-condition outside air stream.</p>

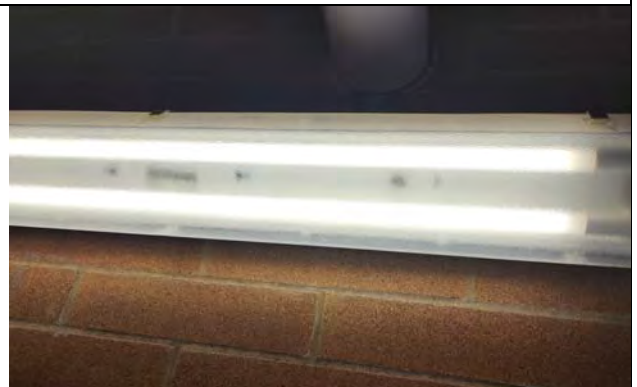
<p>17. – Exterior Receptacles</p> <p><u>Deficiency/Observation:</u> Receptacles are missing correct weatherproof covers.</p> <p><u>Recommendation:</u> Provide receptacle listed for wet-location and weather-proof cover.</p>	
<p>18. – Janitors room</p> <p><u>Deficiency/Observation:</u> Light fixture shielding damaged. Panels in same room show rust.</p> <p><u>Recommendation:</u> Replace with LED light fixtures with 10% up-light and listed for wet or damp location. All supports shall be suitable for location per NEC 300.6. Replace conduit suitable for location NEC 680.12, &amp; 300.6.</p>

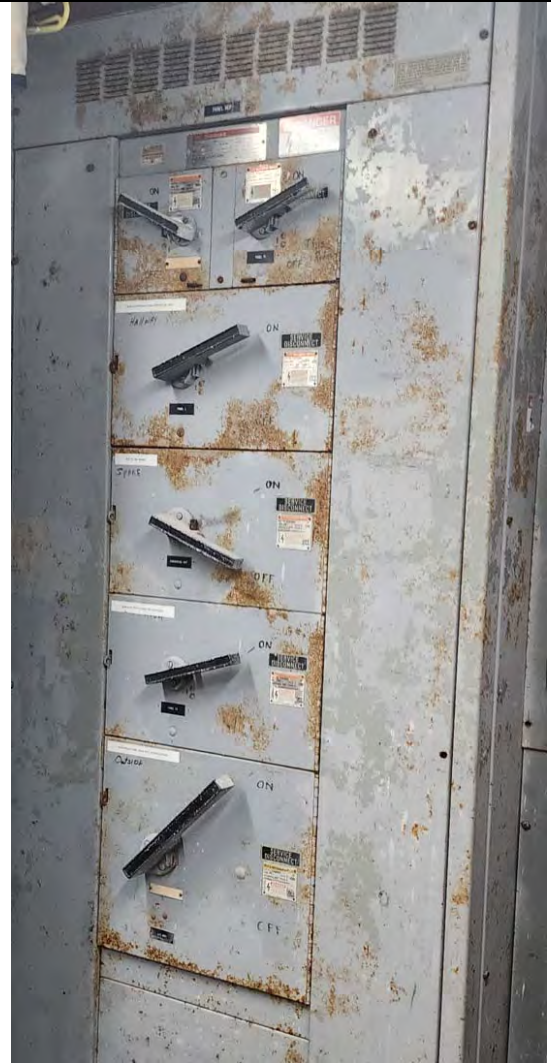
20. – Panel X - 100A, 120/208V, 3 phase

Panelboard is past the standard life expectancy of 30 years. Full replacement and potential upgrades to capacity. Panel and raceway shall be suitable for the environment NEC 680.14, 680.12 & 300.6. Panel will need to be located to meet working space clearances and heights per NEC and local jurisdiction.

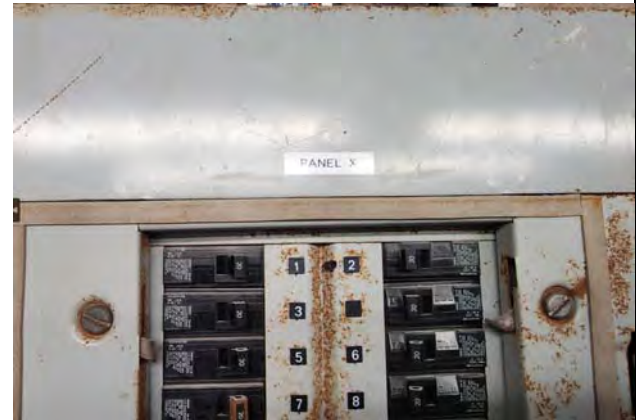
21. – Panel P1 - 225A, 120/208V, 3-Phase

Panelboard past the standard life expectancy of 30 years. Full replacement and potential upgrades to capacity. Panel and raceway shall be suitable for the environment NEC 680.14, 680.12 & 300.6.

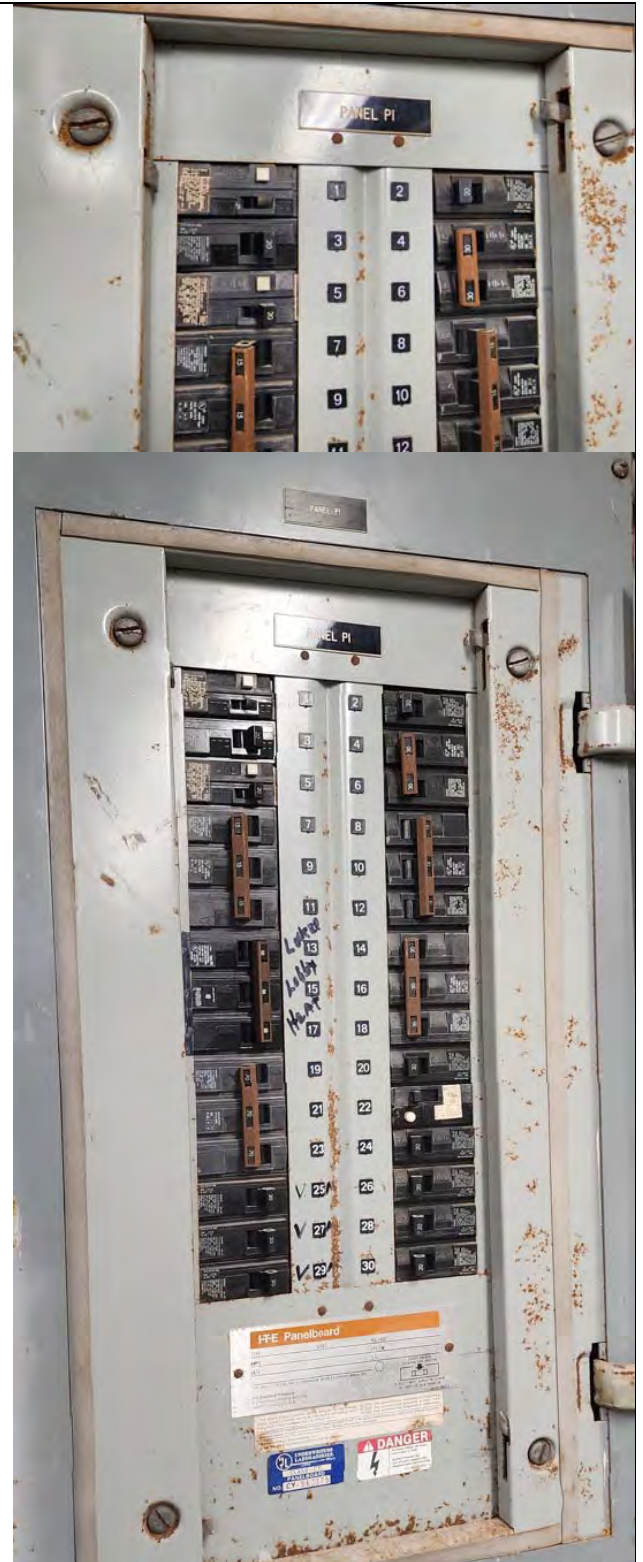
22. – Panel P2 - 225A, 120/208V, 3-Phase

Panelboard is past the standard life expectancy of 30 years. Full replacement and potential upgrades to capacity. Panel and raceway shall be suitable for the environment NEC 680.14, 680.12 & 300.6.

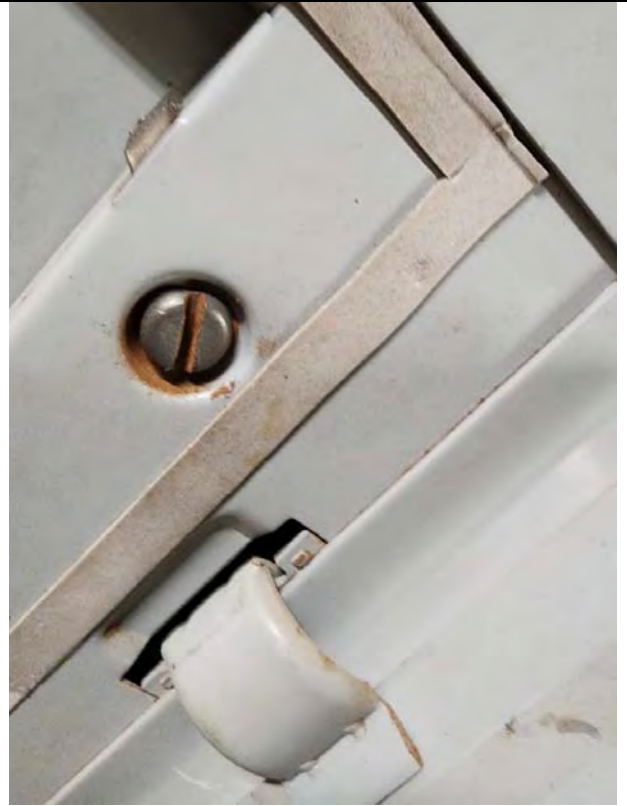
23. – Panel A - 225A, 120/208V, 3-Phase

Full replacement and potential upgrades to capacity. Panel and raceway shall be suitable for the environment NEC 680.14, 680.12 & 300.6.

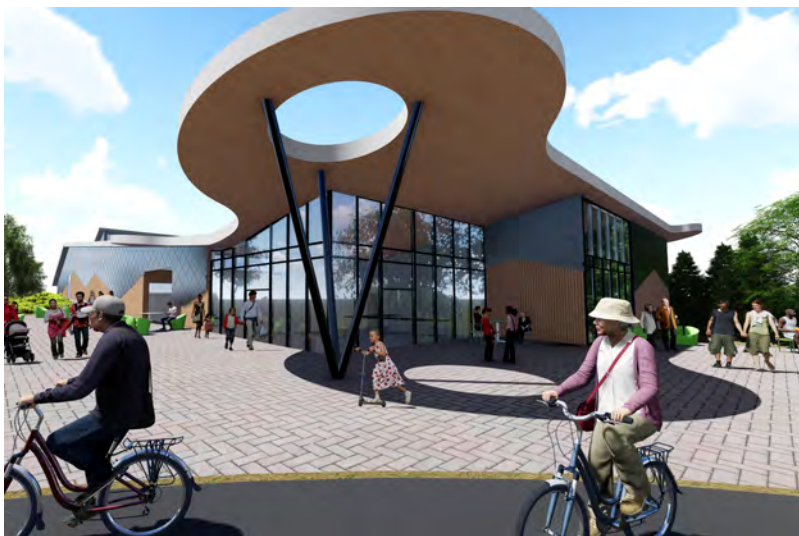
Natatorium with partitioned pool and south addition

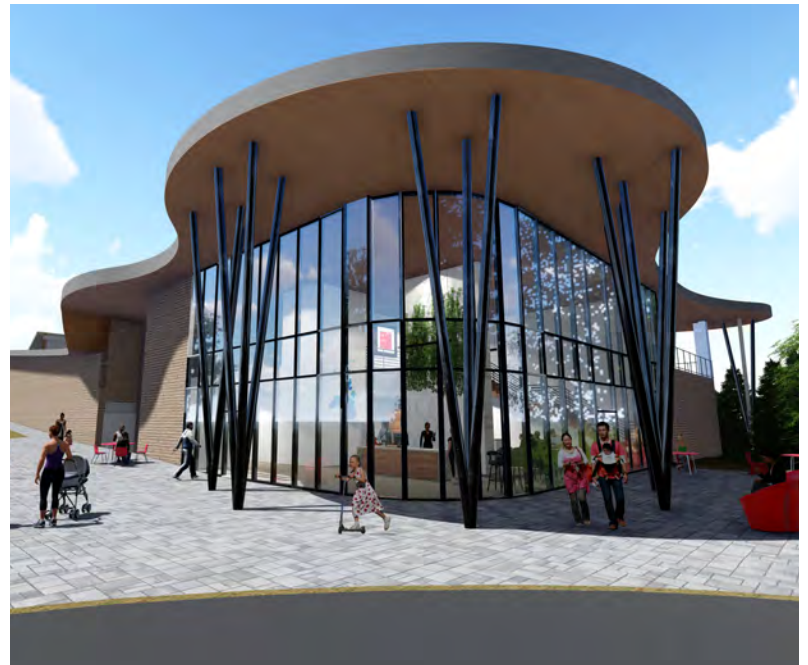
Option 2 Main Entry and Canopy

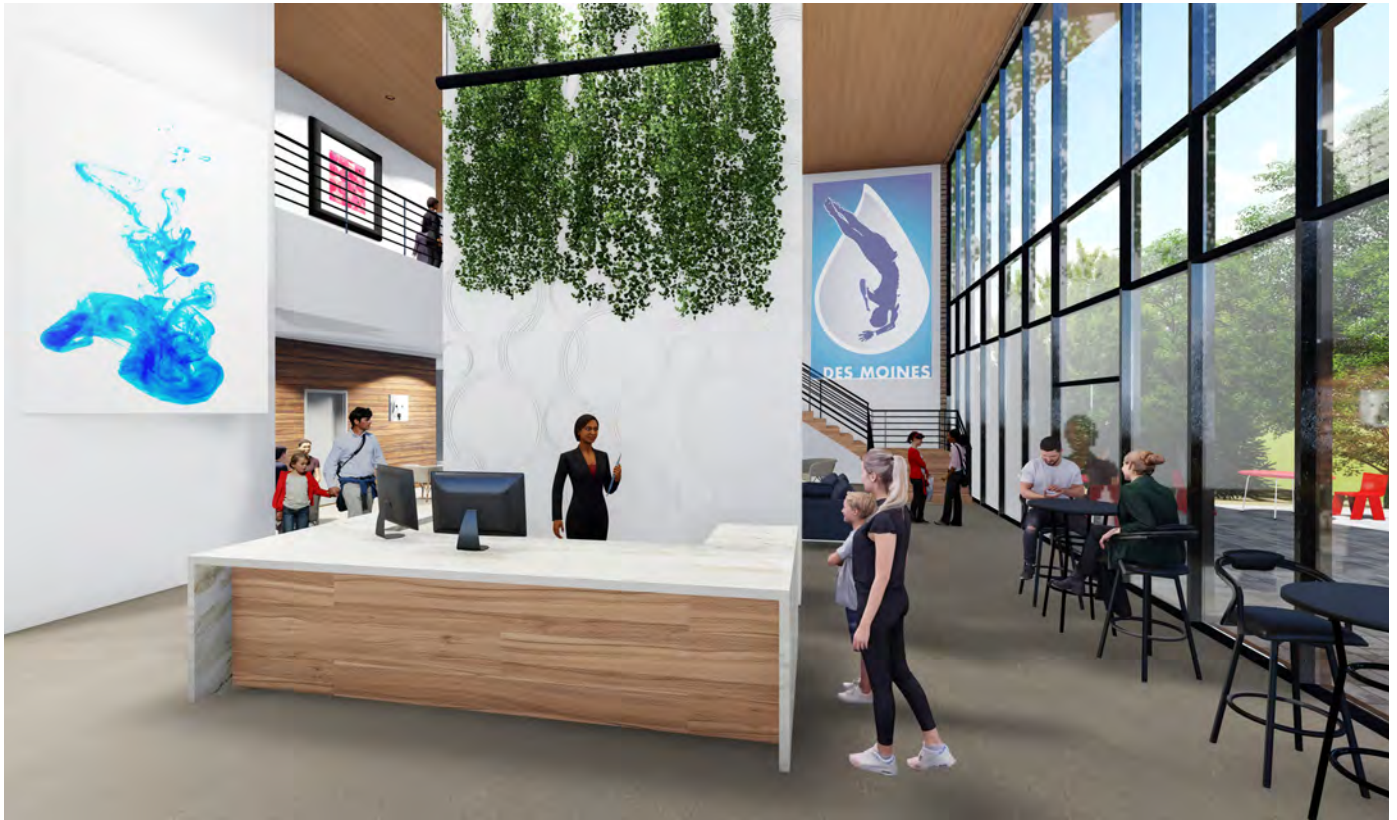
Option 2 Reception at Lobby

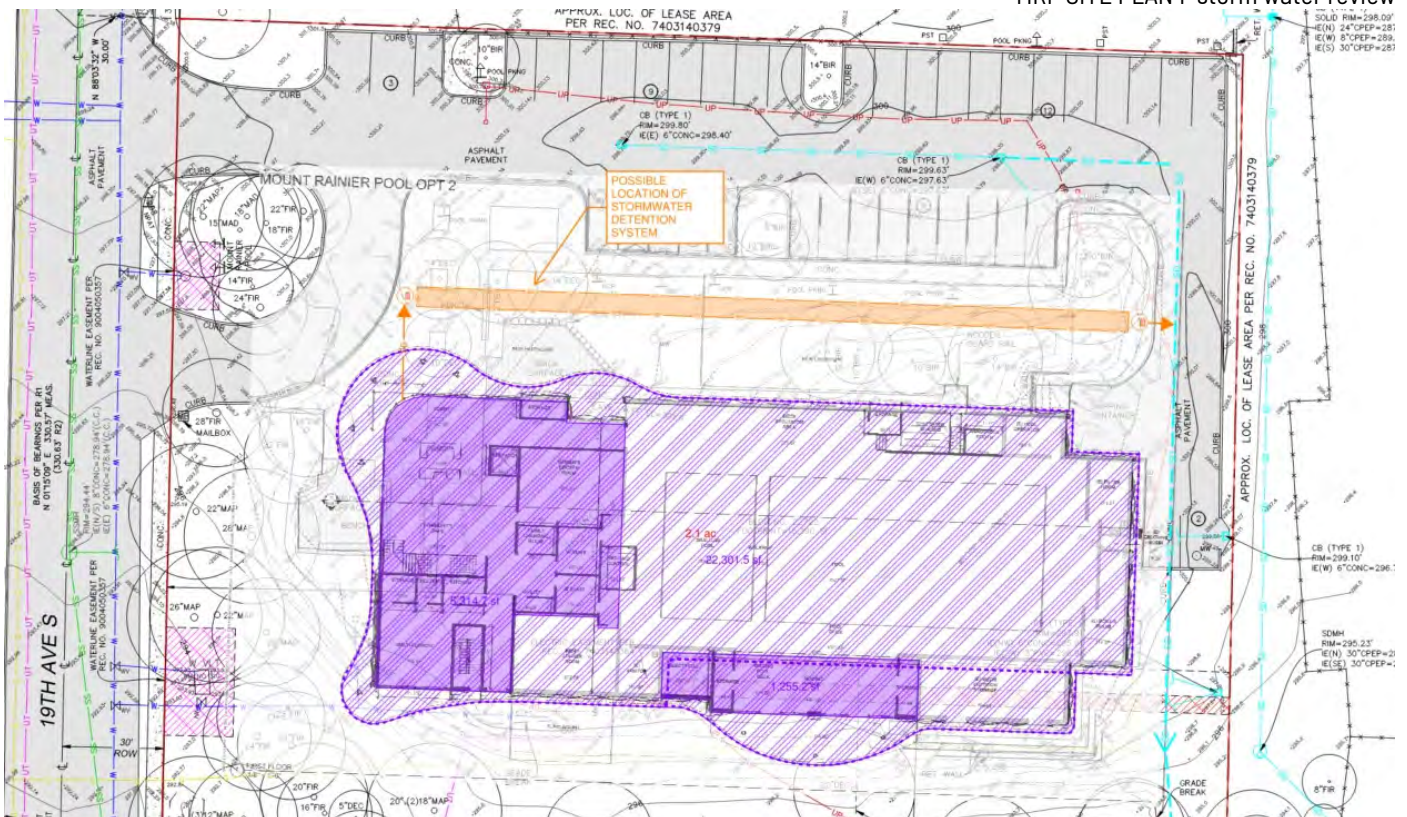
MRP SITE PLAN f-storm water review

Perimeter perforated footing drains should also be provided around the new building additions, to pick up any surface water or incidental ground water from being trapped adjacent to the building foundation.
