Des Moines Pool Metropolitan Park District

August 22, 2023

**MOUNT RAINIER POOL
EXISTING CONDITION ASSESSMENT
and FEASIBILITY STUDY**

PART 1: EXISTING CONDITION ASSESSMENT

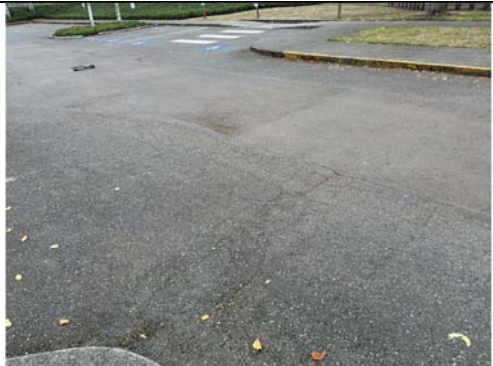
Description	Photo
1. Existing Asphalt <i>Deficiency/Observation:</i> The majority of the asphalt has appeared to be near the end of its useful life. There is significant alligatoring and cracking. There is a patch down the drive aisle that is in better location, but still has some failure occurring. <i>Recommendation:</i> Provide square patch removal at the worst areas, and attempt to install a Petromat or equal over the surface of the parking lot and overlay with a new 2" lift.

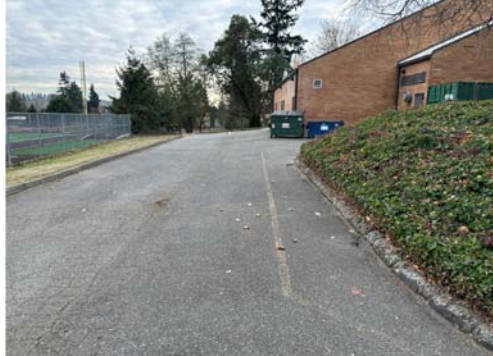
2. Existing Asphalt – See Item 1 <i>Note:</i> The typical maximum threshold to replace asphalt prior to drainage improvements is 5,000 sf. Beyond this amount Water Quality treatment and Flow Control (Detention) could be required. Jurisdictions have different interpretations of maintenance and how and when this threshold is triggered.	 
3. Existing Asphalt – See Item 3

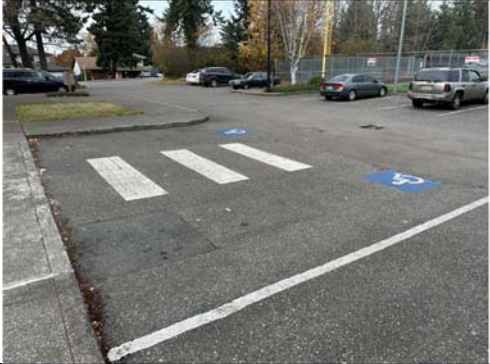
<p>4. ADA Parking</p> <p><u>Deficiency/Observation:</u> The existing ADA is non-compliant and over the maximum ADA slope of 2% in any direction.</p> <p><u>Recommendation:</u> Remove existing asphalt and replace with concrete as it is more durable and tolerant to set precise and flatter slopes.</p>

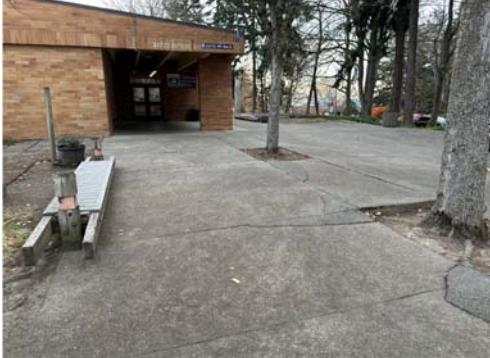
<p>4. Replace ADA Pathway from Parking</p> <p><u>Deficiency/Observation:</u> The existing ADA pathway from the ADA parking stalls to the front door is not complete compliant, and portions exceed the allowable 2% cross slope.</p> <p><u>Recommendation:</u> Remove and replace non-conforming portions of the existing concrete sidewalk ADA Pathway.</p>

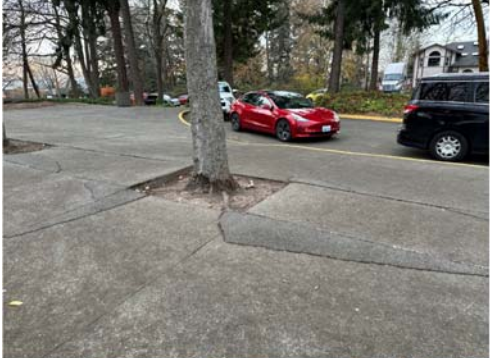
<p>5. Replace Cracking and Lifting Concrete</p> <p><u>Deficiency/Observation:</u> Portions of the existing concrete sidewalks and plazas are lifting due to tree roots or other issues related to life expectancy of the improvements.</p> <p><u>Recommendation:</u> Replace existing concrete to eliminate pedestrian safety concerns.</p>

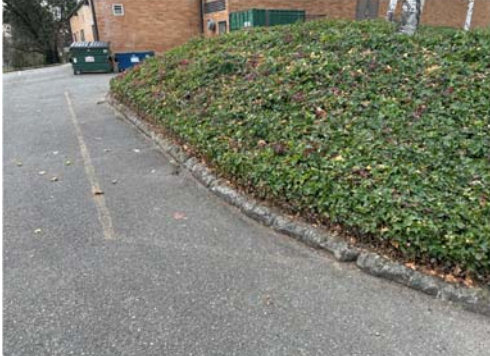
<p>6. Replace Extruded Curbs</p> <p><u>Deficiency/Observation:</u> The majority of the existing extruded curbs are disintegrating.</p> <p><u>Recommendation:</u> Replace existing extruded curbs.</p>

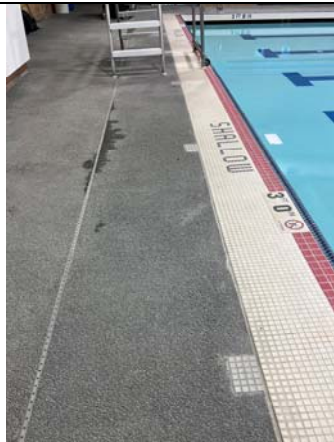
Description	Photo
<p>1. Pool deck surface</p> <p><i>Deficiency/Observation:</i> Pool deck, as well as the entire floor surfaces of the building interior is heavy aggregate concrete; at the pool deck, various areas are worn away and pitting. Additional hairline cracks and minor spalling is occurring. The uneven texture is allowing for pooling of water to occur which can cause slippery conditions; the general pool drainage is functioning.</p> <p><i>Recommendation:</i> cracks and deterioration will continue if untreated; repair cracks and treat surface of deck by replacing the top inch or utilizing a skid resistant coating.</p> <p>Note: cracks noted at stairs for seating area; structural cracks in the concrete platform at seating area. Refer to structural report.</p>

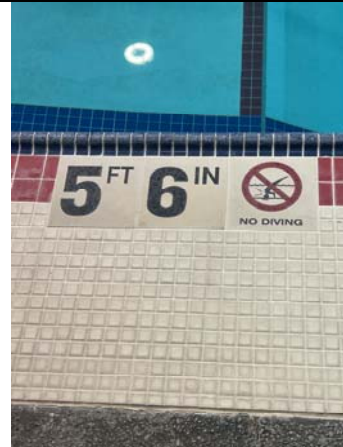
2. Pool tile and grout

Deficiency/Observation: Pool tile and grout looks aged and worn; pool markers are still legible, but the 'no diving' sign is small and difficult to read; perimeter tile is in fair condition. DMPMPD indicates that the pool tile was replaced in 2017.

Recommendation: the existing pool tile can remain in place, though it should be cleaned. Replacing the pool markers and tile should be replaced if significant deck work occurs.

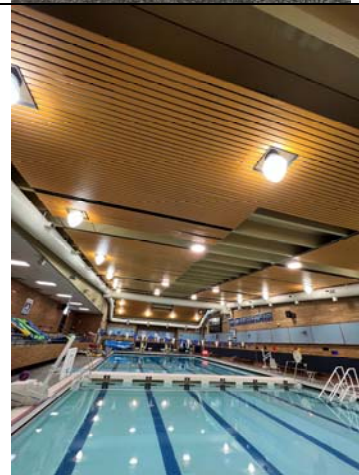
3. Natatorium Lighting/General Lighting

Deficiency/Observation: Natatorium and general lighting at interiors are a mix of metal halide, fluorescent and some LEDs – not energy efficient and do not appear to be on lighting control panels.

Recommendation: Refer to electrical report for recommendations; replacing the light fixtures to be more energy efficient and updated designs will brighten and refresh the spaces.

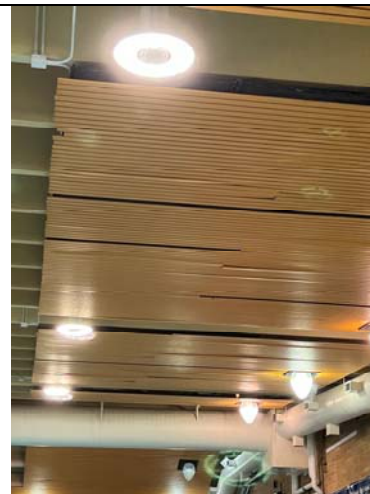
4. Natatorium ceiling

Deficiency/Observation: existing ceiling clouds are showing damage, are unseated or missing in multiple locations;

Recommendation: remove the ceiling clouds and replace with a more durable ceiling system such as an Armstrong Serpentina grid system, or possibly leave exposed to structure.

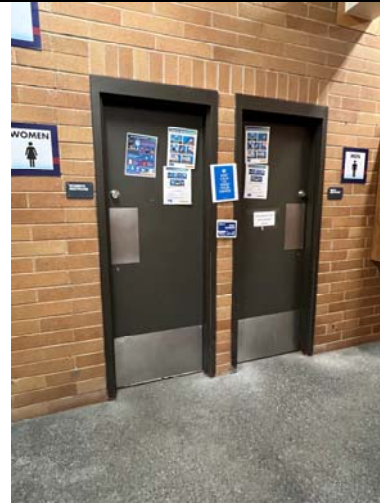
5. Men's and Women's Restrooms – Public Use

Deficiency/Observation: general use restrooms that are located on the main corridor to the natatorium entrance do not comply with accessibility requirements; the door widths are 28.75" clear, the push/pull clearances are 2" or under, and the interior stalls and restrooms areas do not have clearances required for accessible use. Currently, accessible use is in the Men's and Women's Locker Rooms, which is impractical for users who may only be spectators.

Recommendations: revise the restrooms to be stall-free and single use unisex restrooms; widen the door opening(s) and install accessible doors.

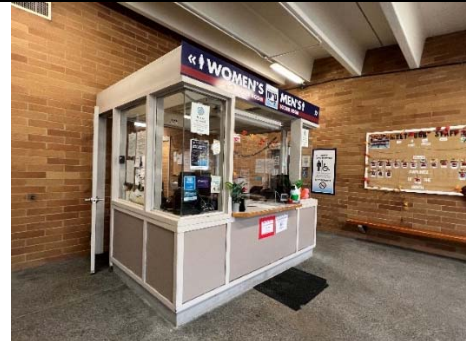
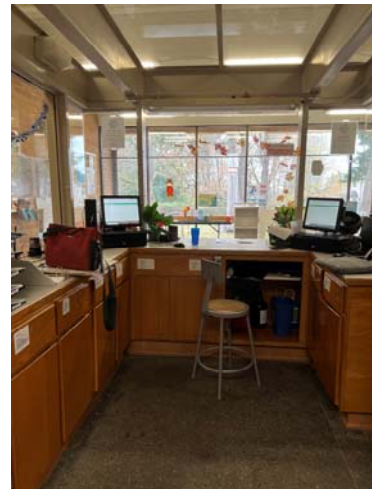
6. Reception Booth

Deficiency/Observation: the reception booth is not accessible at it's entry door (28.5") and does not provide an accessible path to the main counter area; the counter area is not in compliance with accessible requirements (39"aff) and does not provide accessible access for general public; the existing booth also has a wire glass skylight with one panel damaged and cracked.

Recommendations: replace the booth in its entirety to be an open reception desk and counter area that complies with current accessibility requirements.

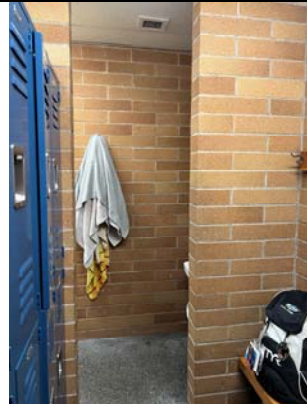
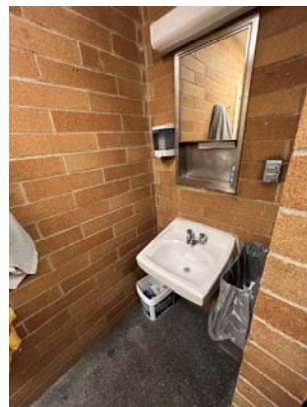
7. Men's and Women's Staff Locker Rooms

Deficiency/Observation: The staff locker rooms are non-compliant for accessibility; doors, pathways, turns, clearances all do not comply;

Recommendations: reconfigure the staff locker room spaces to comply with accessibility requirements. This may require the removal of the brick screen wall(s) and relocation/minimization of lockers.

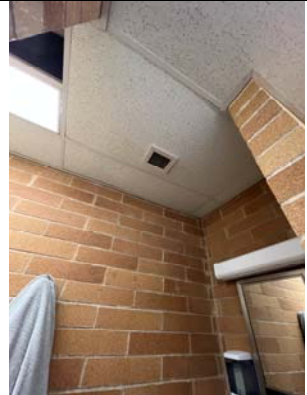
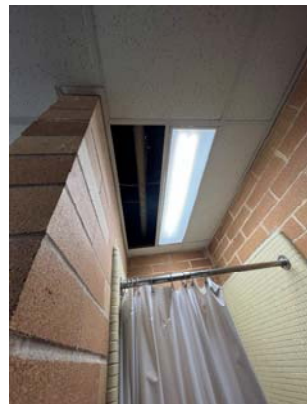
8. Men's and Women's Staff Locker Rooms – Ceiling Grid

Deficiency/Observation: The staff locker rooms ceiling grid is aged and worn with parts of the ACT missing

Recommendations: replace the ACT grid system with a new more resilient system and align with reconfigured space

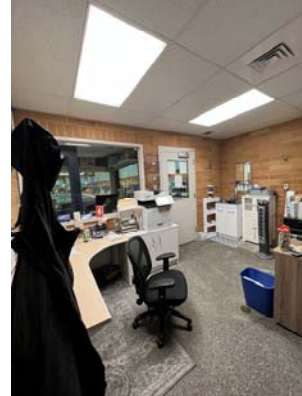
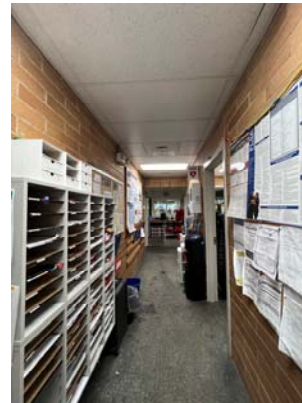
9. Office area, Manager's office, Hallway floors

Deficiency/Observation: The general office area has the same heavy aggregate concrete floor as the natatorium pool deck and is heavily pitted; while durable, it is hard to keep clean with the heavy texturing.

Recommendations: add skid resistant coating over the concrete floor.

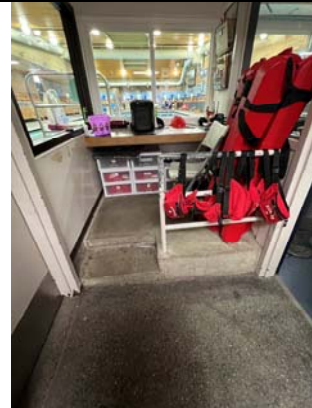
10. Lifeguard watch station

Deficiency/Observation: Lifeguard watch station is cramped and aged; the life guard equipment is crowding the space, the guardrail is worn with paint chipping off and does not meet the 42" off requirement.

Recommendations: provide a hanging rack for the lifeguard equipment, replace the guardrail

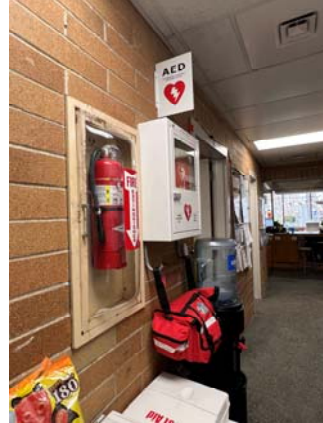
11. Fire Extinguisher Cabinet and AED Station

Deficiency/Observation: existing FEC and AED cabinets do not have required clearances for access.

Recommendations: clear away existing items blocking the access path.

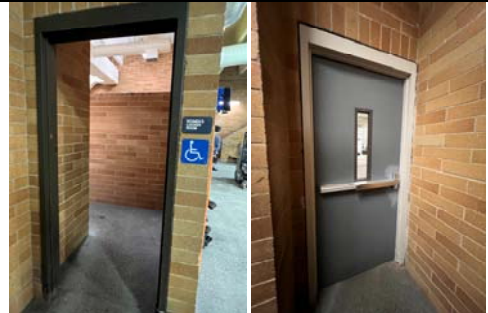
12. Men's and Women's Locker Rooms -General

Deficiency/Observation: natatorium doors to locker rooms do not comply with accessible clearances on the push and pull sides – the existing construction does not allow for these clearances; the locker room benches are aged and worn. Bench posts are worn with paint chipping off; the accessible bench does not comply with current requirements. The locker rooms are undersized for current capacity – occupancy will need to be reviewed and likely reconfiguration of the locker room spaces required.

Recommendations: reversing the door hinging will allow for the required door pull side clearances to comply---option to install automatic operator will also resolve this issue; reconfigure the locker room area and replace all the locker room benches and update the accessible bench.

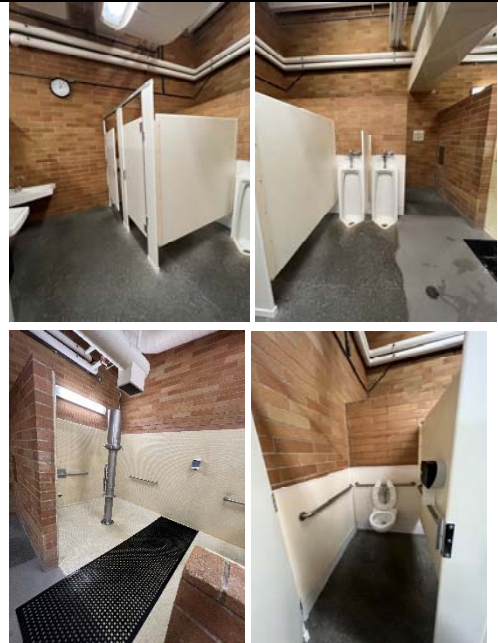
13. Men's and Women's Locker Rooms –Shower and Restroom Areas

Deficiency/Observation: the restroom areas, shower areas, and plumbing fixtures are worn and aged; the shower tile and restroom stalls are stained and aged, but still function. Privacy shower and changing areas are not available (unless the accessible shower stall is being used for this)

Recommendations: the plumbing fixtures will likely require replacement. Refer to mechanical report for details; replace all of the shower tiles and replace the restroom stalls with new heavy duty use stalls (HPDE) for easier maintenance and durability. Provide privacy shower and changing stalls in each locker room. While these areas minimally comply with accessibility requirements, improvements to provide better accessibility pathways and stalls should be considered.

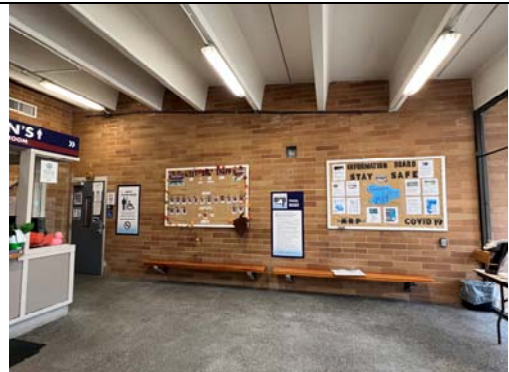
14. Lobby – Brick Veneer

Deficiency/Observation: existing brick veneer throughout the building has various hairline cracks and is effervescing.

Recommendations: repair cracks at brick and clean existing effervescence. The building exterior needs to be treated to prevent further effervescing. Refer to building envelope report for recommendations.

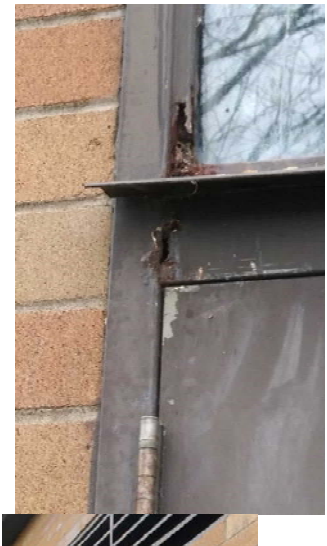
<p>2. Exterior doors and frames</p> <p><u>Deficiency/Observation:</u> Exterior doors of facility are aged; frame, door, and hardware are corroded.</p> <p><u>Recommendation:</u> Replace exterior frames, doors, and re-lites with hollow metal doors with same operation. Furnish and install rough opening flashings, and sheet metal head, jamb, and sill flashing.</p>

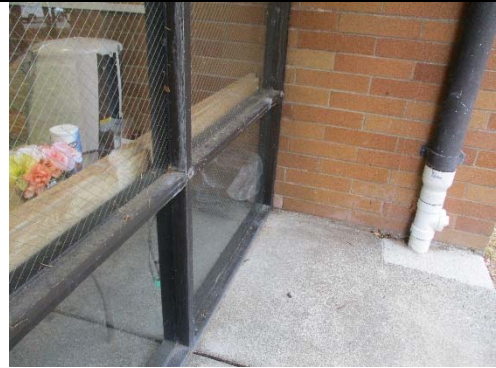
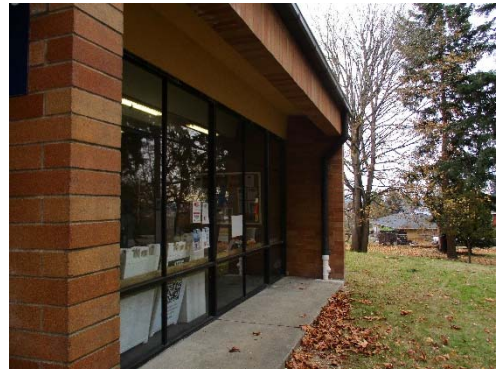
3. Exterior storefront windows

Deficiency/Observation: Existing exterior storefront windows are in fair condition but may be near the end of their service life.

Recommendation: Replace existing storefront windows with thermally broken, energy efficient, aluminum storefront windows.

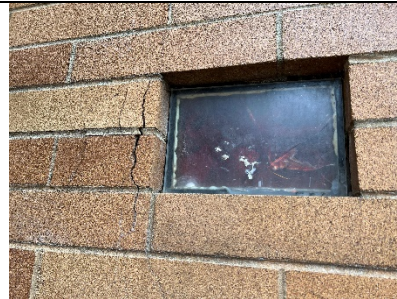
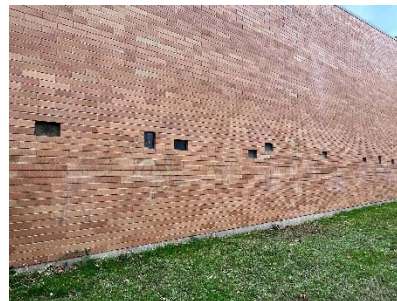
4. Decorative exterior windows

Deficiency/Observation: The existing decorative, colored, windows are broken in many locations. Deficiencies were also noted at the window rough openings and surrounding masonry.

Recommendation: Replace windows with new installation that recognizes and reflects the original design intent. Coordinate with DMPMPD prior to replacement as these appear to be a public art item.

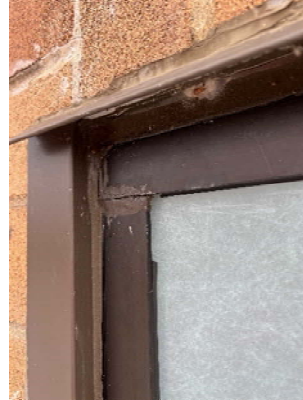
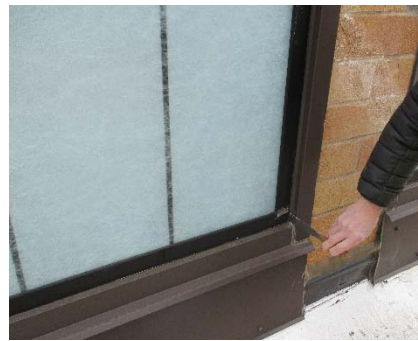
5. Exterior clerestory windows

Deficiency/Observation: Exterior clerestory windows are aged. It appears that there have been attempts to make frame repairs, and sealant repairs to prevent water intrusion.

Recommendation: Remove existing clerestory windows. Furnish and Install self-adhered or liquid applied rough opening membrane flashing. Furnish and install head, jamb, and sill flashing. Replace clerestory panels with translucent clerestory windows or a translucent insulated panel system for energy efficiency.

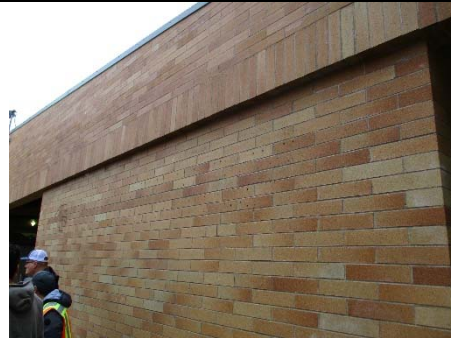
6. Exterior masonry

Deficiency/Observation: Abandoned signage mounting leaves many damaged bricks, with holes.

Recommendation: Masonry needs to be patched / replaced at locations.

****Note:** coordinate comments 6 and 7 with the building envelope narrative as a cladding system over existing structural brick may be needed.

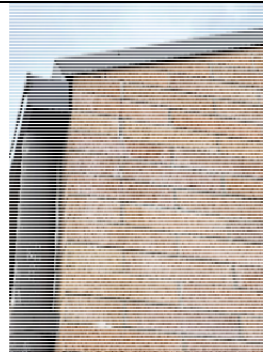
7. Exterior masonry

Deficiency/Observation: Several areas of masonry appear to be deteriorated and cracked due to building movement and extensive power-washing.

Recommendation: Clean brick and replace all brick that has extensive pitting or cracking. Rout and re-point at many of the masonry areas. Apply water repellent and anti-graffiti coating at all masonry elevations.

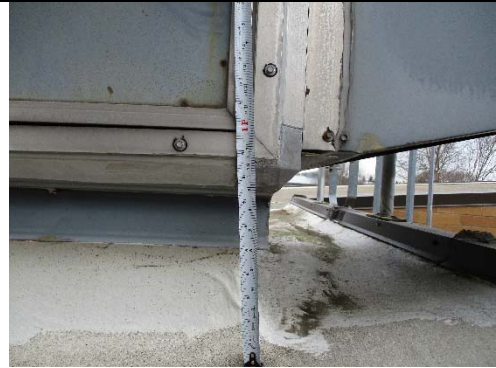
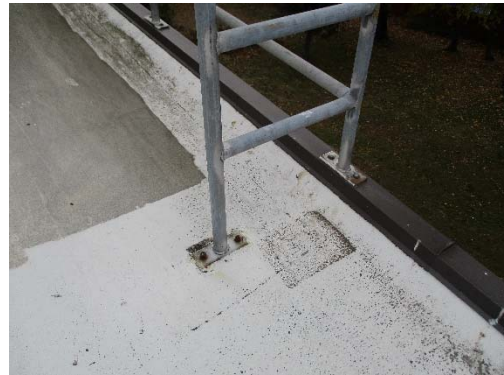
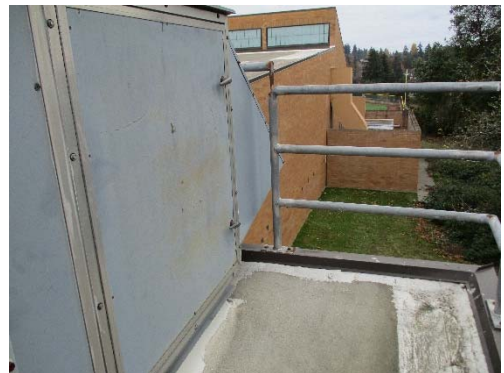
8. Roof-mounted mechanical equipment

Deficiency/Observation: This roof-mounted mechanical unit is in good proximity to the roof access ladder. At the upslope location, the curb does not meet the required height of 8" above adjacent finished roof surface. At the downslope location, the mech curb height is sufficient.

The rail surrounding the roof mounted mech unit is in fair condition. It is corroded at some joint locations. The rail attachment is at the roof surface and parapet, which is not recommended.

Recommendation: Coordinate with mechanical for use of mechanical unit. Any mechanical units installed at the roof must be installed with a curb height of 8" above adjacent roof surface. The existing rail should be replaced and railing attachments should be flashed to prevent water intrusion.

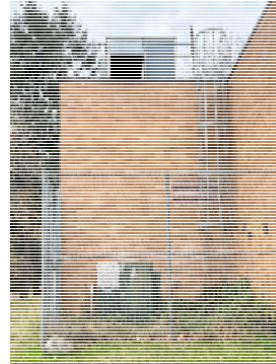
9. Exterior roof access ladder

Deficiency/Observation: The roof access ladder is mounted at the exterior face of the building, at a rear corner. Access to the ladder is through a locked fence. The ladder is in good condition

Recommendation: Modify ladder installation to coordinate with any building envelope modifications. Address landscape overgrowth at base of ladder. Replace the fencing with vinyl slatted fencing.

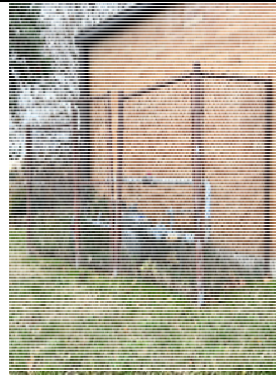
10. Exterior fencing at riser

Deficiency/Observation: Exterior fencing at riser is severely corroded.

Recommendation: replace the fencing in it's entirety with vinyl slatted fencing.

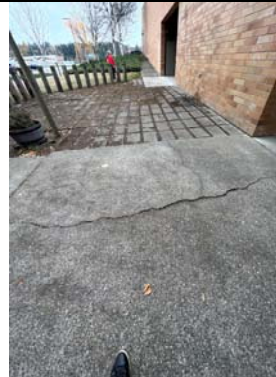
11. Exterior concrete walk and bicycle yard

Deficiency/Observation: existing sidewalk at building entry is cracking and spalling; the bicycle yard is underutilized and pavers are in various stages of deterioration.

Recommendation: repair the sidewalk cracks and spalls by shaving down uneven areas and sealing the cracks; clean the bicycle yard and pressure wash the pavers; replace pavers that are cracked or broken. For areas where major spalling is occurring, break out the concrete and replace the concrete panel.

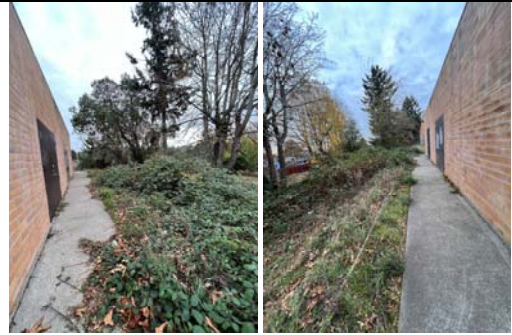
11. Foliage overgrowth

Deficiency/Observation: at exterior south wall, there is overgrowth of foliage and existing terracing that is adjacent to the sidewalk that is almost concealed by the overgrowth; this potentially is a safety issue as the south property slopes down in from the existing sidewalk

Recommendation: remove the overgrowth of foliage so the terracing is visible.

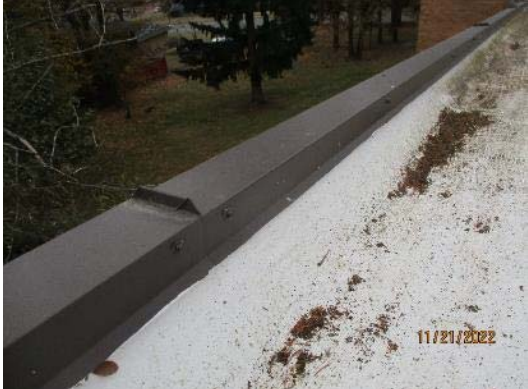
Description	Photo
<p>1. Overview of the low parapet wall and standing seam coping metal. Coating terminates at bottom edge of coping, indicating coping was not removed as part of the coating application. <i>Recommendation: Leave as-is and monitor for now. This condition can be addressed when reroofing, as there appear to be no current problematic conditions from this application.</i></p>

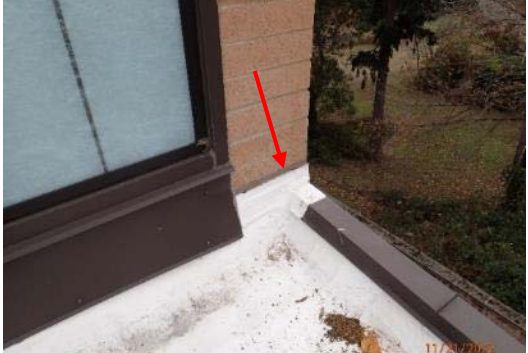
<p>2. Overview of the parapet to rising wall transition at the southeast corner of the main roof. The top edge of the baseflashing is not sealed (arrow). <i>Recommendation: Seal top edge of coating, install soldered saddle flashing that returns outside corner, and install sheet metal in saw cut to counterflash the saddle flashing.</i></p>

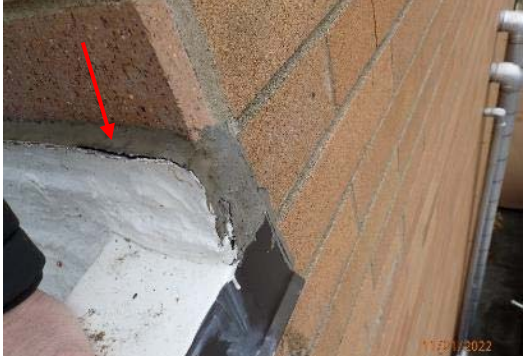
<p>3. Closer view of previous photo showing unsealed coating and lack of return around corner.</p>

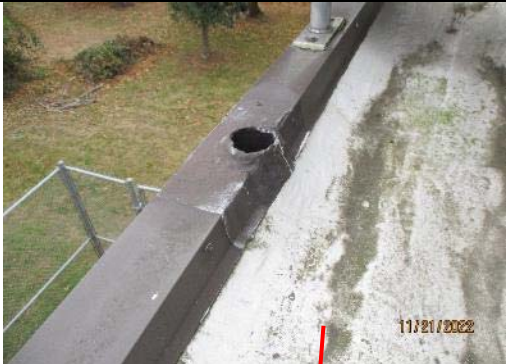
<p>4. Low pipe penetration through parapet at south side of roof adjacent roof access ladder. <i>Recommendation: Raise pipe penetration with extension and flash with reinforced liquid flashing, such as PMMA, or similar.</i></p>

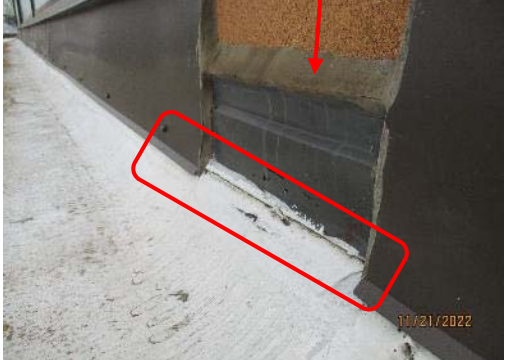
<p>5. Overview of the one-piece counterflashing at the roof to wall transition at the east end of the main roof. The sealant along the top edge of the counterflashing is cracking (arrow) and the roof membrane (and coating) does not terminate behind the counterflashing (highlighted). <i>Recommendation: Remove counterflashing, extend roof membrane further up vertical surface, termination bar at top edge, and install new counterflashing set in a saw cut.</i></p>

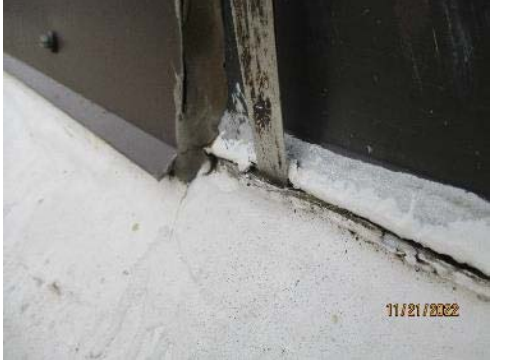
<p>6. Closer view of previous photo showing roof membrane and coating not installed behind metal flashing.</p>

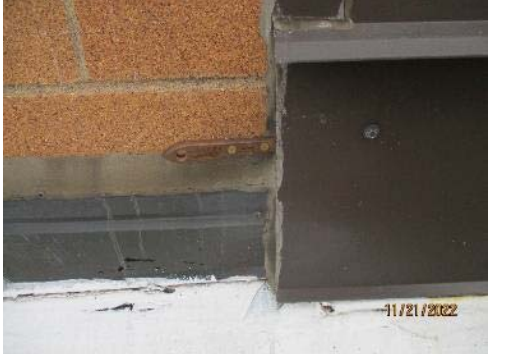
<p>7. Sealant no longer adhered between brick and metal flashing at the base of the clerestory window at the east end of the main roof. <i>Recommendation: Reseal joints after lower counterflashing is replaced, per item #5 & 6.</i></p>

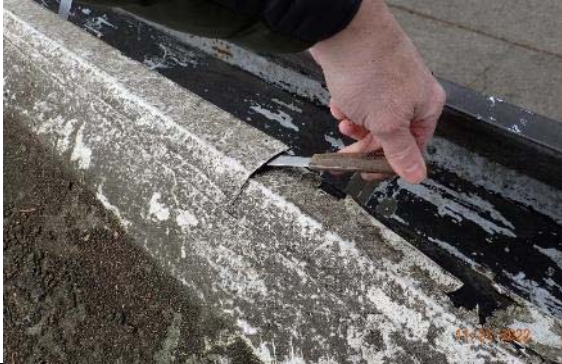
<p>12. View of open lap joints in drip edge metal, as indicated in previous item. <i>Recommendation: See item #11.</i></p>

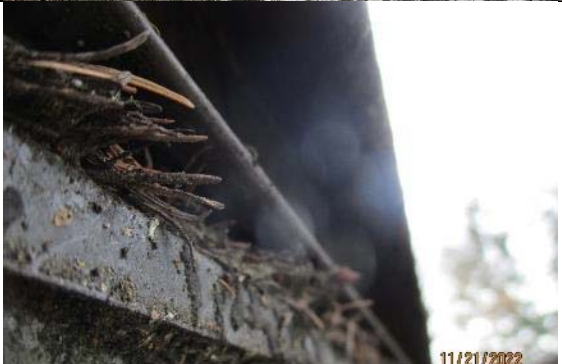
<p>13. View of the underside of the drip edge metal as shown in the two previous photos. Note the second layer of metal drip edge and organic debris collecting under the drip flashing. <i>Recommendation: Remove debris.</i></p>

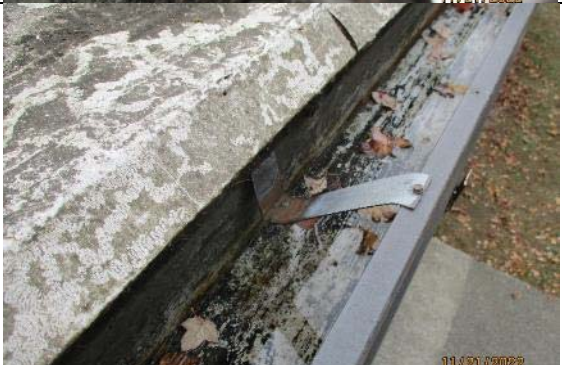
<p>14. Broken gutter straps at the west end of the main roof. <i>Recommendation: Replace gutters when reroofing occurs.</i></p>

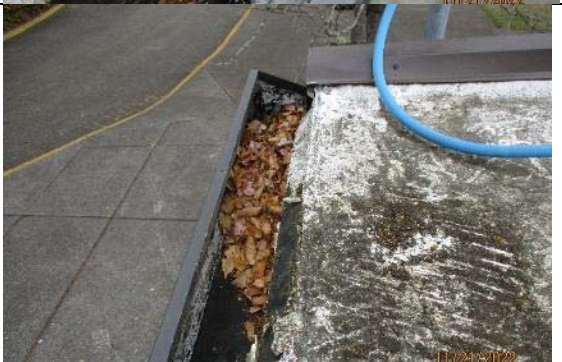
<p>15. Front edge of gutter appears to be higher than drip edge metal which creates a condition where water can backup under drip edge metal and into roof assembly. <i>Recommendation: Replace gutters when reroofing occurs. Front edge of new gutter should be lower than back and gutters sized appropriate for roof area.</i></p>

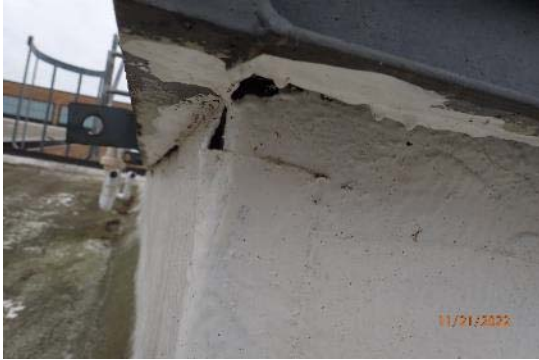
<p>20. Closer view of the breach in the curb baseflashing highlighted in the previous photo. <i>Recommendation: Seal corner and/or attempt to insert sheet metal skirt flashing up behind flange of unit, lapping over roof membrane/coating. When reroofing, unit will likely need to be lifted to allow installation of new roofing and sheet metal flashing.</i></p>

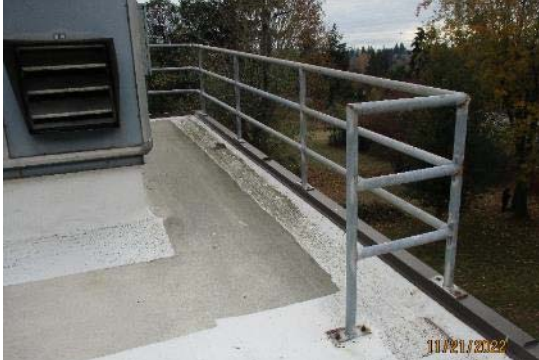
<p>22. Railing installed around mechanical unit at the south end of the roof is mounted with fasteners driven directly through the coping and roofing membrane, without flashing. <i>Recommendation: Install reinforced liquid flashing membrane up pipe penetrations, covering bolts and base plates. Verify there are no open holes in pipe rails</i></p>

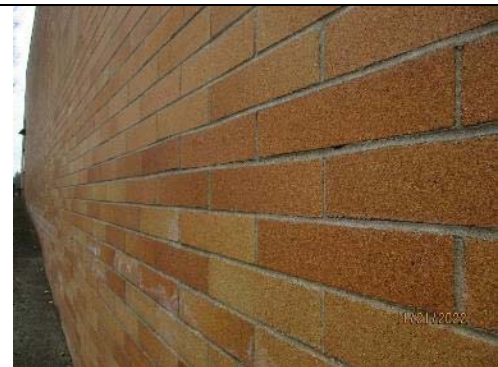
1. View of the north elevation, looking west. Voids in the mortar were observed at the north elevation, although less than observed at other elevations.
Recommendation: Repair voids in the mortar with the additional mortar after tuckpointing to remove existing mortar, as necessary. Install water repellent over surface of brick and mortar.

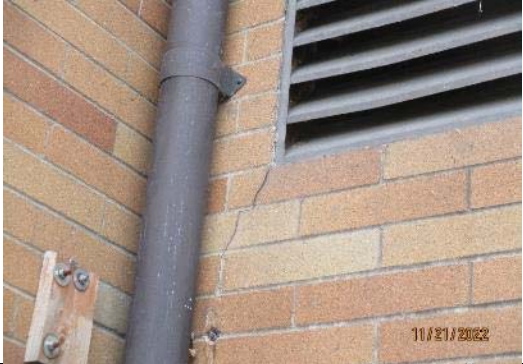
<p>6. Additional cracks at the east elevation. <i>Recommendation: see previous.</i></p>

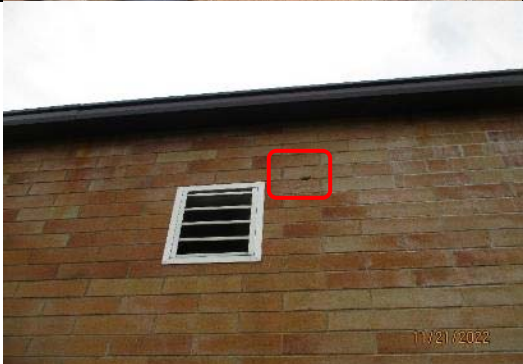
<p>7. Damaged brick, or brick with a hole from a previous penetration at the east elevation (highlighted). <i>Recommendation: Patch with mortar or clad over brick as indicated above.</i></p>

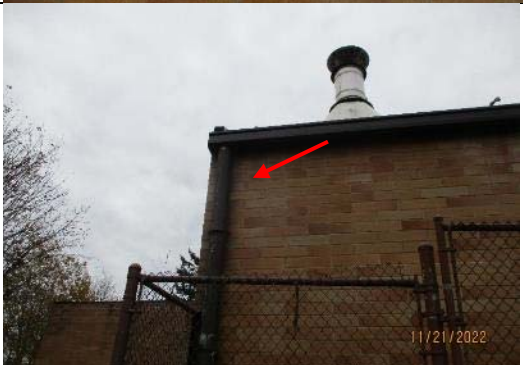
<p>8. Cracked brick at the southeast corner, east elevation (arrow).</p>

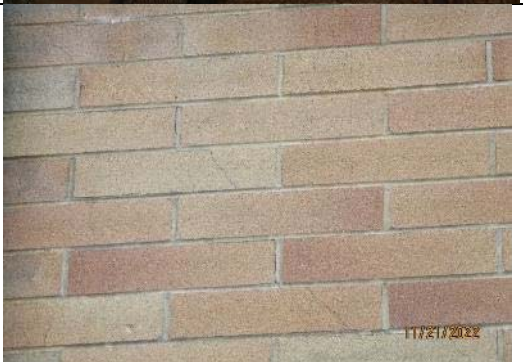
<p>9. Closer view of previous photo showing crack through brick and mortar. <i>Recommendation: Structural repair appears necessary to prevent future cracking, followed by replacement of the brick. Another option is to install new cladding, insulation, and weather barrier over the brick after structural repairs.</i></p>

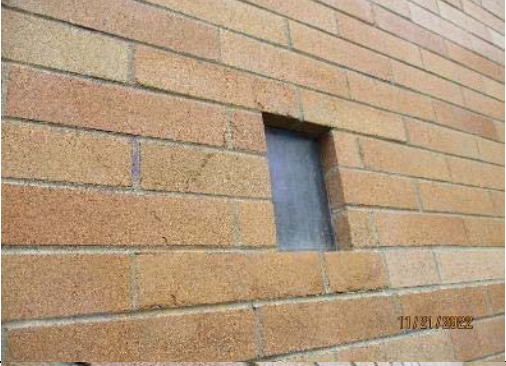
<p>14. Cracked brick around small windows at the south elevation, towards the west end of the building. <i>Recommendations: Structural repair appears necessary to prevent future cracking, followed by replacement of the brick. Another option is to install new cladding, insulation, and weather barrier over the brick after structural repairs.</i></p>

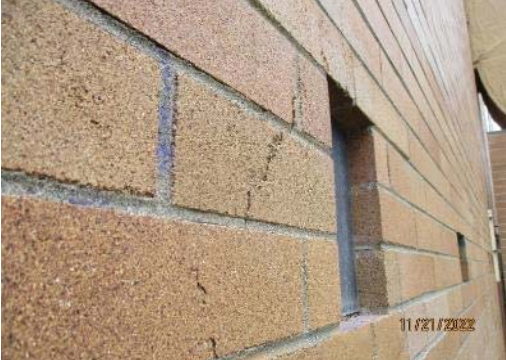
<p>15. Closer view of cracks in brick as noted in previous photo. <i>Recommendations: See previous.</i></p>

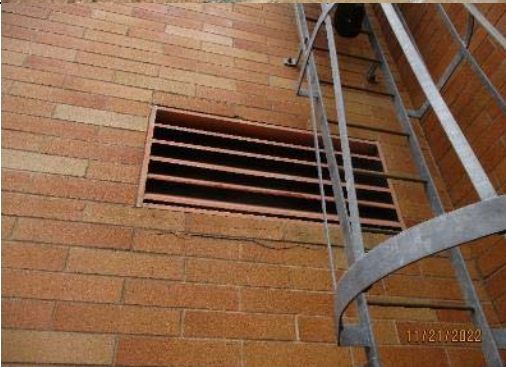
<p>16. Overview of cracking/spalled brick below louver adjacent the roof access ladder at the south elevation. <i>Recommendations: Structural repair appears necessary to prevent future cracking, followed by replacement of the brick. Another option is to install new cladding, insulation, and weather barrier over the brick after structural repairs.</i></p>

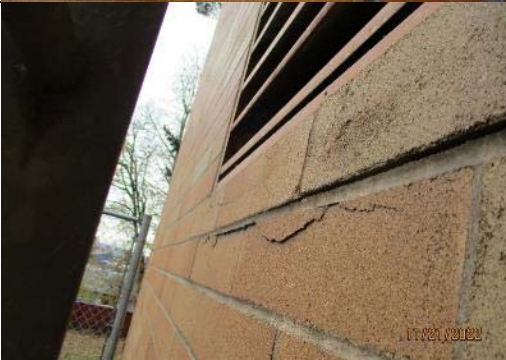
<p>17. Closer view of cracks in brick as noted in previous photo. <i>Recommendations: See previous.</i></p>

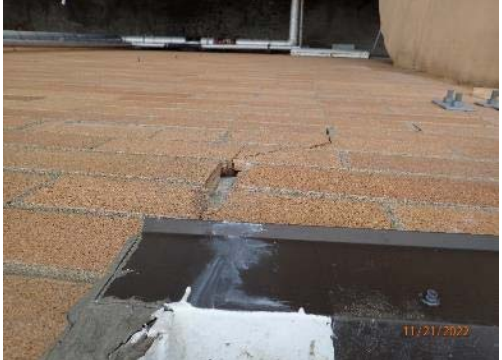
<p>18. Looking down from the roof at the south elevation, where the main roof transitions to the clerestory structure. There is a large crack in the brick and mortar.</p> <p><i>Recommendations: Structural repair appears necessary to prevent future cracking, followed by replacement of the brick. Another option is to install new cladding, insulation, and weather barrier over the brick after structural repairs.</i></p>

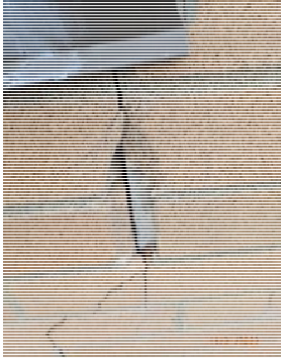
<p>19. Closer view of cracks in brick as noted in previous photo.</p> <p><i>Recommendations: See previous.</i></p>

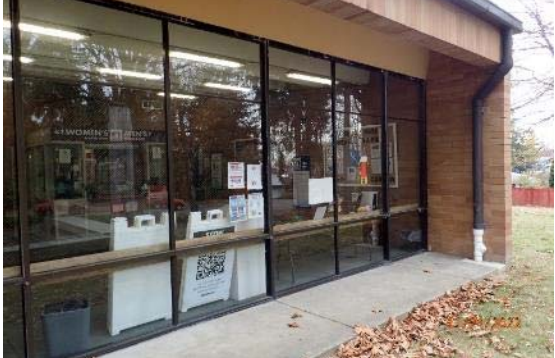
<p>20. Overview of storefront windows at the west elevation. Note the downspout from the gutter that extends to grade and the reduced diameter of the PVC (white) drain line that extends below grade.</p> <p><i>Recommendations: Perform drain calculations for roof to determine if below grade drain lines need to be increased in size to match roof downspout diameter.</i></p>

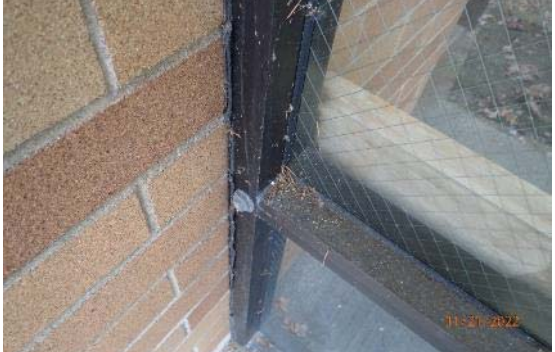
<p>21. Unadhered sealant joint at the perimeter joint of the storefront windows-to-brick.</p> <p><i>Recommendations: Remove existing sealant and replace with new sealant and backer rod.</i></p>

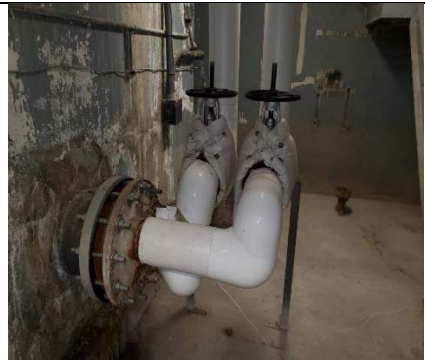
<i>Description</i>	<i>Photo</i>
<p>1. Pool heating tube bundle (Critical-1, wear and tear) <u>Deficiency/Observation:</u> M001 <u>Recommendation:</u> The connection between the hydronic piping and the pool heating tube bundle leaks. According to staff, the bundle was replaced in 2020 and the leak is due to a failure in the penetration itself. Re-installation of the tube bundle is required and needs to be coordinated with any surge tank repairs.</p>

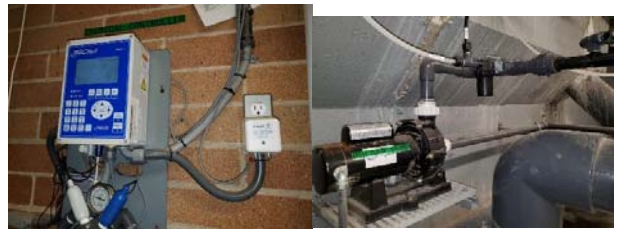
<p>3. Disinfecting Chemical Conversion. (Optional-wish list) <u>Deficiency/Observation:</u> M003 (Optional- wish list) <u>Recommendation:</u> Replace existing solid Chlorine injection system to a Bromine or Saline electrolysis system.</p>

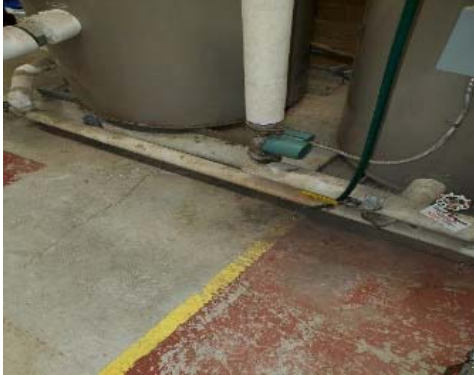
Description	Photo
<p>4. Domestic Water Heaters (Critical -1, life safety) <u>Deficiency/Observation:</u> M004 <u>Recommendation:</u> Domestic water heaters are not seismically restrained. While this is a life-safety issue, the age of the tanks indicates replacement. If replacement is undertaken, the entire domestic hot water design needs to be evaluated and alternatives designs considered. The major hot water load (locker rooms, showers) is on the opposite end of the building. Alternative heat sources and configuration should be considered.</p>

Item #4: replace domestic hot water system. We suggest a heat pump water heater with a gas-fired or hydronic back-up heating tube bundle.

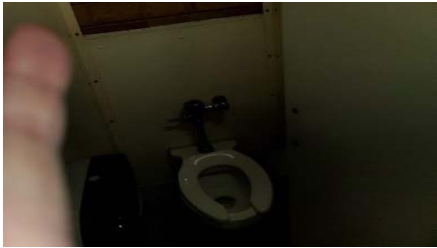
<p>5. Lobby public restrooms (General -3; ADA violations) <u>Deficiency/Observation:</u> M005 <u>Recommendation:</u> Existing public restrooms need to be re-configured to meet ADA requirements. Replace fixtures with code compliant fixtures. Staff suggests low flow fixtures not be used, due to frequent clogging. A code variance should be considered to use blow-out type water closets.</p>

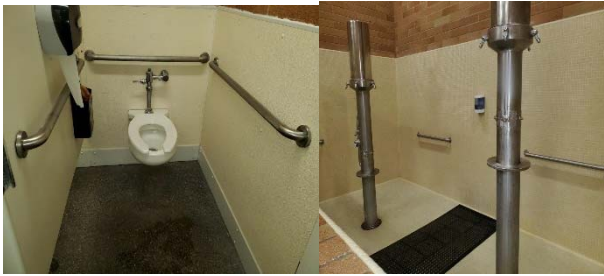
<p>6. Locker room plumbing fixtures (General-3; Wear and tear) <u>Deficiency/Observation:</u> M006 <u>Recommendation:</u> Replace all existing plumbing fixtures with modern, code compliant fixtures. Replace existing gang showers with individual temperature control shower valves and heads.</p>

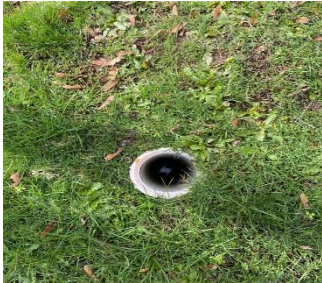
<p>7. Exterior clean-out caps (General-3; Wear and Tear) <u>Deficiency/Observation:</u> M007 <u>Recommendation:</u> Install new hub and cap on existing open clean-out south of the building.</p>

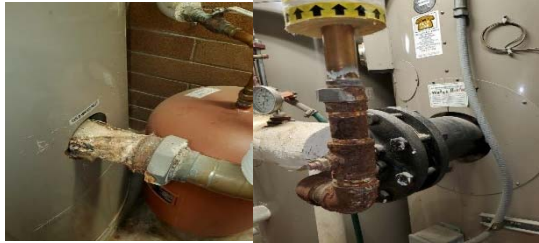
Description	Photo
<p>8. Replace di-electric unions (Critical 1, wear and tear) <u>Deficiency/Observation:</u> M008 <u>Recommendation:</u> Replace all di-electric unions with proper di-electric waterway fittings. Replace corroded sections of piping and damaged insulation. This should be coordinated with the boiler system replacement.</p>

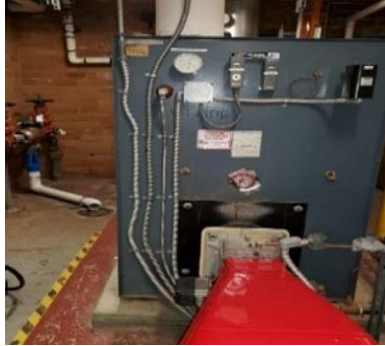
<p>9. Cast iron boiler system (Critical -2; wear and tear) <u>Deficiency/Observation:</u> M009 <u>Recommendation:</u> The existing cast iron boiler system has no redundancies. The boiler was recently (2013) retrofit with a variable-fire burner, which reduced energy use, however, the cast iron boiler has limited thermal efficiency. We suggest replacement of the single boiler with two 50% load sized, condensing boilers, and revise/replace piping and pumps to accommodate a conventional variable speed pumping design.</p>

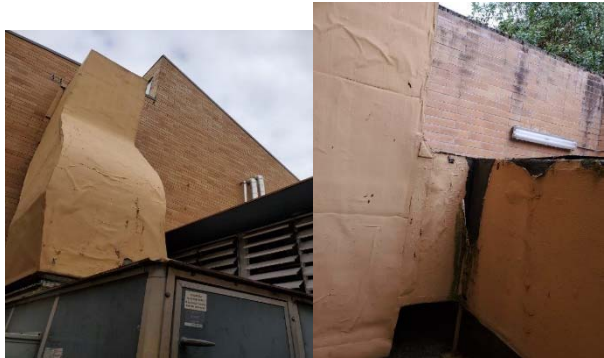
<p>10. Exterior insulated supply and exhaust ductwork (Critical-1: wear and tear) <u>Deficiency/Observation:</u> M010 <u>Recommendation:</u> Existing fabric exterior duct insulation has failed. Remove existing insulation and replace sections of rusted ductwork. Install new duct insulation and provide sheet metal jacketing. The extent of ductwork damage is not known. This should be incorporated with the replacement of the Natatorium HV unit.</p>

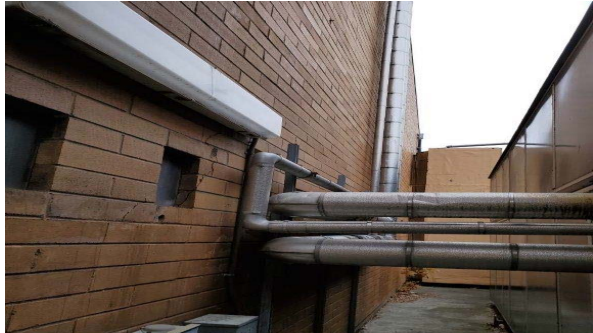
<p>11. Natatorium HV unit (Critical-2, wear and tear) <u>Deficiency/Observation:</u> M011 <u>Recommendation:</u> Replace pad mounted Natatorium HV system with a new refrigerated de-humidification system. New equipment will require additional electric circuits to operate the refrigeration section, which will also require electric service upgrades.</p>

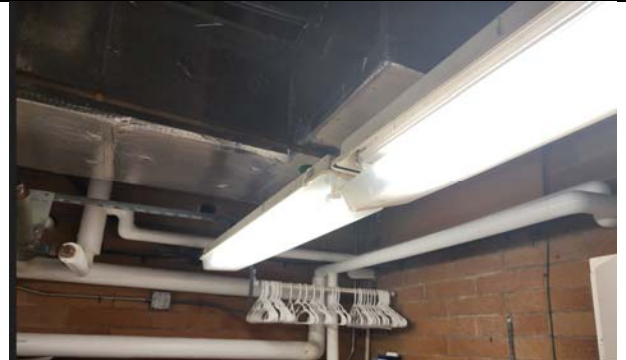
Recommendation:

Replace with LED light fixtures with 10% up-light and listed for wet or damp location. All supports shall be suitable for location per NEC 300.6. Replace conduit suitable for location NEC 680.12, & 300.6.
