Des Moines Pool Metropolitan Park District

September 26, 2023 7:00 p.m. Regular "Hybrid" Meeting

MOUNT RAINIER POOL EXISTING CONDITION ASSESSMENT and FEASIBILITY STUDY

CONDITION ASSESSMENT REPORT for MOUNT RAINIER POOL

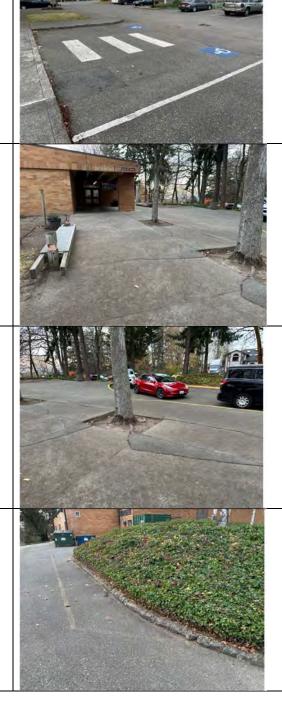
Deficiency/Observation: The majority of the existing extruded curbs are disintegrating.

Recommendation: Replace existing extruded curbs.

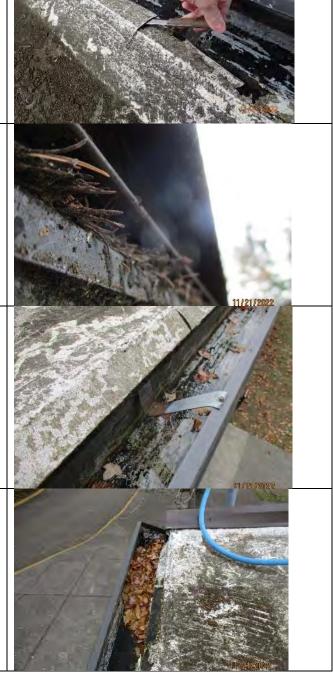
15. Front edge of gutter appears to be higher than drip edge metal which creates a condition where water can backup under drip edge metal and into roof assembly.

Recommendation: Replace gutters when reroofing occurs. Front edge of new gutter should be lower than back and gutters sized appropriate for roof area.

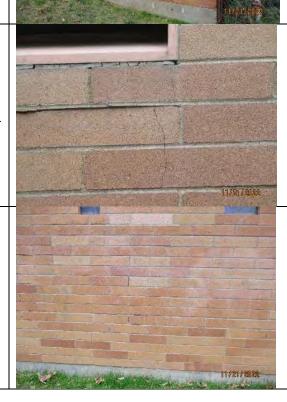
13. Overview of damaged mortar and brick where power washing has occurred to remove graffiti at the south elevation.

Recommendation: Repair voids in the mortar with the additional mortar after tuckpointing to remove existing mortar, as necessary. Install water repellent and anti-graffiti coating, over surface of brick and mortar. Another option is to install new cladding, insulation, and weather barrier over the brick.

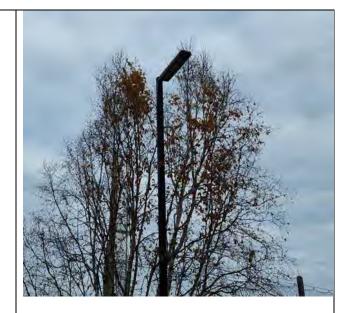
Newer LED pole lights appear to be sufficient.

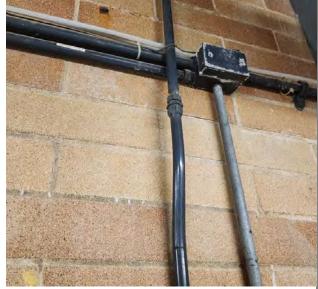
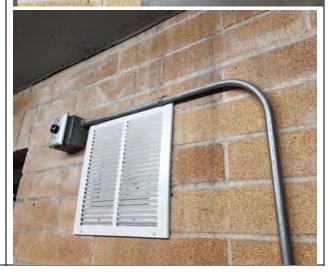
13. – Pool Area Room

Deficiency/Observation: Many conduits, elbows, couplings and fittings in pool area appear corroded.

Replace with corrosive resistant conduits, elbows, couplings and fittings in pool area per NEC 680.12 & 300.6.

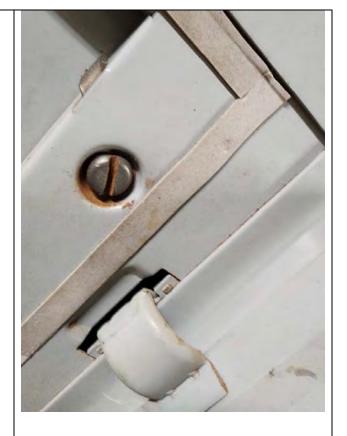
Deficiency/Observation: Panel P2 225A 120/208V 3-Phase shows rust but not as bad as other panelboards. Panelboard appear to be from 1987 and manufactured by ITE.

Panelboard is past the standard life expectancy of 30 years. Full replacement and potential upgrades to capacity. Panel and raceway shall be suitable for the environment NEC 680.14, 680.12 & 300.6.
